Access Audit Final Site Report

**Gary Morava Recreation Center
110 W Camp McDonald Rd
Prospect Heights, IL 60070**

**Inspection Date: 02/29/2024
Inspectors: Shelley Zuniga**

Prepared By
WT Group

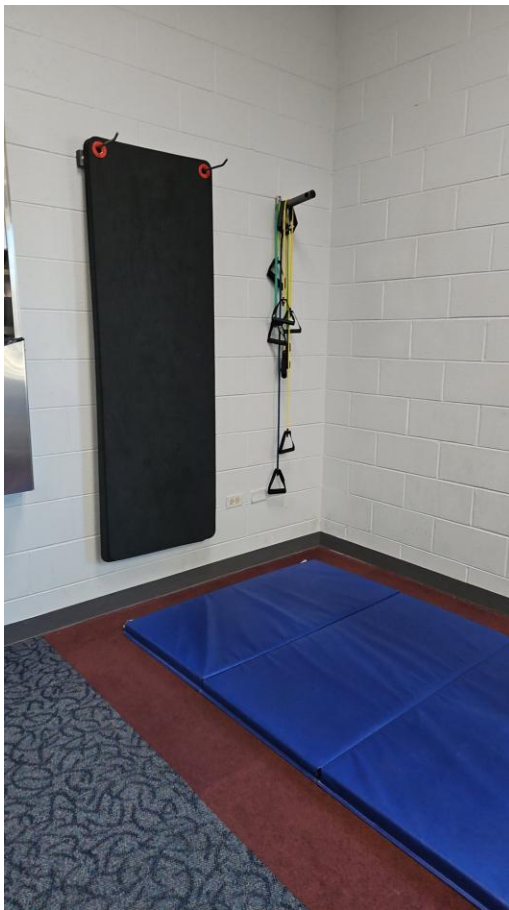
Fitness - mat in CFS at loose equipment

Remove, or relocate storage in CFS at fixtures and operable parts.

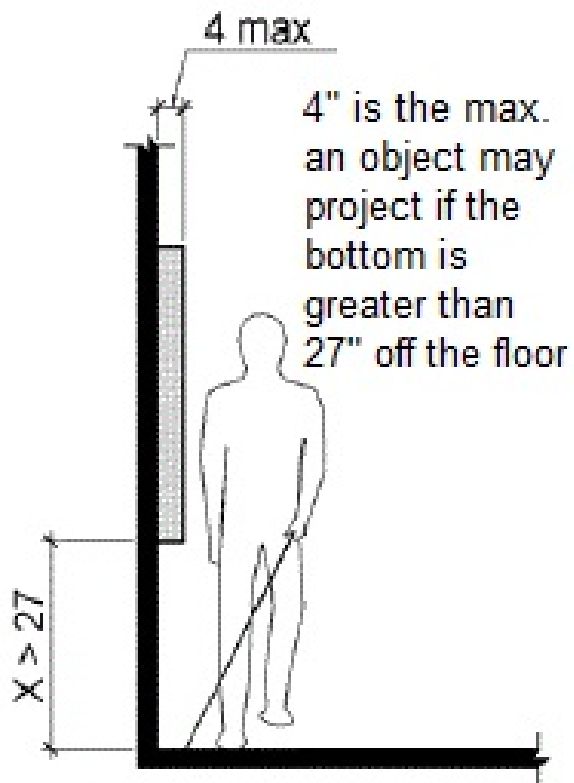
Finding #120 Additional Finding Photos

Wall-mounted objects that have leading edges between 27 inches and 80 inches from the floor must not project more than 4 inches into the circulation path. Protruding objects that extend to the floor or within 27 inches of the floor are cane detectable and are therefore not hazardous. Where it is necessary or desirable to have objects protrude from the wall, a manner of cane detection must be provided.

Relocate protruding objects or place cane detectable bollard at foot of item.
