Access Audit Final Site Report

Lions Park
110 W Camp McDonald Rd
Prospect Heights, IL 60070

Inspection Date: 02/29/2024
Inspectors: Shelley Zuniga

Prepared By
WT Group

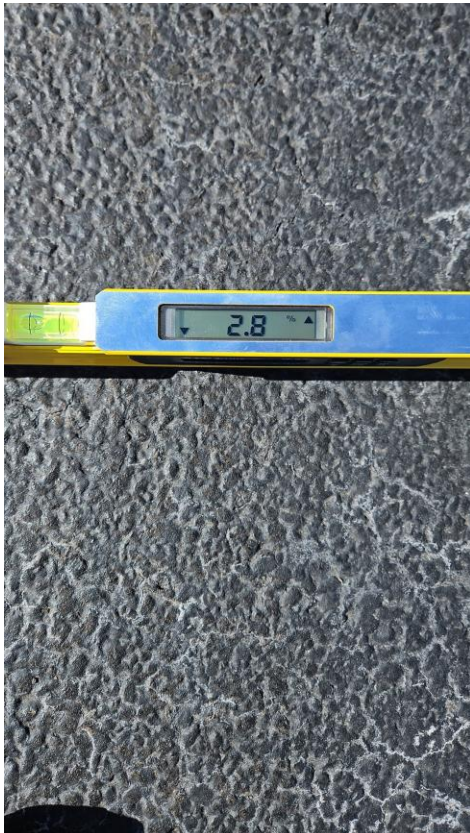
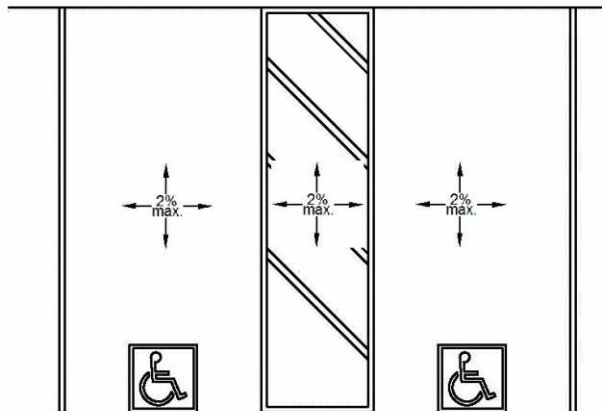
Finding: 2

The cross slopes (narrow dimension) and/or running slopes (long dimension) of the access aisle exceeds 2%.

baseball aisle - 2.8%
slope; right aisle at
tennis - 2.9%

Repair or correct slope of parking space and access aisle to max 2.08% in any direction.

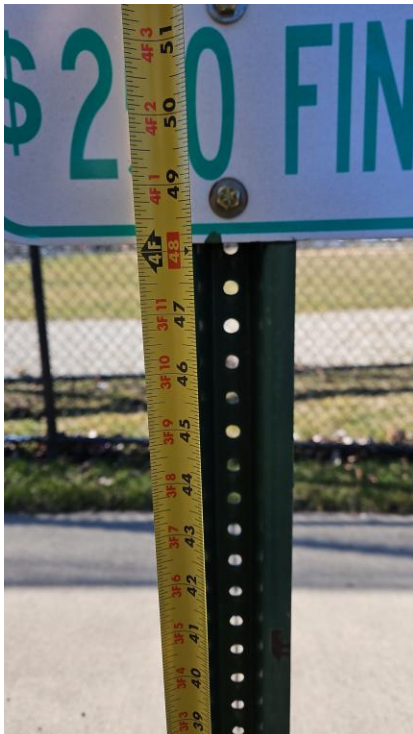
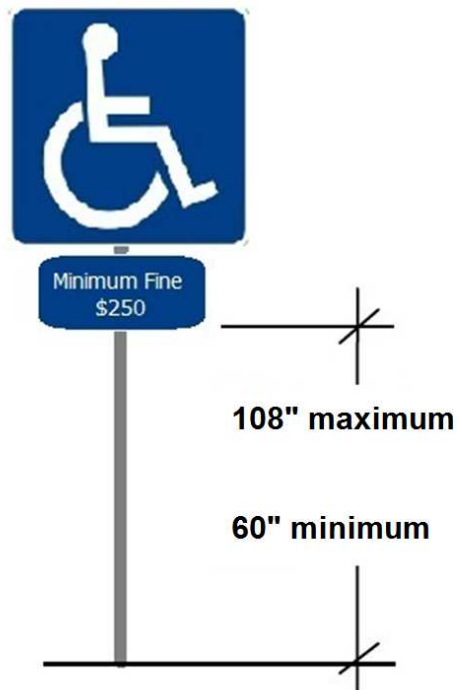
Finding: 3

The parking sign is mounted too low.

baseball stall - sign at 48"; tennis stalls - 48" and 49"

Raise existing accessible parking signs so lowest end of bottom sign is min 60" aff and max 108" aff

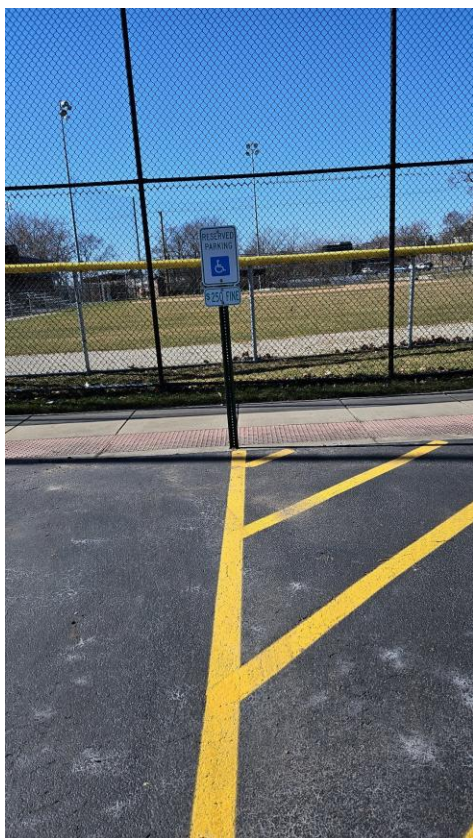
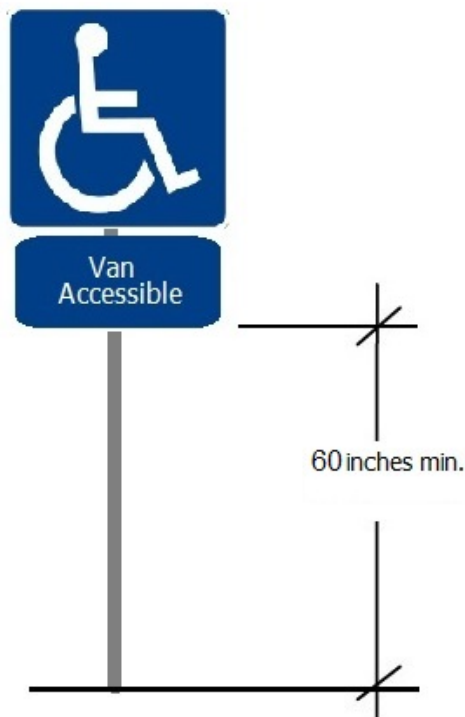
Finding: 4

The van stall is missing a sign identifying it as a van accessible stall.

van sized stalls lack
van sign

Add one van parking sign to one accessible stall and ensure stall and access aisle are 11' and 5' or 8' and 8'.

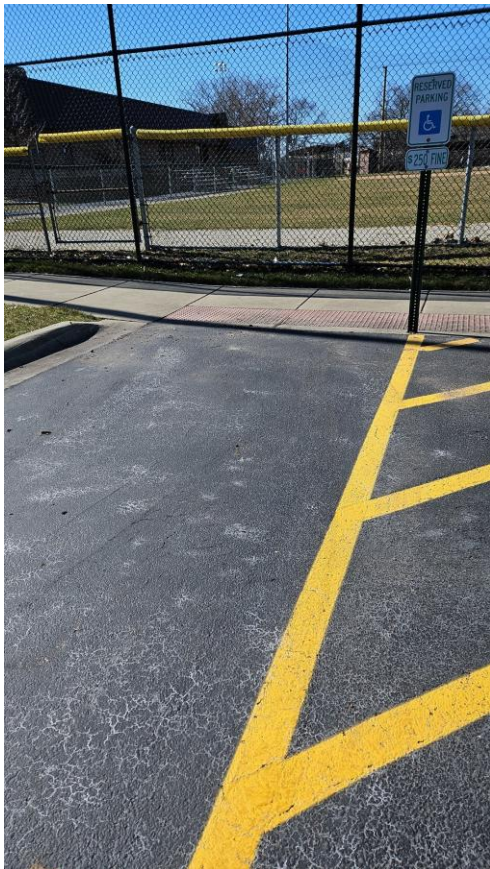
Finding: 5

The accessible route is constructed such that a park vehicle can obstruct the minimum 36 inch width.

stalls lack parking
bumpers

Install parking stops to prevent cars from parking and overhanging the accessible route.

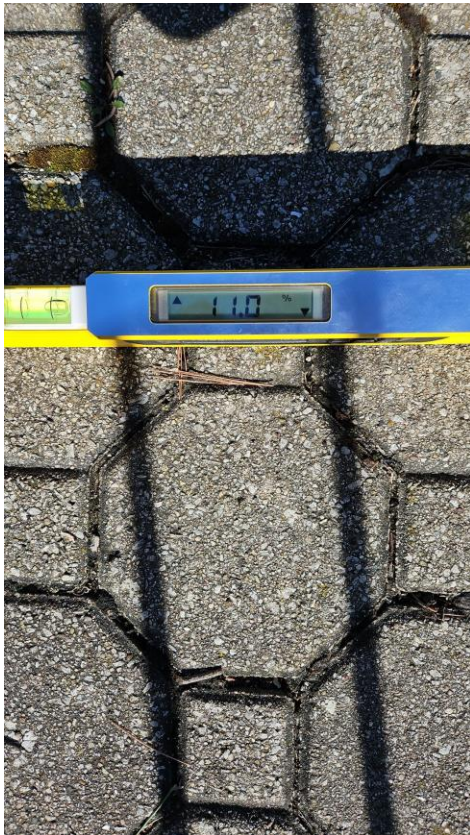
Finding: 6

The ramp slope exceeds the maximum running slope (direction of travel) allowable of 8.33%.

Ramp to shelter - 11%
running on second run

Correct slope of ramp to max 8.33%

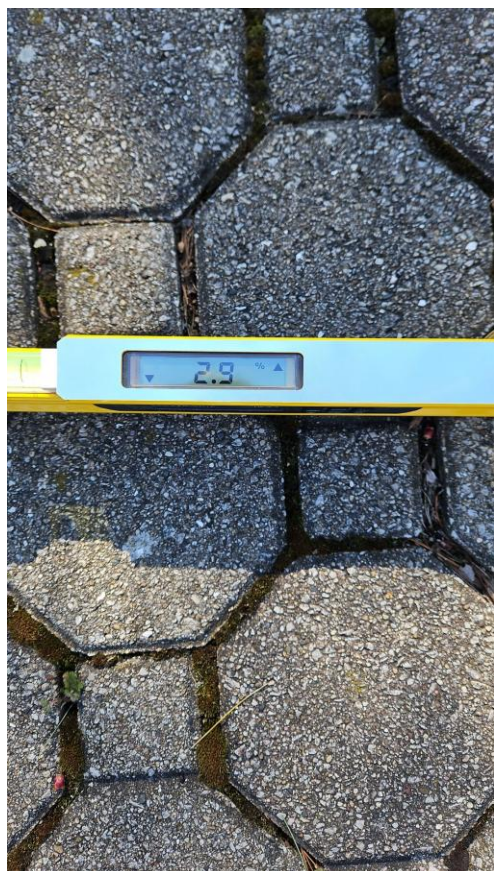
Finding: 7

The ramp on the accessible route contains cross slopes greater than 2%.

Ramp to shelter -
cross slopes: 2.9% at
top of first run, 5.4%,
20.2% on second run,
4.5% at top near
shelter

Correct ramp cross slope to max 2.08%

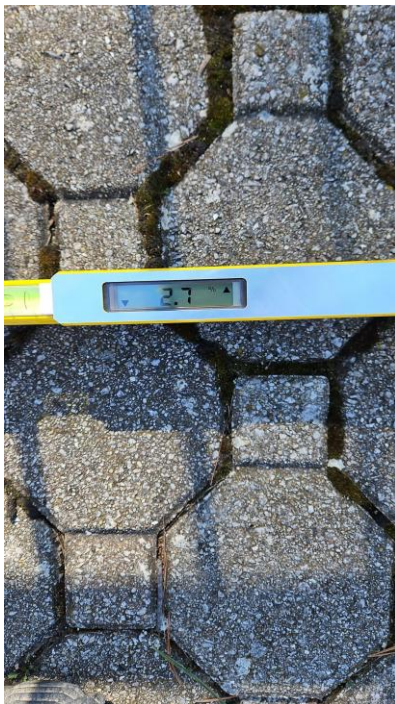
Finding: 8

The landing at the bottom of the ramp has a slope greater than 2%.

Ramp to shelter - 2.7%
at first landing, 6.3%
bottom landing

Correct ramp landing slope to max 2.08%

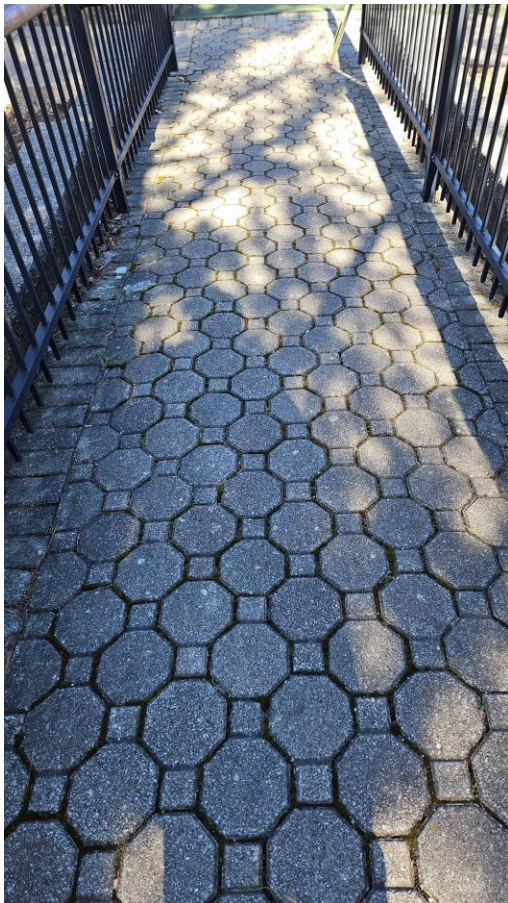
Finding: 9

Ramp to shelter -
pavers in disrepair,
recommend full redo

See previous findings for corrections to all runs and landings of ramp.

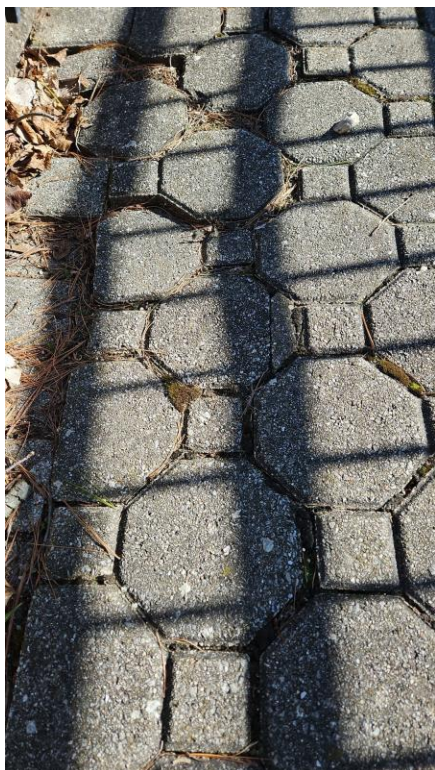
Finding: 10

There is a change in level greater than 1/4 inch.

Ramp to shelter -
sinking pavers create
CIL

Repair, bevel or ramp CIL along accessible route (AR) to max .25". Reset pavers, or create ramp out of a more stable material. Cost is previous findings.

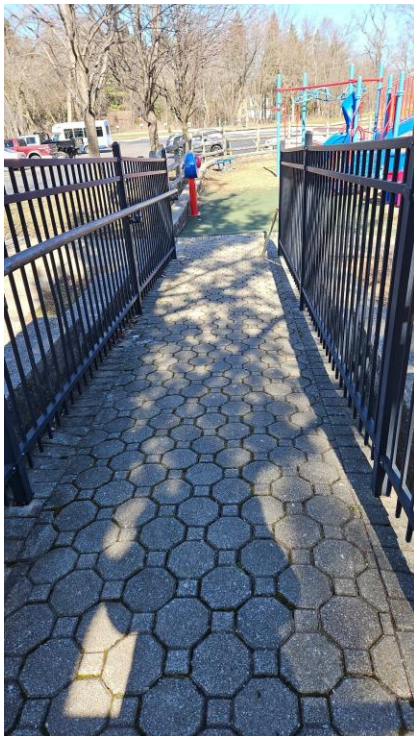
Finding: 11

The ramp does not have compliant handrails.

Ramp to shelter -
handrail on one side
only

Install handrails that are rounded and/or extend to the ground, with handrail extensions and mounted 34" to 38" aff

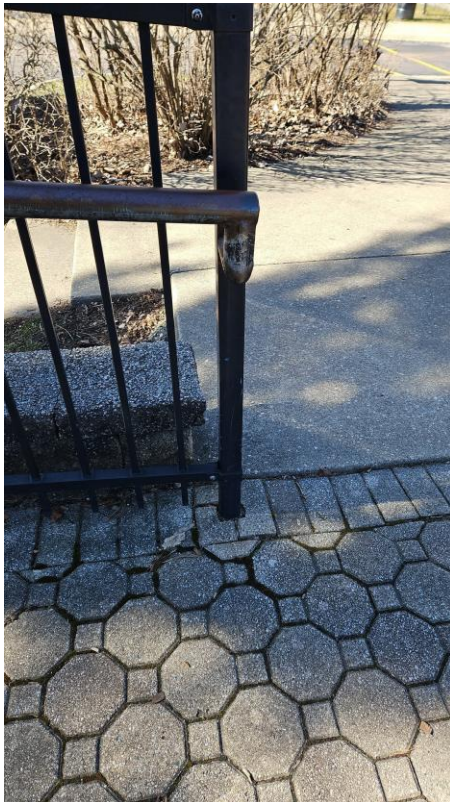
Finding: 12

The handrail is not continuous the entire length of the ramp.

Ramp to shelter - lack top and bottom extensions

Replace existing handrail with one that is continuous along the full length of the ramp and having required top and bottom extensions.

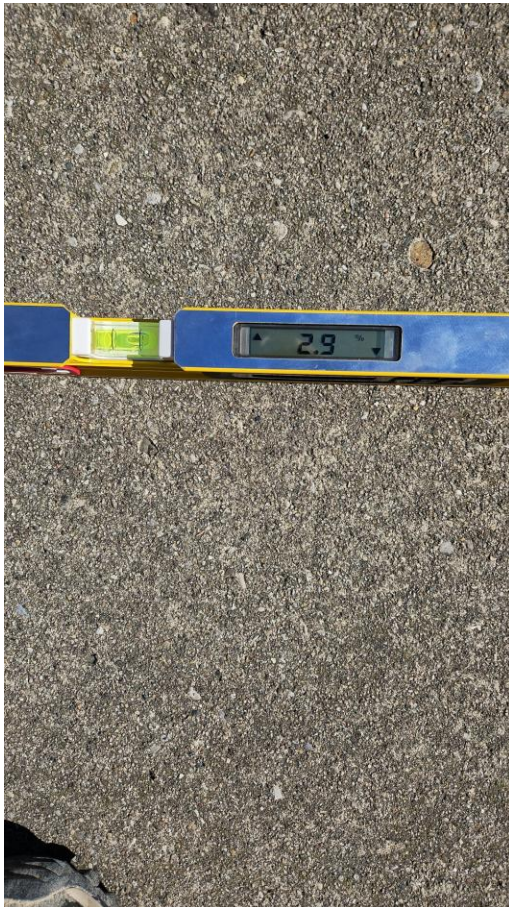
Finding: 14

2.9% cross to play area

Correct cross slopes to max 2.08%.

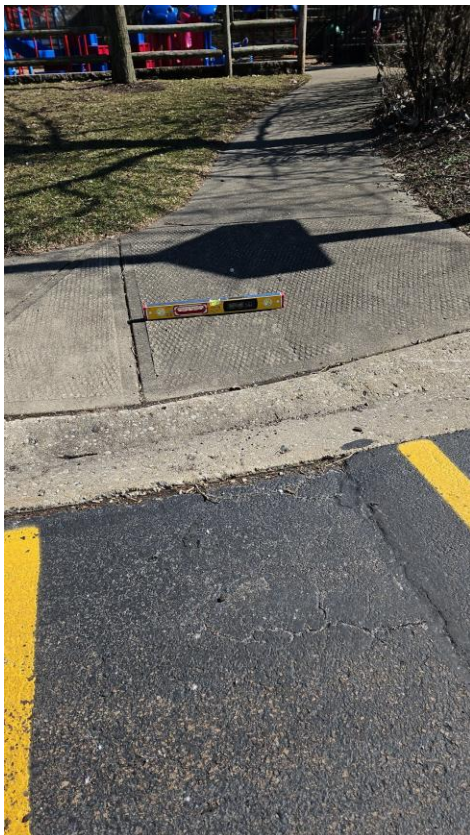
Finding: 15

The surface of the curb ramp is not firm, stable and/or slip resistant..

deterioration at curb
ramp from parking to
play area

Redo ramp to provide firm, stable and slip resistant surface.

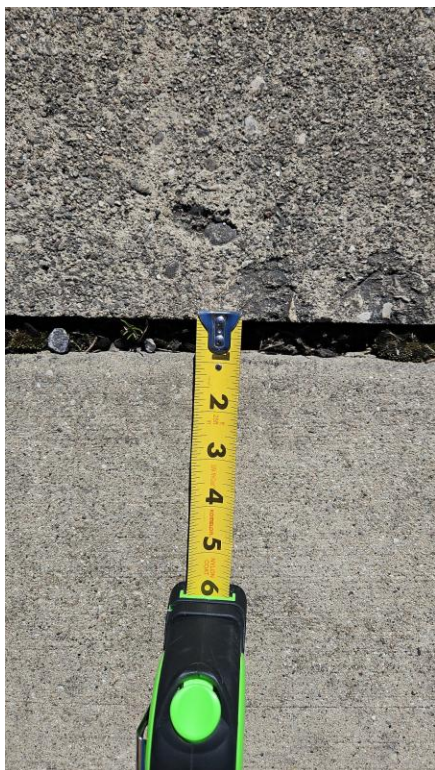
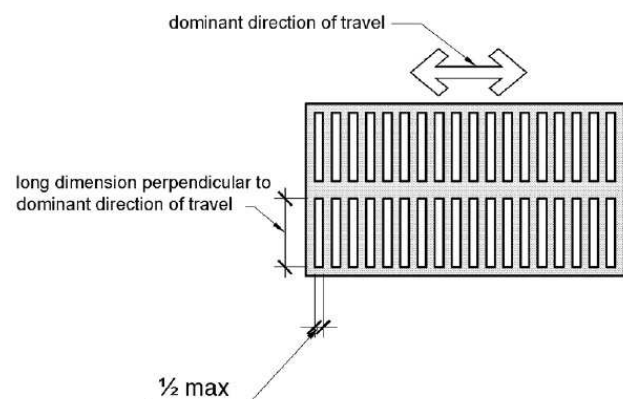
Finding: 16

There is a gap spaced greater than a 1/2 inch.

1" gap along tennis parking

Correct or fill gaps to be max .5".

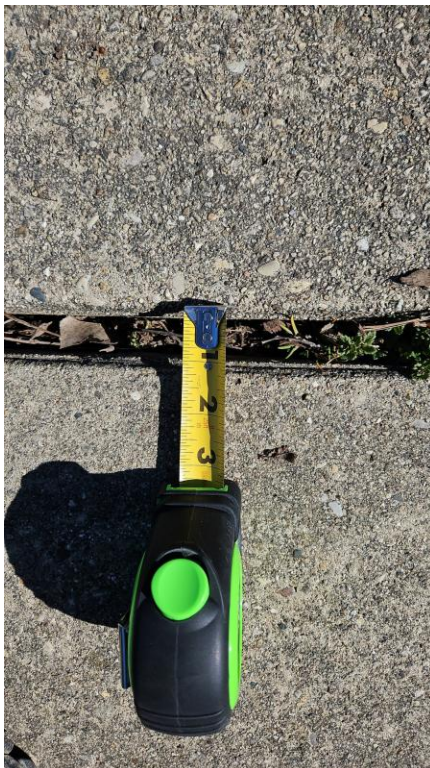
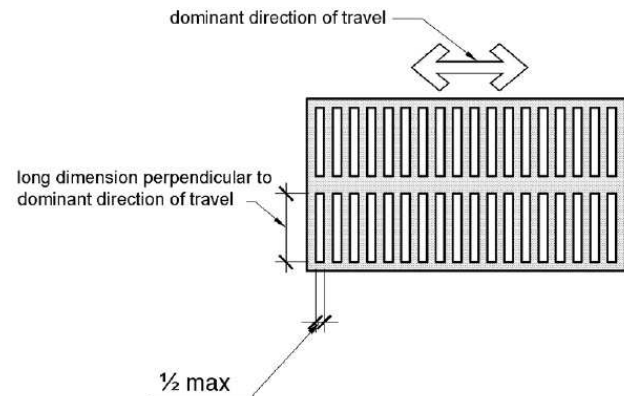
Finding: 17

There is a gap spaced greater than a 1/2 inch.

1" gap at tennis path

Correct or fill gaps to be max .5".

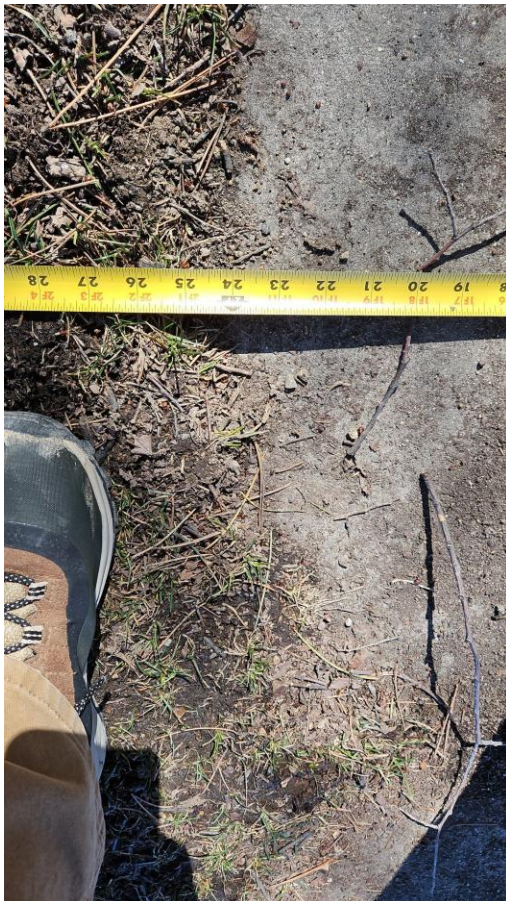
Finding: 18

The route of travel at this location does not provide the required minimum width.

route to shelter
reduces to 24" due to
mud runoff

Maintain route to min 36" clear width.

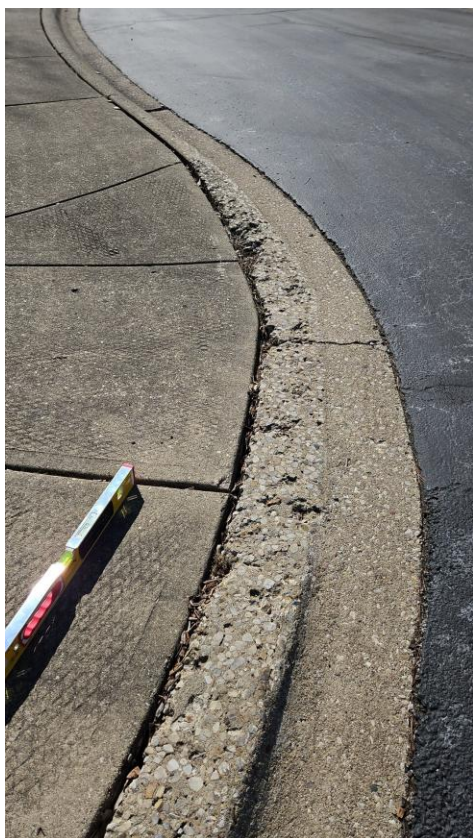
Ramp near baseball
stall - gutter
deterioration

Repair curb ramp to be firm, stable and slip resistant.

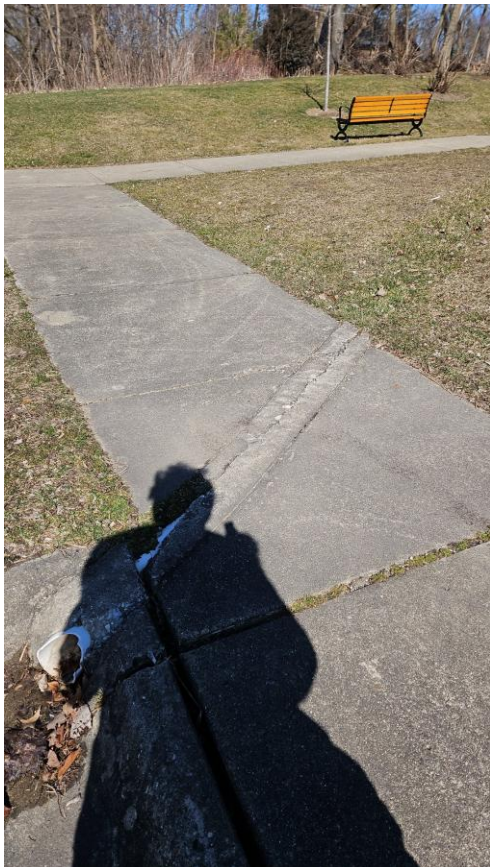
The accessible route contains loose gravel and/or surfaces that do not provide for a stable, firm slip resistant surface.

deterioration at
drainage pipe near trail

Resurface accessible route where deterioration occurs.
