# Access Audit Final Site Report

**McDonald Field**  
**200 W Camp McDonald Rd**  
**Prospect Heights, IL 60070**

**Inspection Date: 02/29/2024**  
**Inspectors: Shelley Zuniga**

Prepared By  
**WT Group**

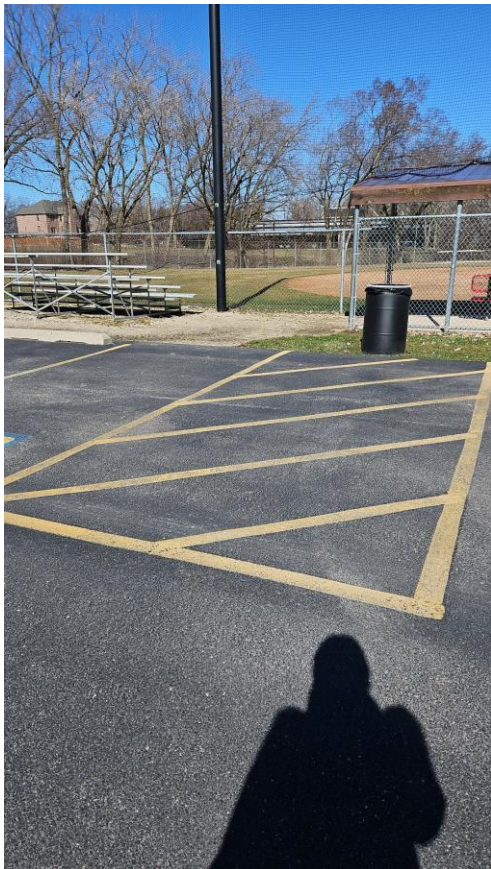
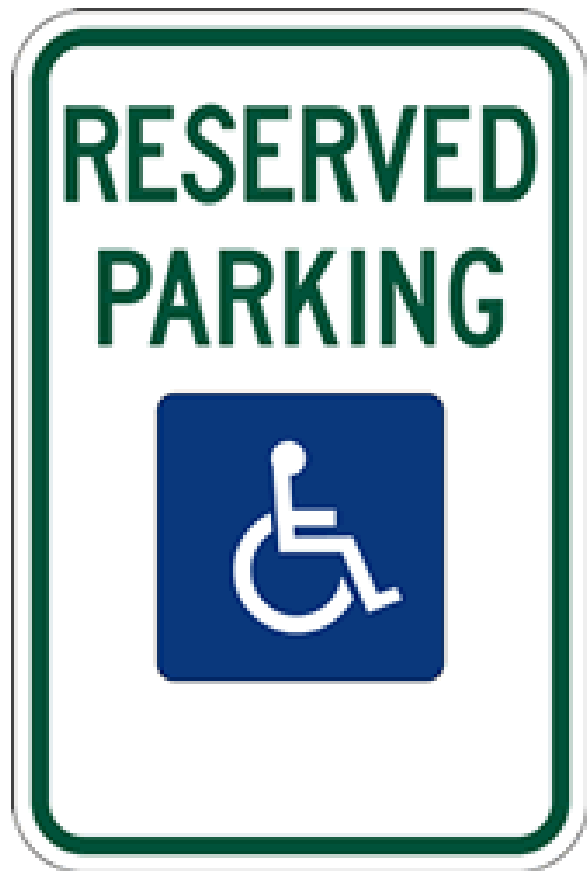
### Finding: 2

The accessible parking stall signage is incorrect and/or missing from each accessible parking space.

far left stall lacks sign

Acquire or replace and mount at appropriate heights and locations accessible parking signs where incorrect or missing. We recommend R7-8 signage.

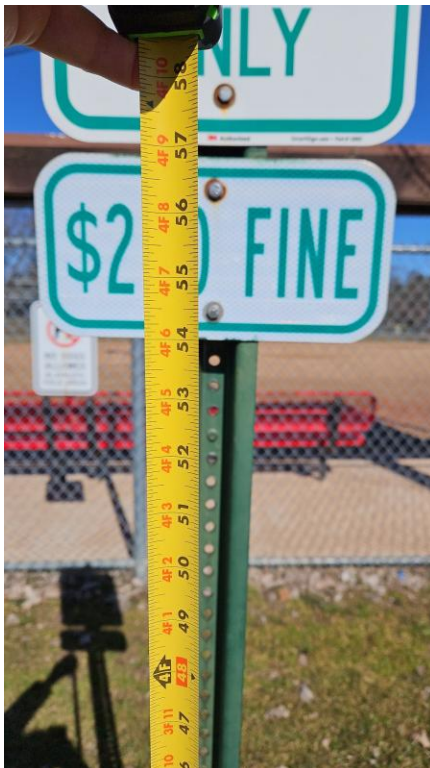
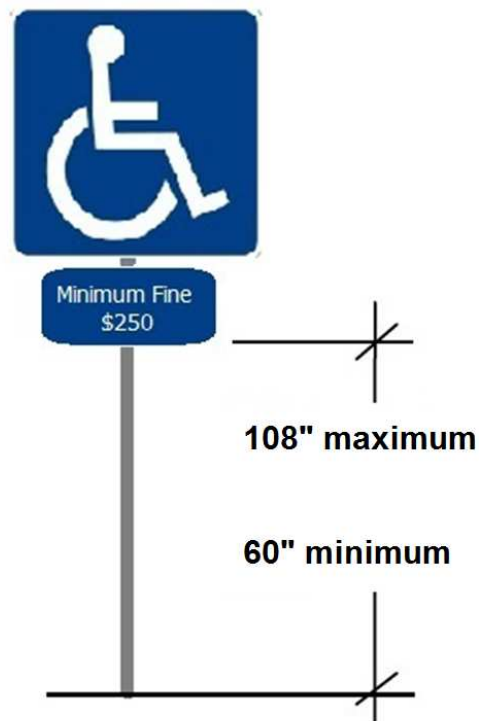
### Finding: 3

The parking sign is mounted too low.

signs low at 54" and 56"

Raise existing accessible parking signs so lowest end of bottom sign is min 60" aff and max 108" aff

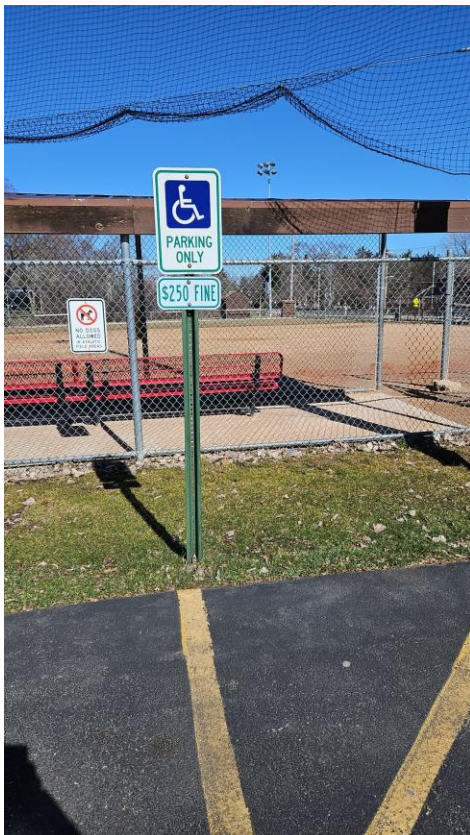
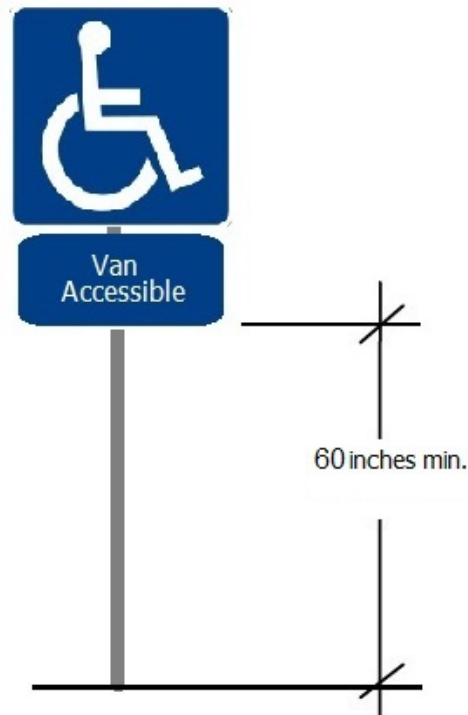
### Finding: 4

The van stall is missing a sign identifying it as a van accessible stall.

lacks van sign on van sized stall

Add one van parking sign to one accessible stall and ensure stall and access aisle are 11' and 5' or 8' and 8'.

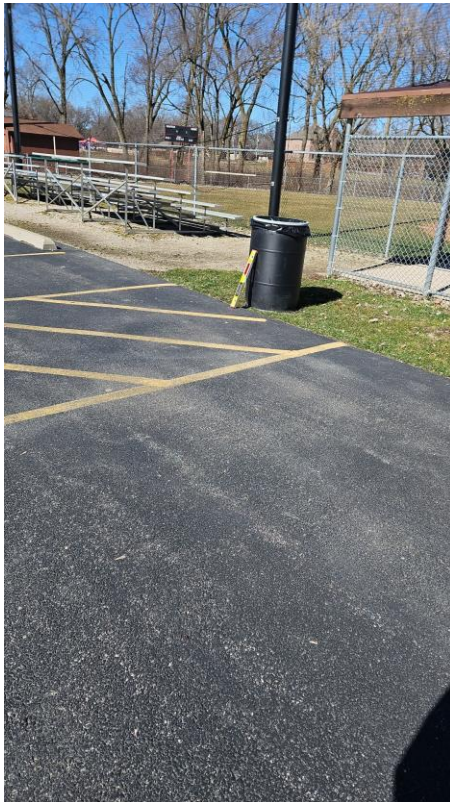
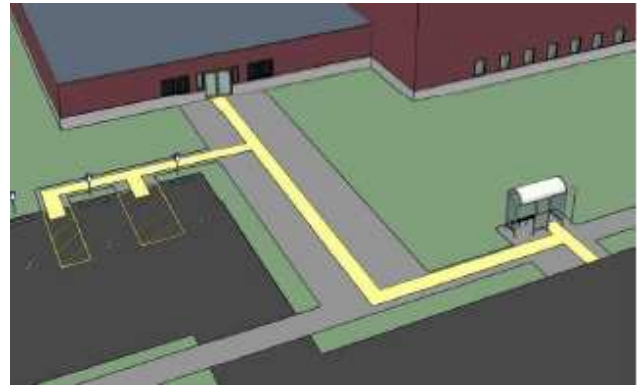
### **Finding: 5**

The access aisle is not located on an accessible route of travel to the accessible building entrance.

no accessible route

Assure access aisles connect to an accessible route once provided.

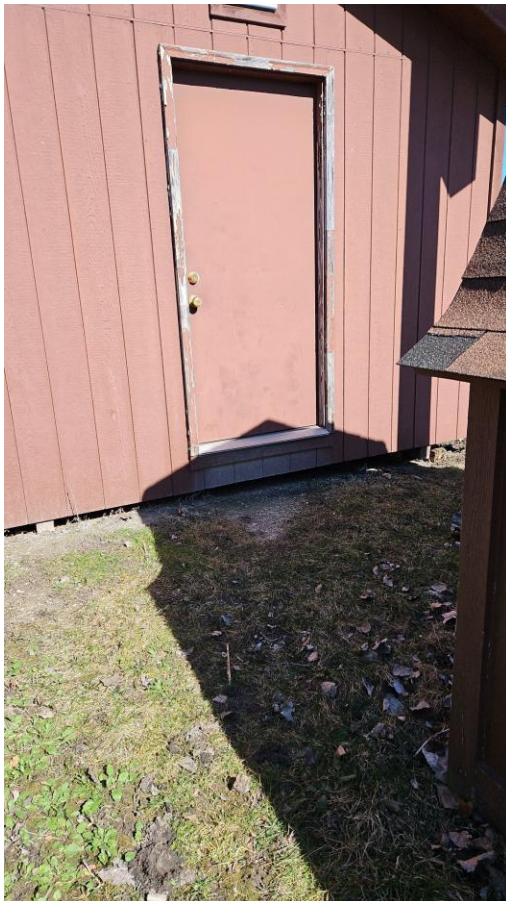
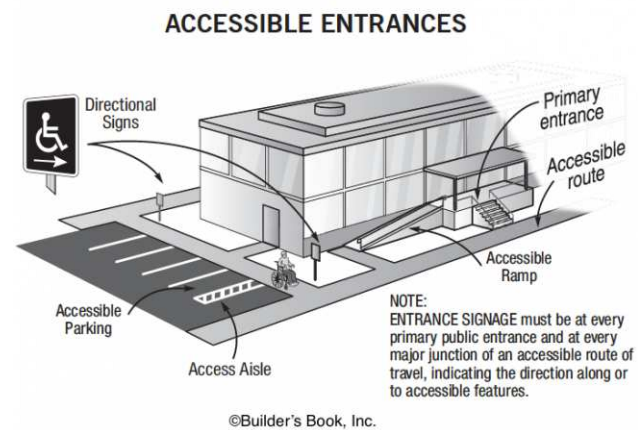
### Finding: 6

There is no accessible route to the element.

no route to affiliate  
group storage sheds  
(2)

Create an accessible route with crushed stone or other outdoor material from parking or walkway to element.

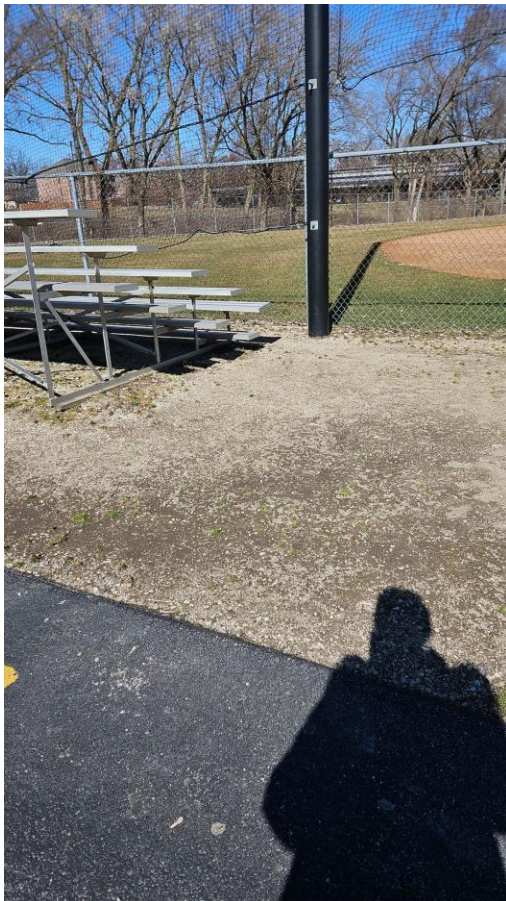
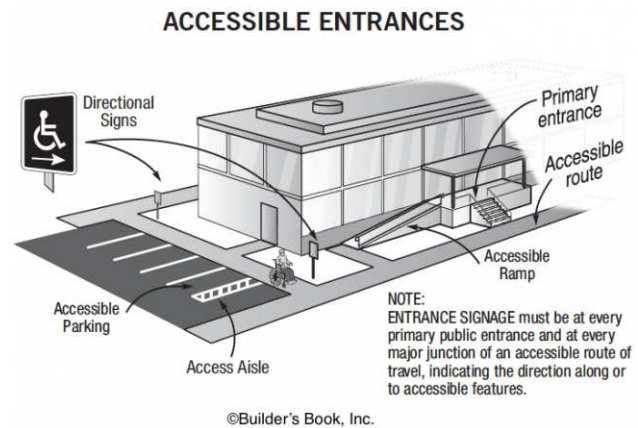
**Finding: 7**

There is no accessible route to the element.

bleachers and dugouts  
lack route - dirt or  
grass

Create an accessible route with crushed stone or other outdoor material from parking to dugouts and bleachers on both sides.

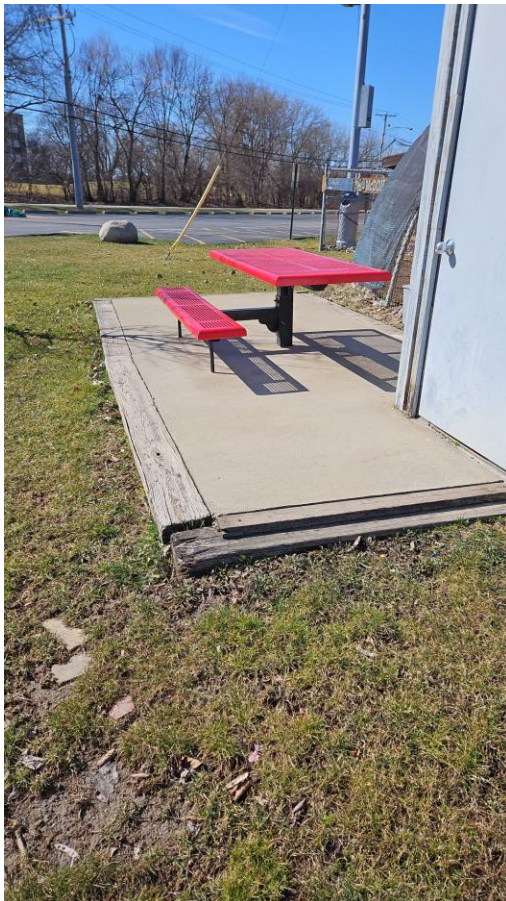
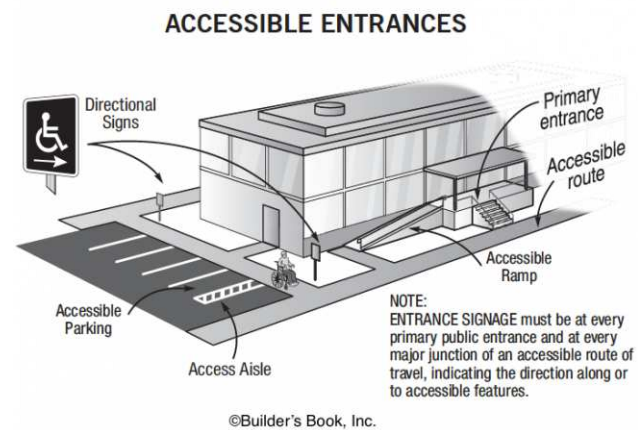
### Finding: 8

There is no accessible route to the element.

scorers table lacks  
route - grass

Create an accessible route with crushed stone or other outdoor material from parking or walkway to element.

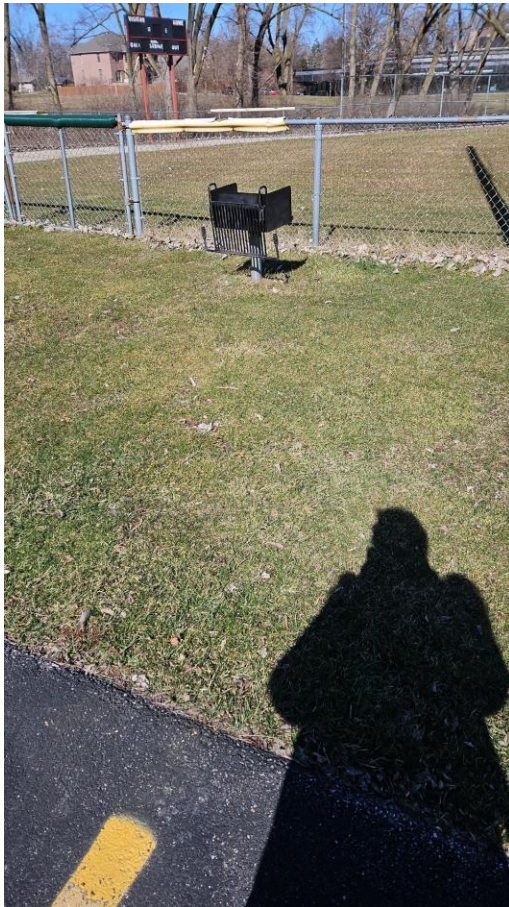
**Finding: 9**

The surface of outdoor recreation access routes, passing spaces, and resting intervals shall be firm and stable

grill lacks route - grass

Create an ORAR to be firm and stable to grill.

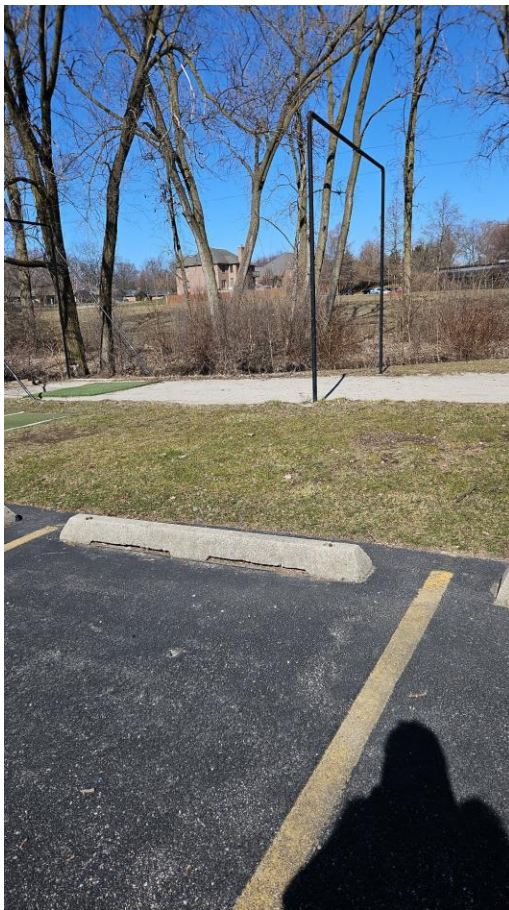
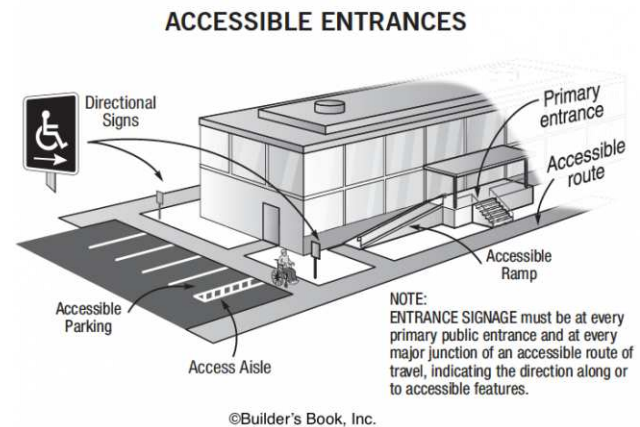
**Finding: 10**

There is no accessible route to the element.

batting cage lacks  
route - grass

Create an accessible route with crushed stone or other outdoor material from parking batting cage.

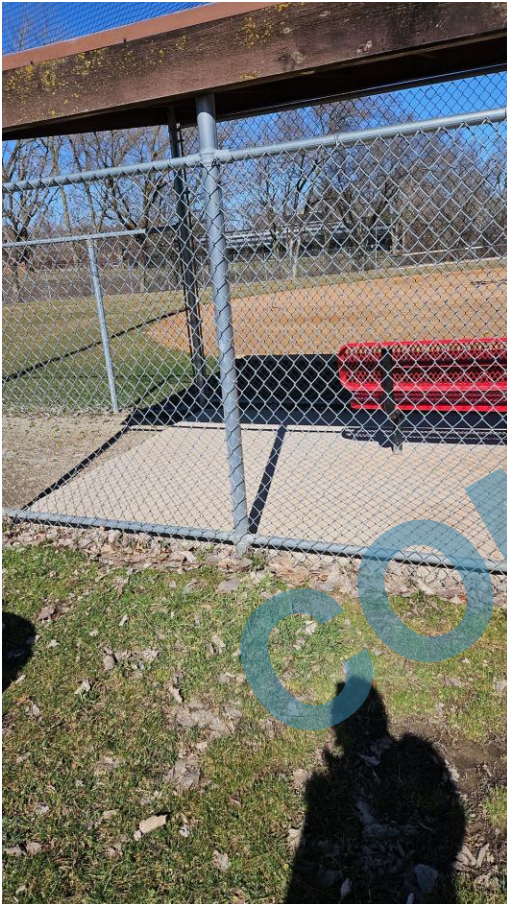
**Finding: 11**

Element meets all standards and requirements.

dugouts have required  
CFS at seating

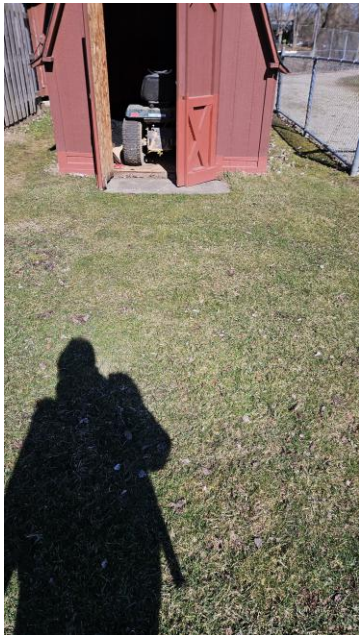
### Finding: 13

mower shed lacks  
route, CIL at entry

For employee spaces, relocate storage, furniture, and other obstacles at doorways to provide approach, enter and exit at the employee space.

Repair, bevel, or ramp CILs at door entries to max .25".

Provide an accessible route to the shed.
