Access Audit Final Site Report

**Old Orchard Country Club
700 W Rand Rd
Mt Prospect, IL 60056**

**Inspection Date: 02/28/2024
Inspectors: Shelley Zuniga**

Prepared By
WT Group

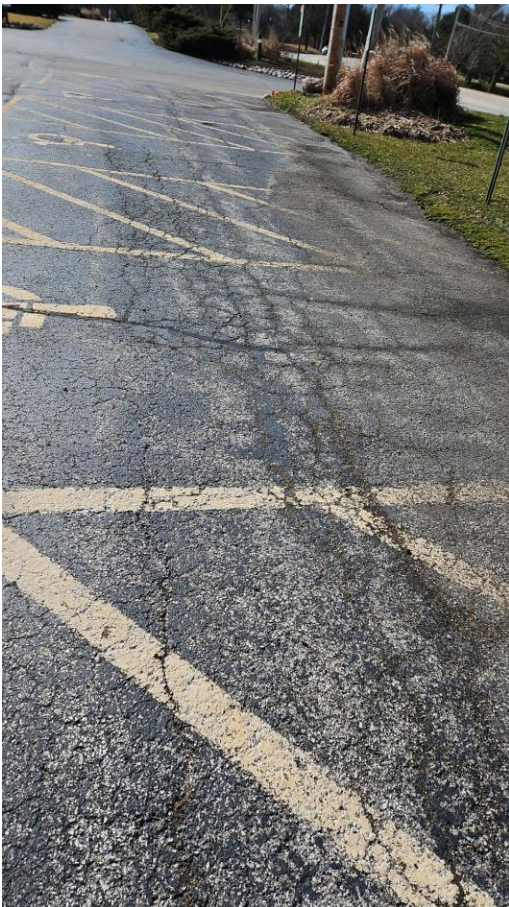
Finding: 3

A high quality yellow paint recommended by the paint manufacturer for pavement striping shall be used.

Repaint stalls and access aisles to be 8' and 8' each using high quality yellow paint.

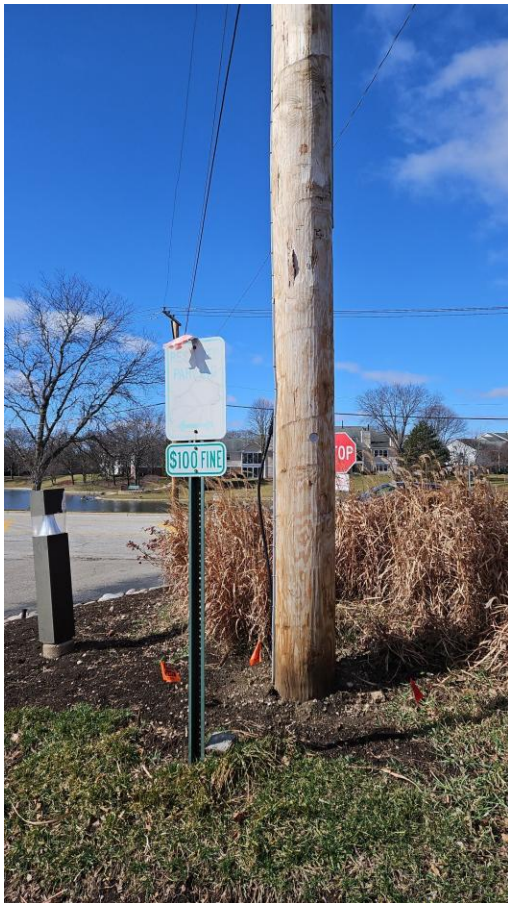
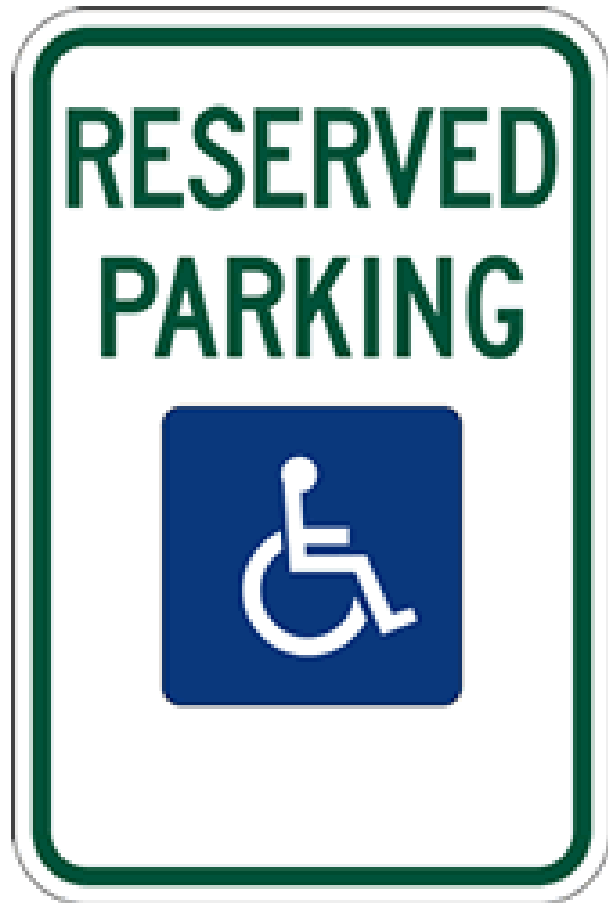
Finding: 5

The accessible parking stall signage is incorrect and/or missing from each accessible parking space.

Acquire or replace and mount at appropriate heights and locations accessible parking signs where incorrect or missing. We recommend R7-8 signage.

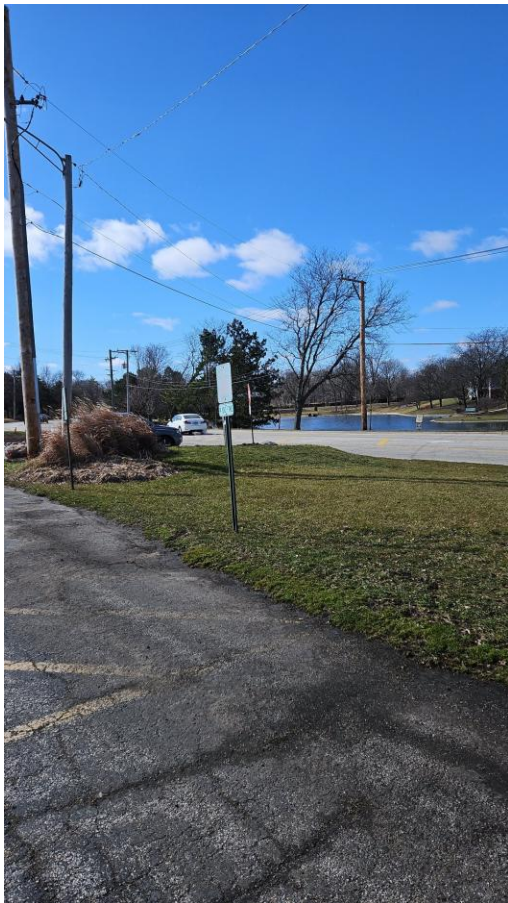
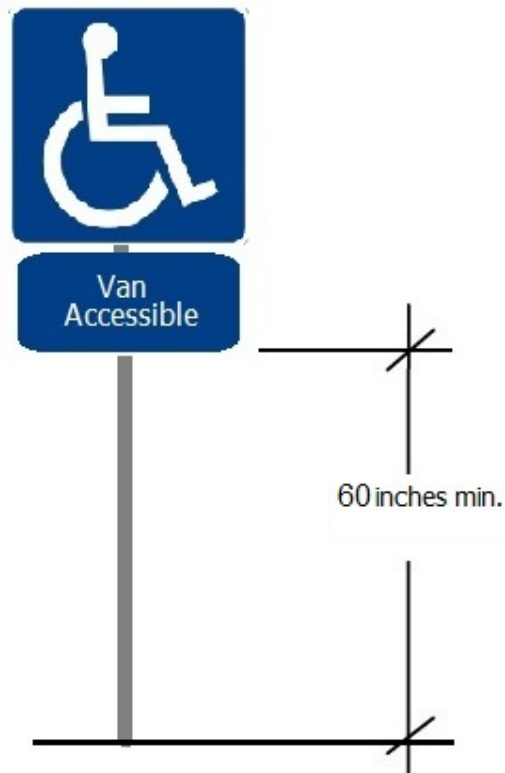
Finding: 6

The van stall is missing a sign identifying it as a van accessible stall.

Add one van parking sign to one accessible stall and assure stall and access aisle to 11' and 5' or 8' and 8'.

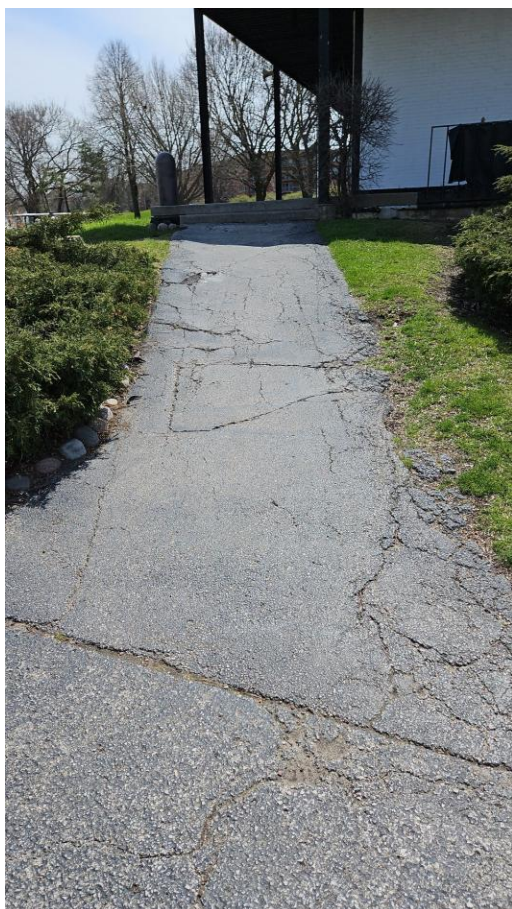
route to building steep
and has surface
deterioration, leads to
stairs, no route

Correct running slopes to max 5% and resurface route to firm and stable.

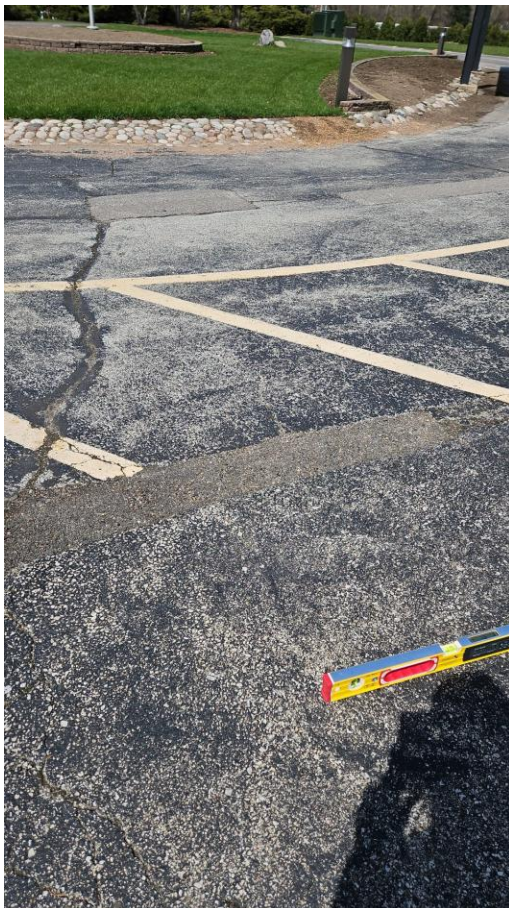
The accessible route contains loose gravel and/or surfaces that do not provide for a stable, firm slip resistant surface.

deterioration at entry
to path from drop off

Resurface accessible route where deterioration occurs.

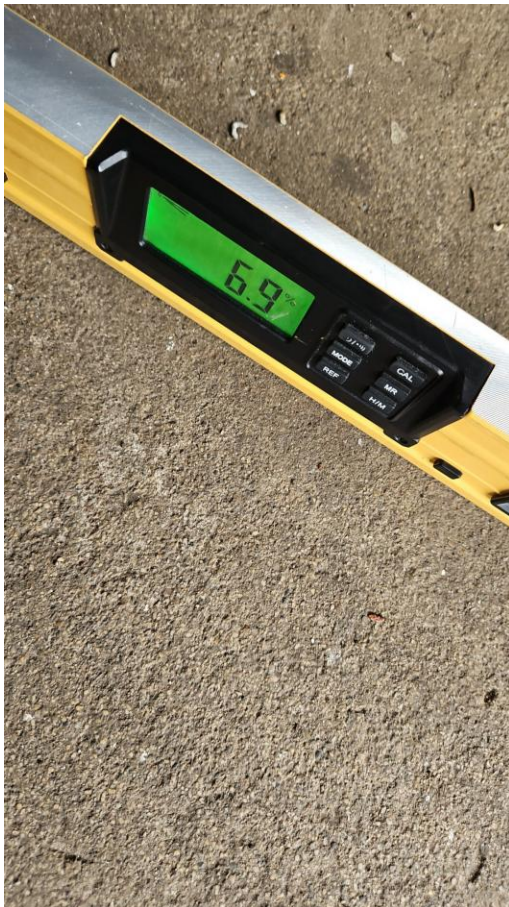
Exterior double doors from cart room - fast close, 30# push, slope of 6.9% in pull side clearance, deterioration in pull side clearance, locking mechanism within bottom 10" of push side, bolt lock on inactive leaf at 51.75" and is difficult to operate with a closed fist

For all doors/gates along the public circulation route, replace hardware with lever hardware or hardware operable without a tight pinch or grasp.

For all doors/gates along the public circulation route, replace hardware with lever hardware or hardware operable without a tight pinch or grasp and having a max profile of 4", mounted to 34" to 38" AFF.

For all doors/gates along the public circulation route, remove door holder to provide a smooth surface on the push side of door/gate from floor to 10" AFF.

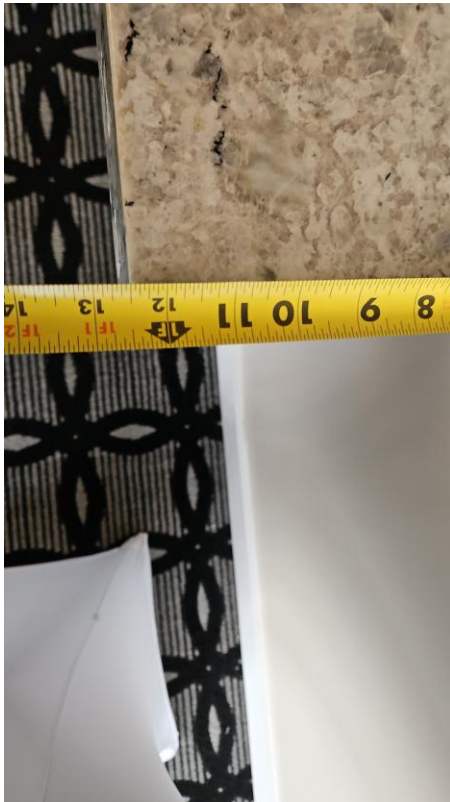
Wall-mounted objects that have leading edges between 27 inches and 80 inches from the floor must not protrude more than 4 inches into the circulation path. Protruding objects that extend to the floor or within 27 inches of the floor are cane detectable and are therefore not hazardous. Where it is necessary or desirable to have objects protrude from the wall, a manner of cane detection must be provided.

Relocate protruding objects or place cane detectable bollard at foot of item.

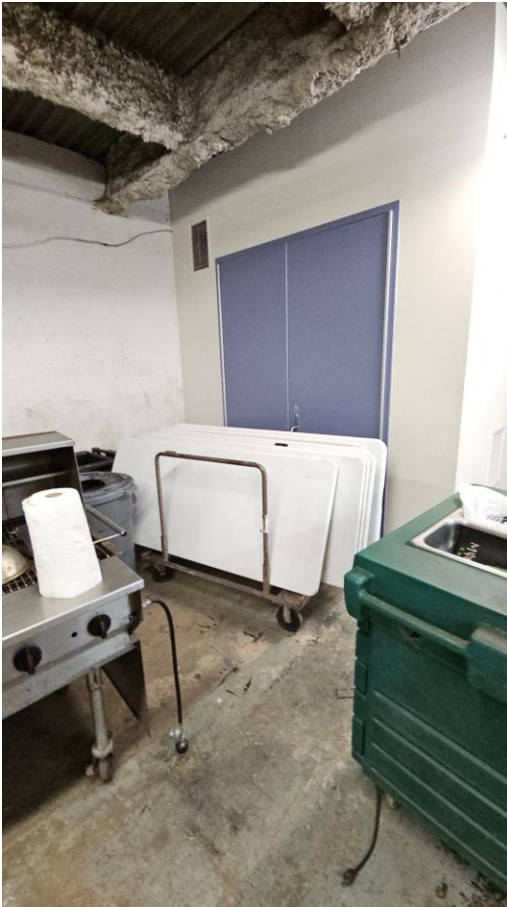
Electrical box room - storage in pull side clearance, both leaves 20# push; left supply room - lacks hardware on both sides, 16# push; right right food supply storage room - 15# push, ladder in pull side clearance, lacks hardware on both sides; dinnerware storage room - knobs, 30" wide, storage and shelving in pull side clearance; door to putting practice area - wall and column in pull side clearance, knobs, 15# push; double doors to kitchen area - hold open device on active leaf, 20# push, loose floor mat on push side, bolt locks on both doors at 81.5"

Secure rug at door to prevent trip hazard.

Replace doors with doors having 80" overhead clearance and 32" clear width.

Replace hardware with lever hardware or hardware operable without a tight pinch or grasp.

Remove door holder to provide a smooth surface on the push side of door from floor to 10" AFF.

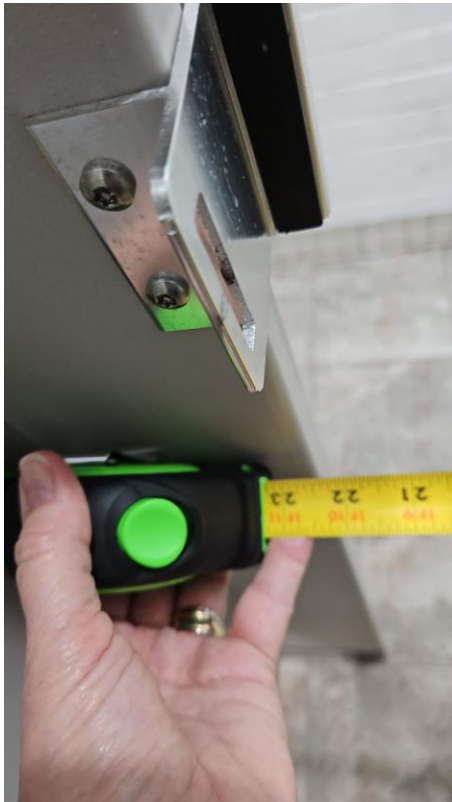
The stall door fails to comply with all of the door requirements.

Replace stall hardware with hardware operable without a tight pinch or grasp on both sides of the stall door.
