Access Audit Final Site Report

**Gary Morava Recreation Center
110 W Camp McDonald Rd
Prospect Heights, IL 60070**

**Inspection Date: 02/29/2024
Inspectors: Shelley Zuniga**

Prepared By
WT Group

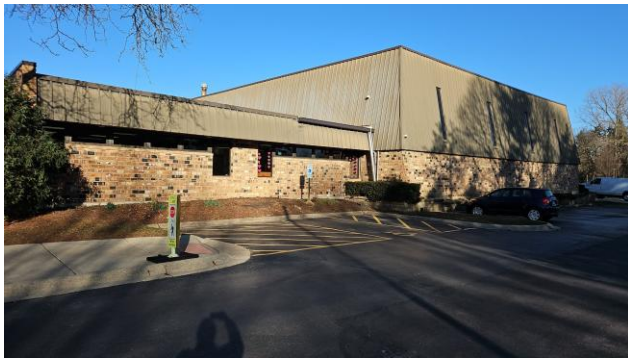
Finding: 7

The van stall is missing a sign identifying it as a van accessible stall.

Add one van parking sign to one accessible stall and ensure stall and access aisle are 11' and 5' or 8' and 8'.

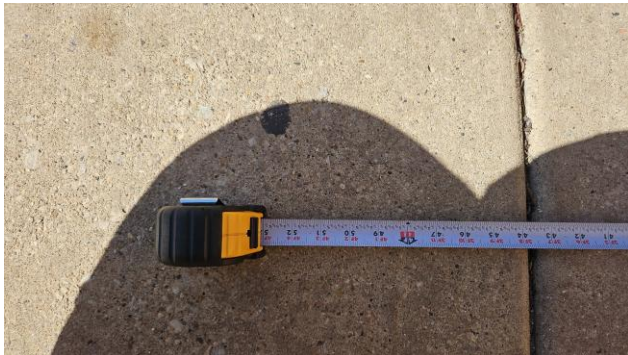
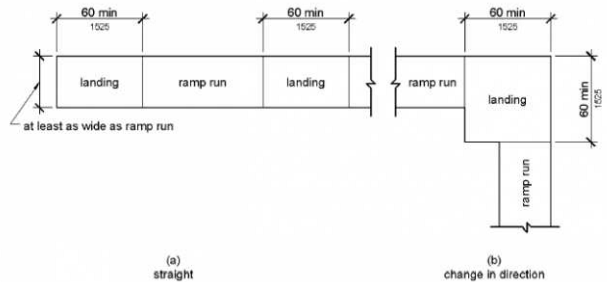
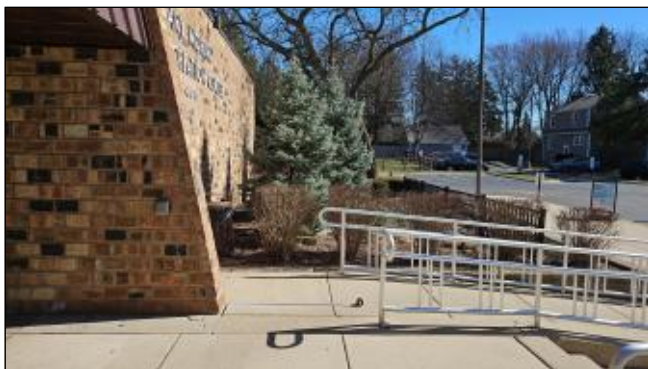
Finding #12 Additional Finding Photos

Finding: 12

Enlarge landing to be 60" deep and as wide as the ramp

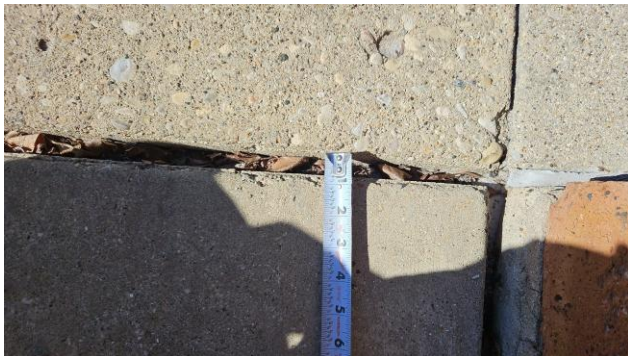
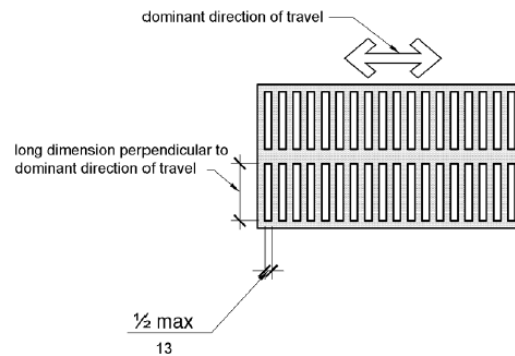
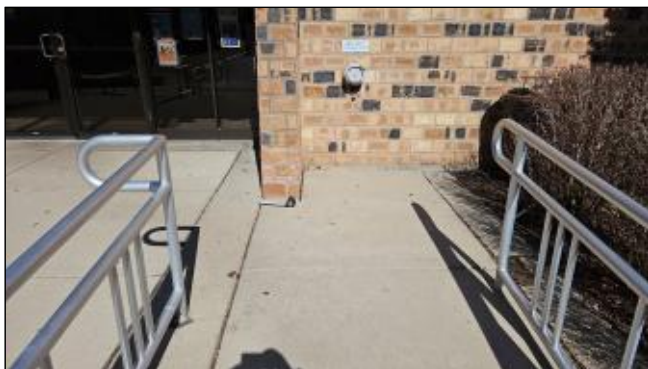
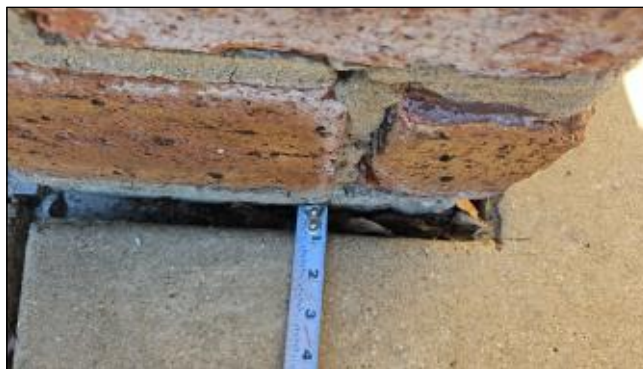
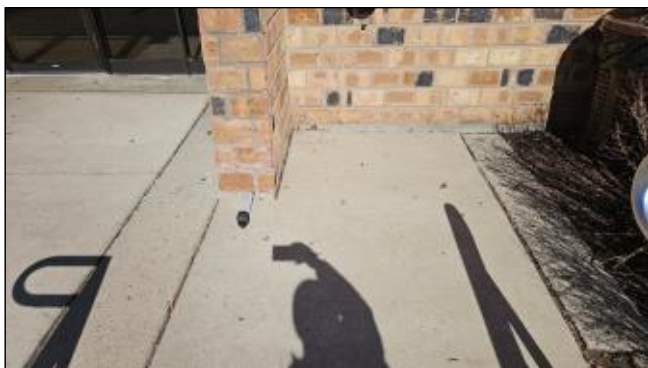
Finding #13 Additional Finding Photos

Finding: 13

Fill and maintain gaps to max .5"

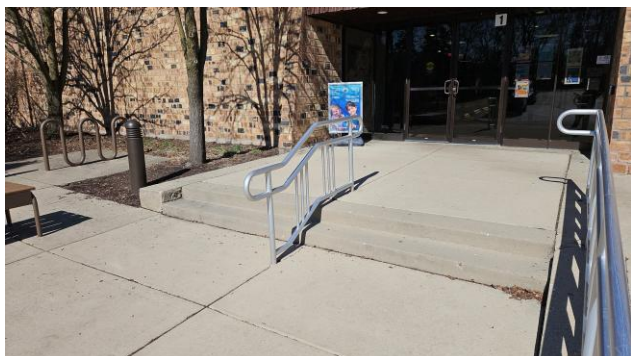
Finding #15 Continued

Finding: 15

Install handrails on both sides of stairway, mounted 34" to 38" aff with top and bottom extensions and having a 1.25" – 2" in diameter, or a non-circular grip that has a perimeter dimension of 4"- 6.25" max with a min gap of 1.5" between handrail and wall

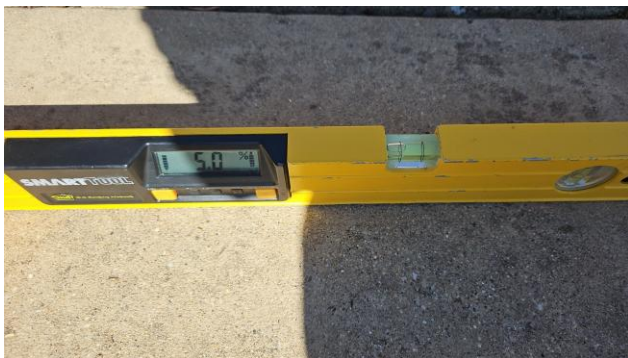
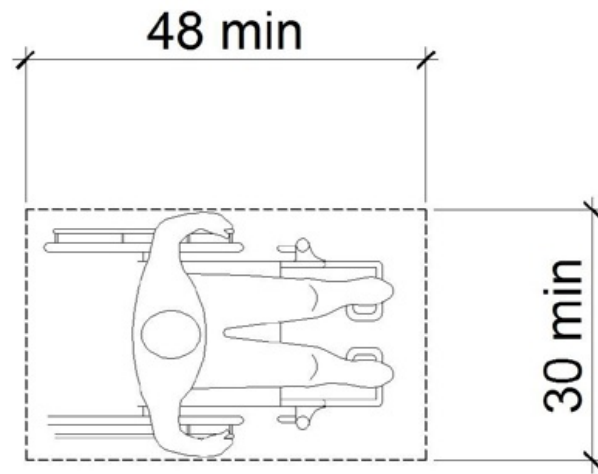
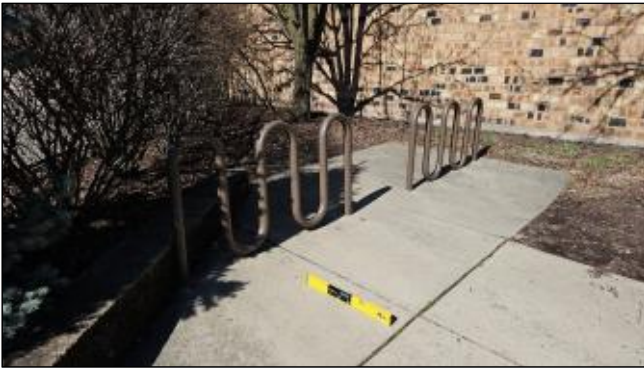
Finding #16 Additional Finding Photos

Finding: 16

Correct or repair slope in CFS to max 2.08%

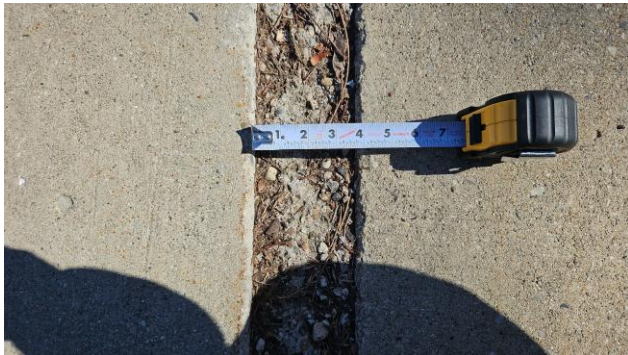
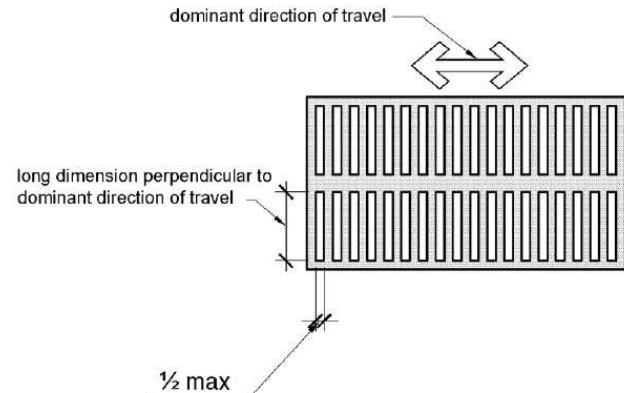
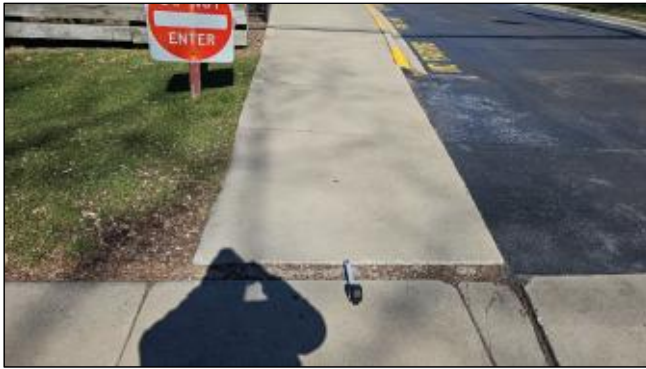
Finding #18 Additional Finding Photos

Finding: 18

Correct or fill gaps to be max .5".

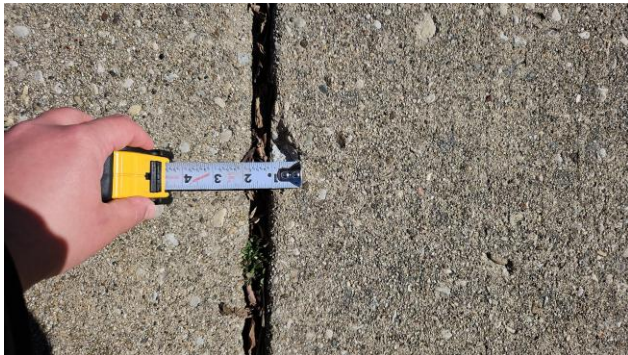
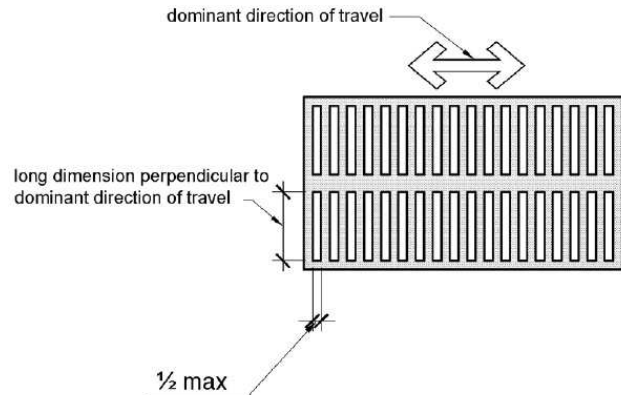
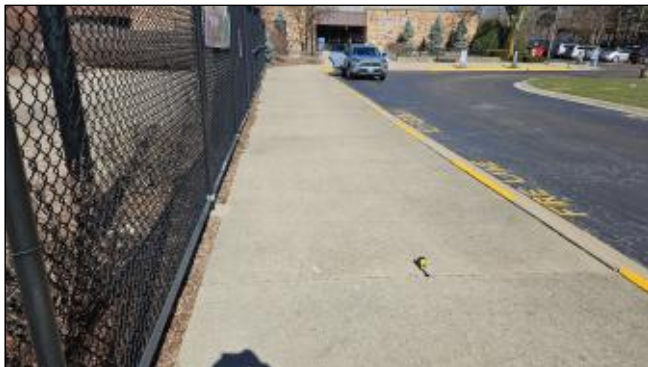
Finding #19 Additional Finding Photos

Finding: 19

Correct or fill gaps to be max .5".

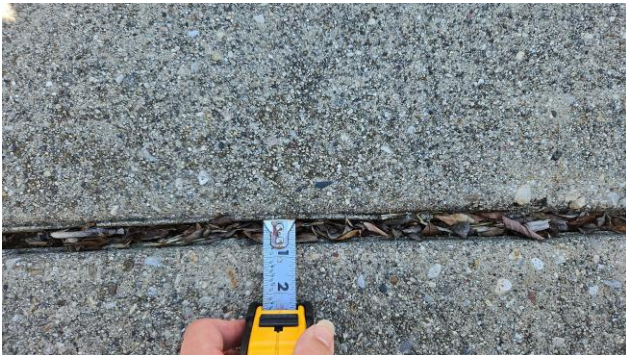
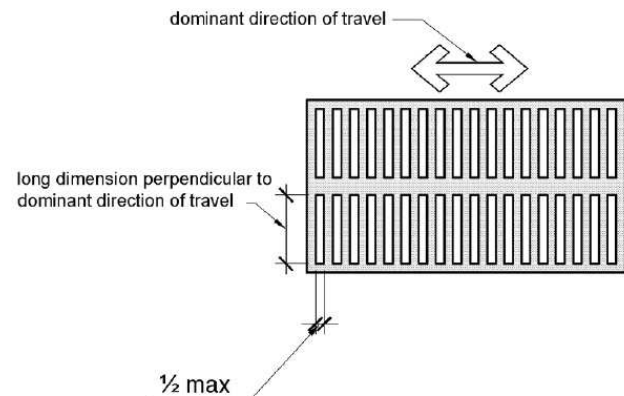
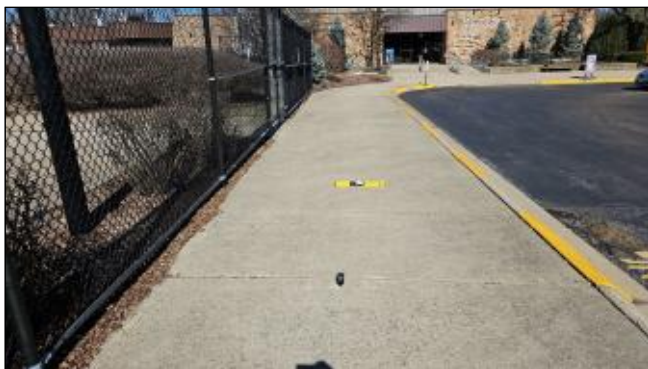
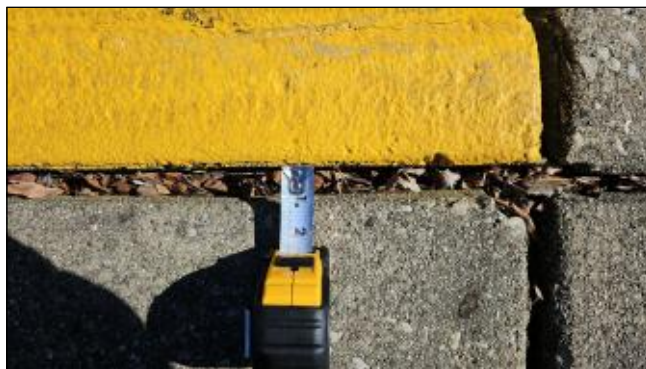
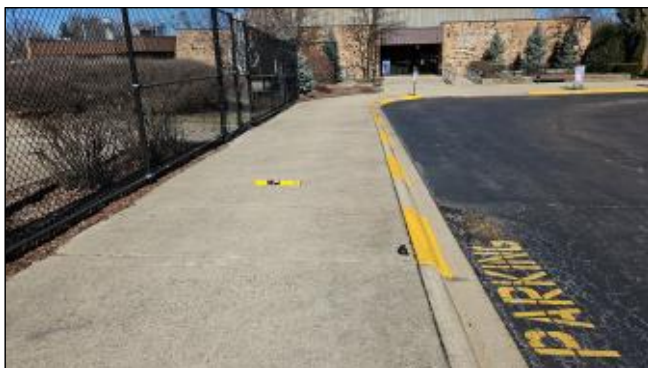
Finding #20 Additional Finding Photos

Finding: 20

Correct or fill gaps to be max .5".

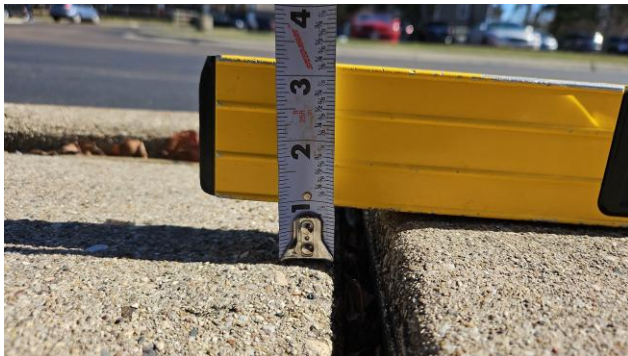
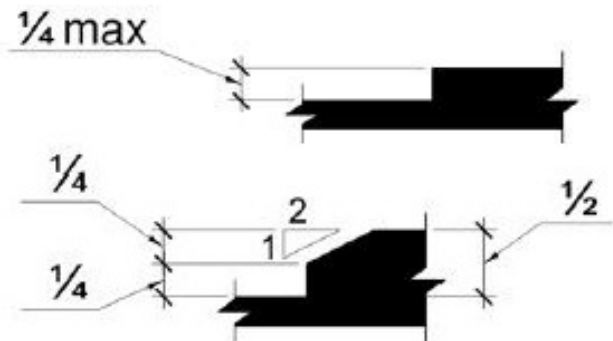
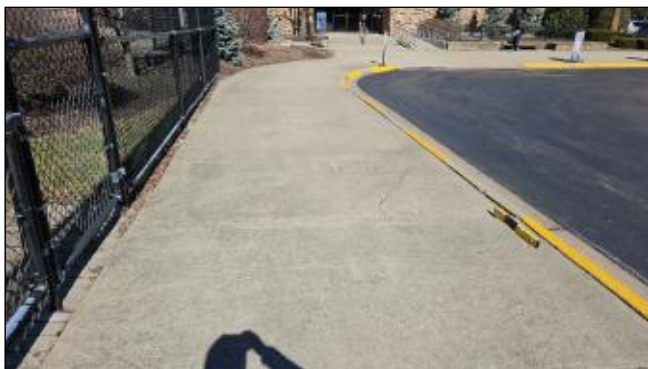
Finding #21 Additional Finding Photos

Finding: 21

Repair, bevel or ramp change in level along accessible route.

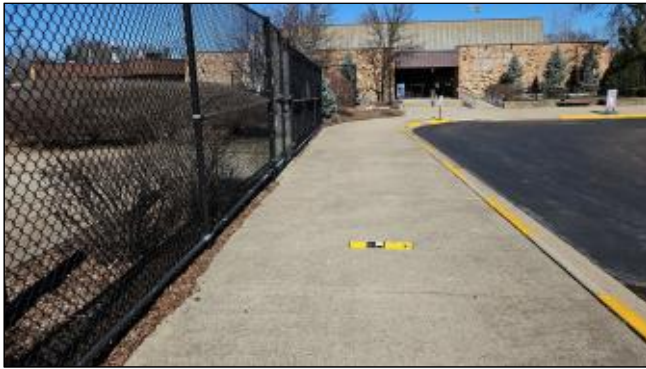
Finding #22 Additional Finding Photos

Finding: 22

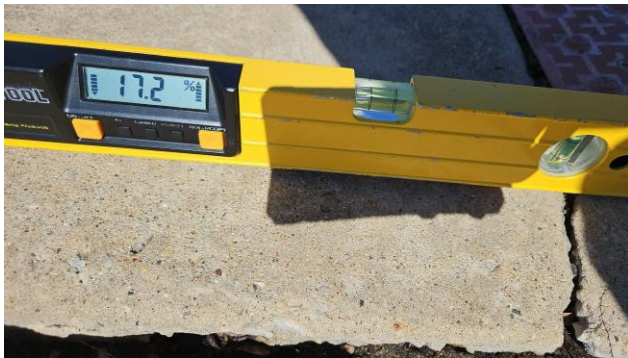
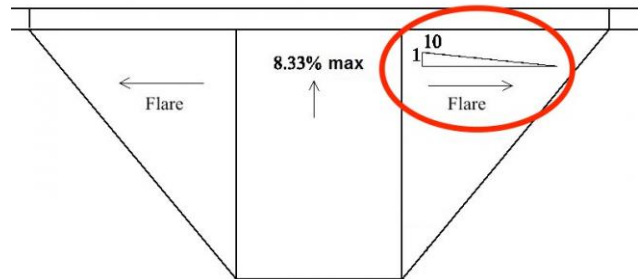
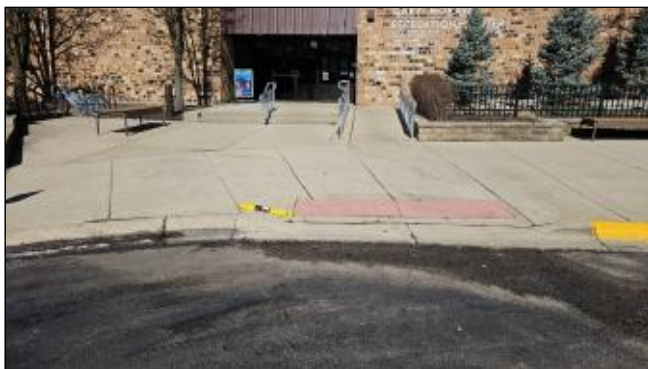
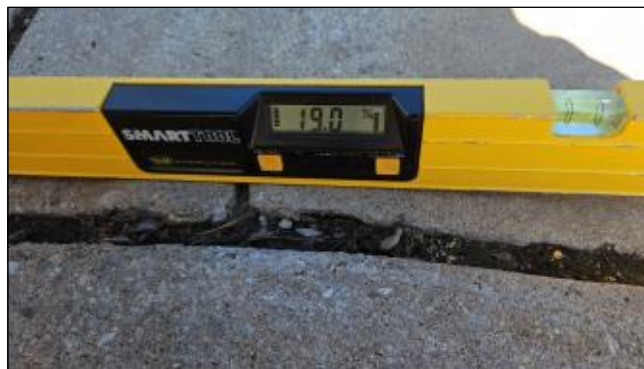
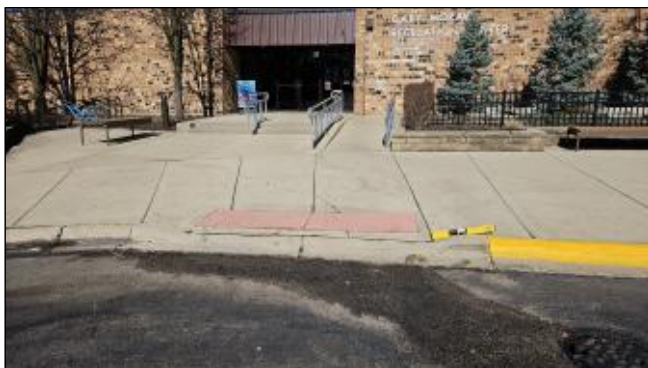
Finding #23 Additional Finding Photos

Finding: 23

Correct slope of curb ramp side flares to max 10%

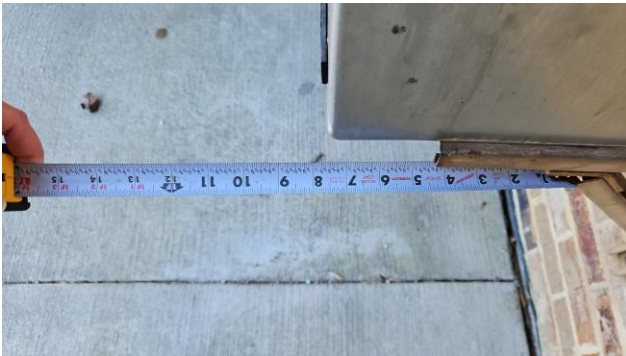
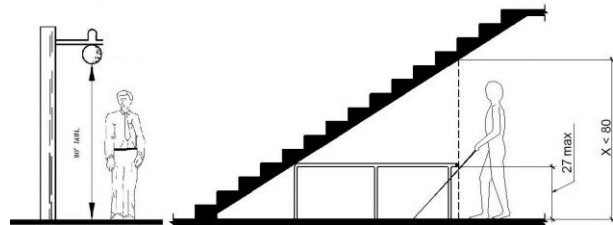
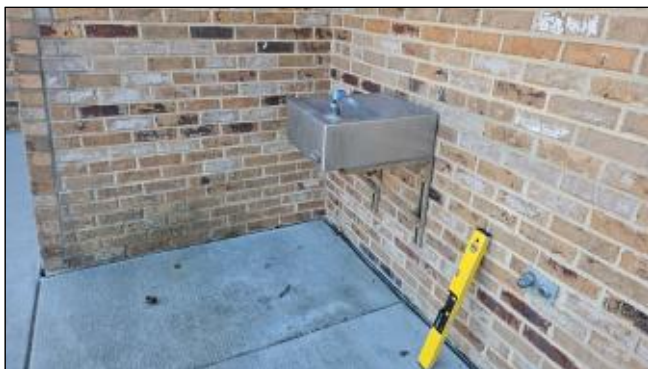
Finding: 34

Wall-mounted objects that have leading edges between 27 inches and 80 inches from the floor must not protrude more than 4 inches into the circulation path. Protruding objects that extend to the floor or within 27 inches of the floor are cane detectable and are therefore not hazardous. Where it is necessary or desirable to have objects protrude from the wall, a manner of cane detection must be provided.

Relocate protruding objects or place cane detectable bollard at foot of item.

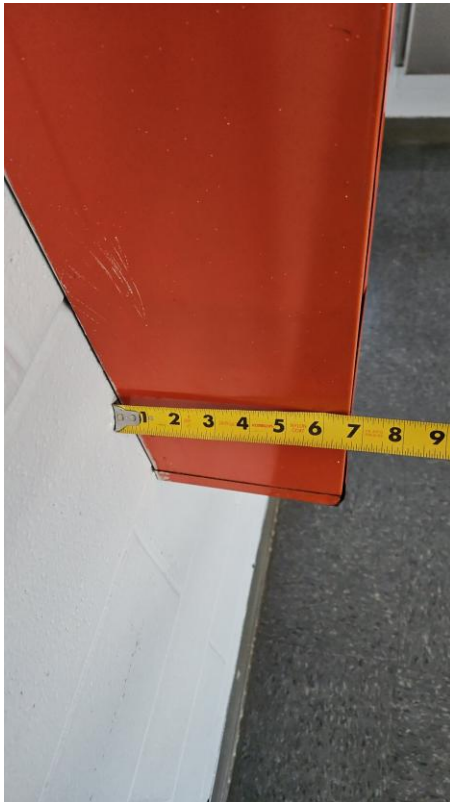
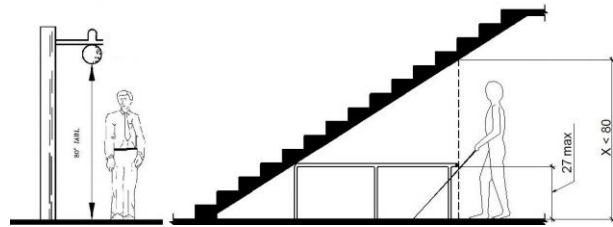
Finding: 48

Wall-mounted objects that have leading edges between 27 inches and 80 inches from the floor must not protrude more than 4 inches into the circulation path. Protruding objects that extend to the floor or within 27 inches of the floor are cane detectable and are therefore not hazardous. Where it is necessary or desirable to have objects protrude from the wall, a manner of cane detection must be provided.

Relocate protruding objects or place cane detectable bollard at foot of item.

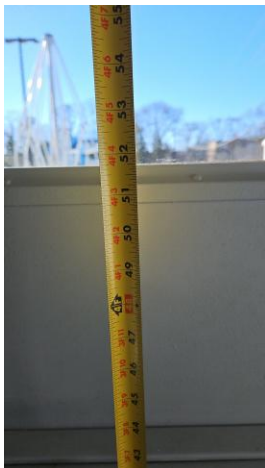
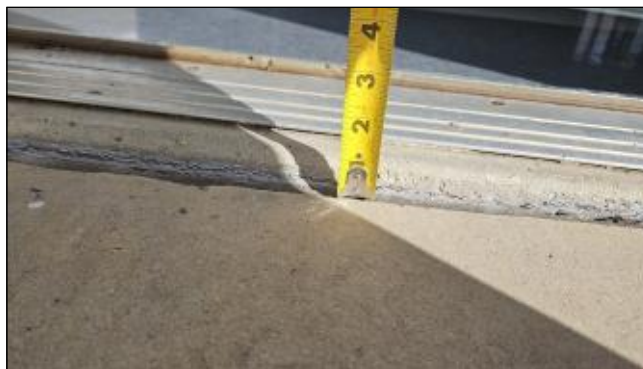
Finding #57 Additional Finding Photos

Exterior doors or gates are recommended to be maintained at 8.5 lbf. Force is to be measured at the operating hardware or 30 inches from the hinges, whichever is greater.

For all doors/gates along the public circulation route, repair, bevel, or ramp CILs at entries to max .25".

For all doors/gates along the public circulation route, inspect, adjust, and maintain 8.5 lbf to open exterior doors/gates.

For all doors/gates along the public circulation route, replace doors/gates with ones having sidelight viewing windows max 43" AFF.

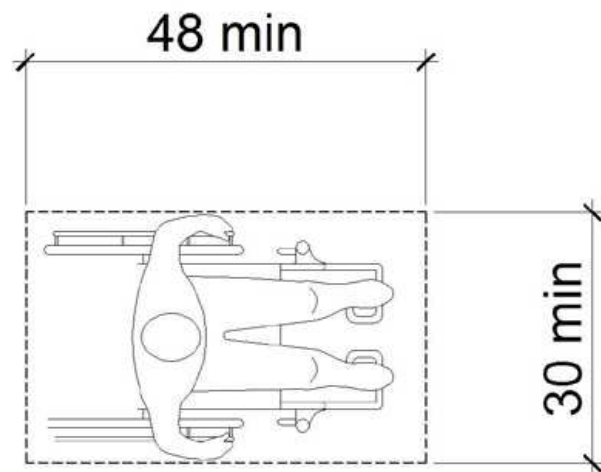
Fitness - mat in CFS at loose equipment

Remove, or relocate storage in CFS at fixtures and operable parts.

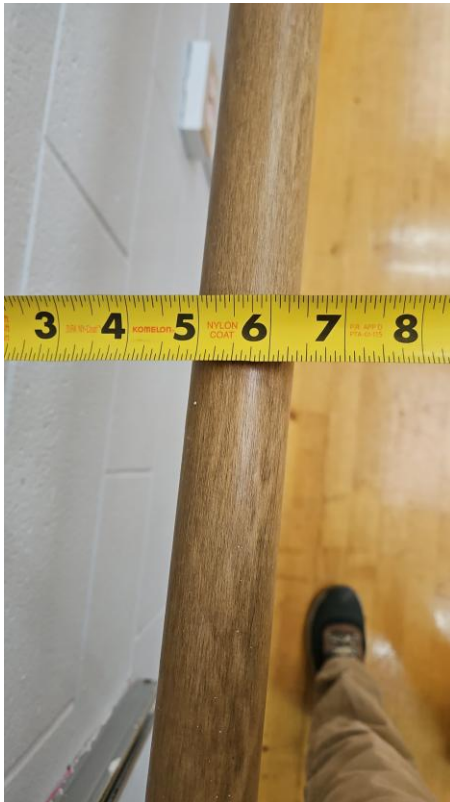
Finding: 66

Wall-mounted objects that have leading edges between 27 inches and 80 inches from the floor must not protrude more than 4 inches into the circulation path. Protruding objects that extend to the floor or within 27 inches of the floor are cane detectable and are therefore not hazardous. Where it is necessary or desirable to have objects protrude from the wall, a manner of cane detection must be provided.

Relocate protruding objects or place cane detectable bollard at foot of item.

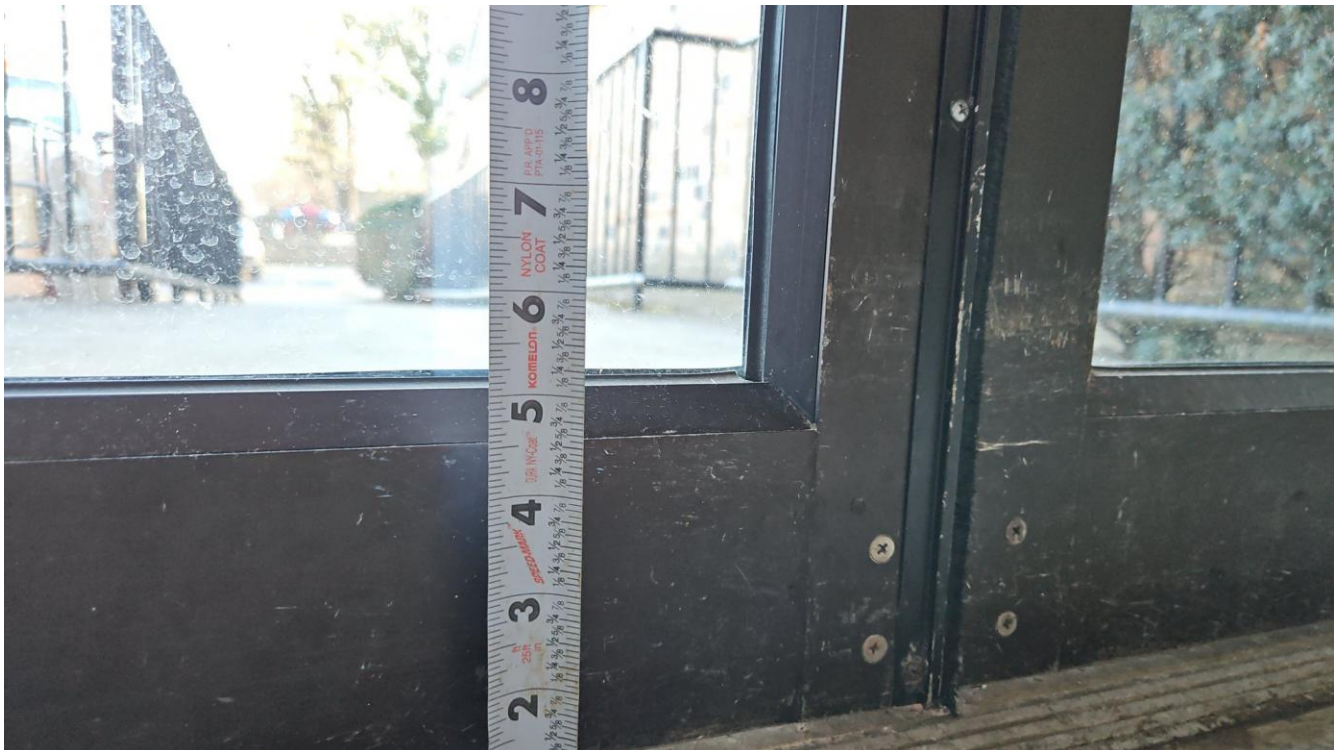
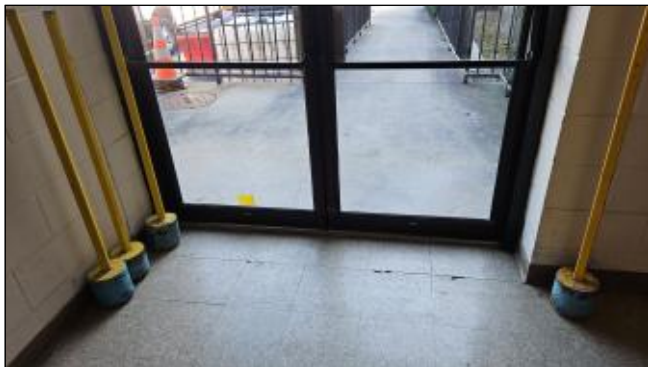
Finding: 76

Exterior doors or gates are recommended to be maintained at 8.5 lbf as a smart practice. Force is to be measured at the operating hardware or 30 inches from the hinges, whichever is greater.

For all doors/gates along the public circulation route, inspect, adjust, and maintain 8.5 lbf to open exterior doors/gates.

For all doors/gates along the public circulation route, provide kick plate on push side of door/gate from floor to 10" AFF.

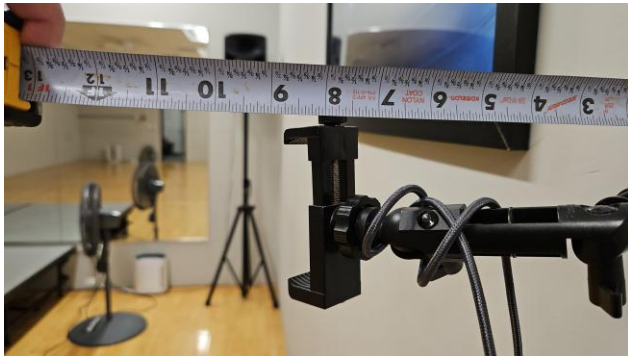
Finding: 79

Wall-mounted objects that have leading edges between 27 inches and 80 inches from the floor must not protrude more than 4 inches into the circulation path. Protruding objects that extend to the floor or within 27 inches of the floor are cane detectable and are therefore not hazardous. Where it is necessary or desirable to have objects protrude from the wall, a manner of cane detection must be provided.

Relocate protruding objects or place cane detectable bollard at foot of item.

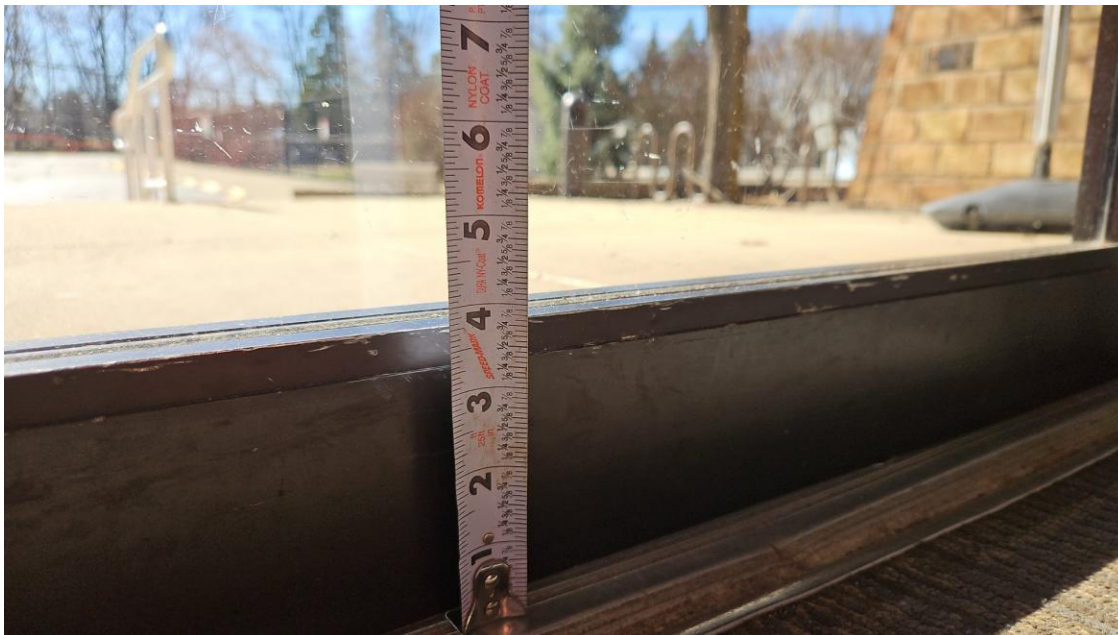
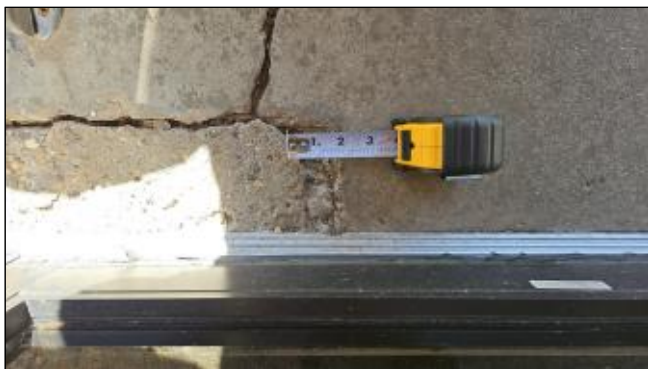
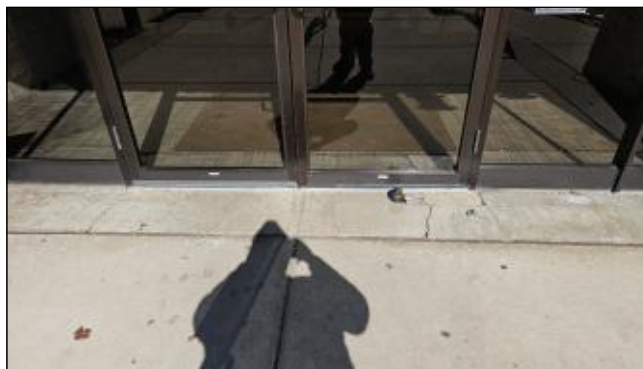
Finding #89 Additional Finding Photos

Exterior doors or gates are recommended to be maintained at 8.5 lbf. Force is to be measured at the operating hardware or 30 inches from the hinges, whichever is greater.

For all doors/gates along the public circulation route, inspect, adjust, and maintain 8.5 lbf to open exterior doors/gates.

For all doors/gates along the public circulation route, provide kick plate on push side of door/gate from floor to 10" AFF.

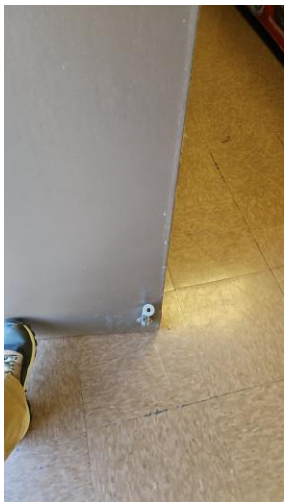
Finding #91 Additional Finding Photos

Exterior doors or gates are recommended to be maintained at 8.5 lbf. Force is to be measured at the operating hardware or 30 inches from the hinges, whichever is greater.

For all doors/gates along the public circulation route, inspect, adjust, and maintain 8.5 lbf to open exterior doors/gates.

For all doors/gates along the public circulation route, remove door holder to provide a smooth surface on the push side of door/gate from floor to 10" AFF.

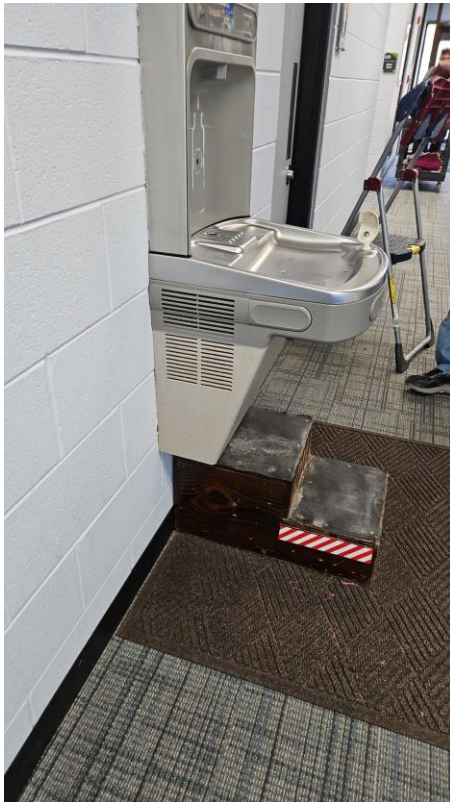
Finding: 112

Wall-mounted objects that have leading edges between 27 inches and 80 inches from the floor must not protrude more than 4 inches into the circulation path. Protruding objects that extend to the floor or within 27 inches of the floor are cane detectable and are therefore not hazardous. Where it is necessary or desirable to have objects protrude from the wall, a manner of cane detection must be provided.

Relocate protruding objects or place cane detectable bollard at foot of item.

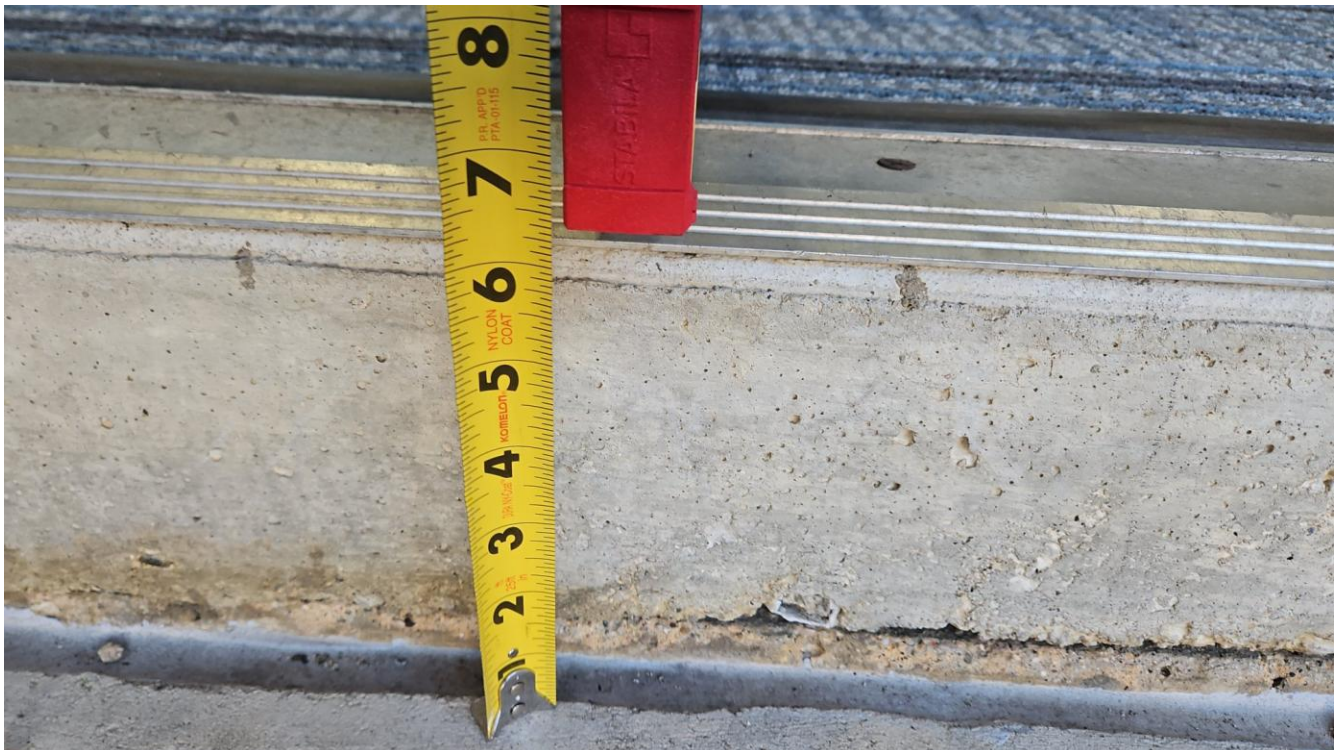
Finding: 113

Exterior doors or gates are recommended to be maintained at 8.5 lbf. Force is to be measured at the operating hardware or 30 inches from the hinges, whichever is greater.

For all doors/gates along the public circulation route, ramp CILs at entries to max .25".

For all doors/gates along the public circulation route, inspect, adjust, and maintain 8.5 lbf to open exterior doors/gates.

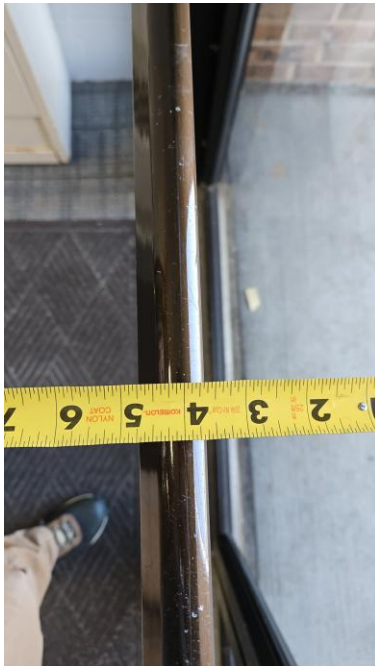
Finding #115 Additional Finding Photos

Exterior doors or gates are recommended to be maintained at 8.5 lbf. Force is to be measured at the operating hardware or 30 inches from the hinges, whichever is greater.

For all doors/gates along the public circulation route, inspect, adjust, and maintain 8.5 lbf to open exterior doors/gates.

For all doors/gates along the public circulation route, replace hardware with lever hardware or hardware operable without a tight pinch or grasp and having a max profile of 4".

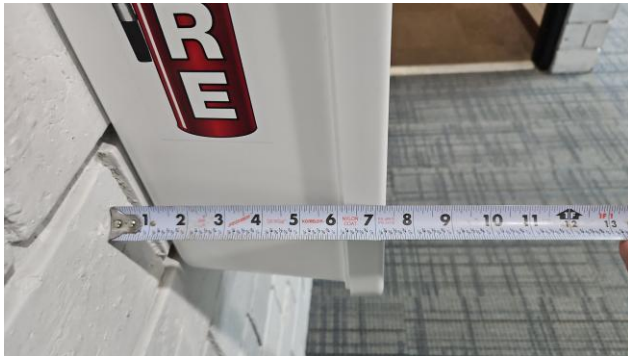
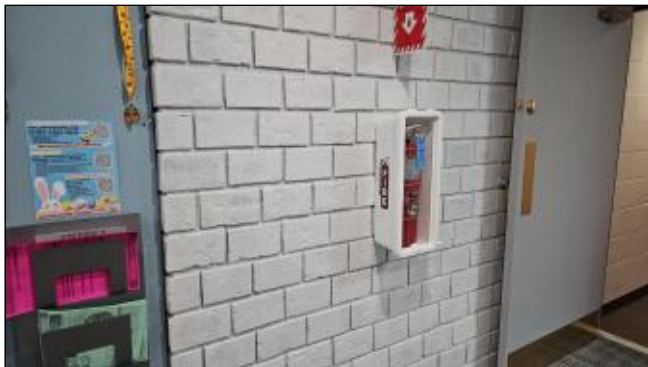
Finding: 120

Wall-mounted objects that have leading edges between 27 inches and 80 inches from the floor must not project more than 4 inches into the circulation path. Protruding objects that extend to the floor or within 27 inches of the floor are cane detectable and are therefore not hazardous. Where it is necessary or desirable to have objects protrude from the wall, a manner of cane detection must be provided.

Relocate protruding objects or place cane detectable bollard at foot of item.

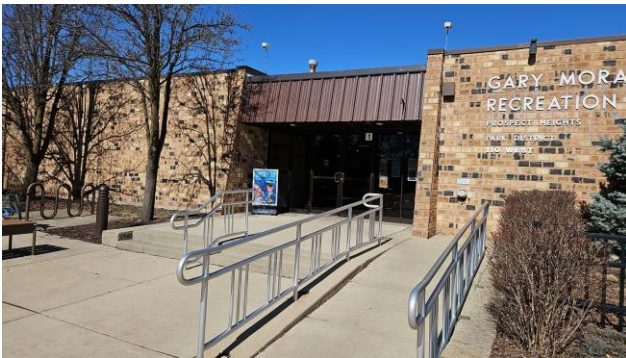
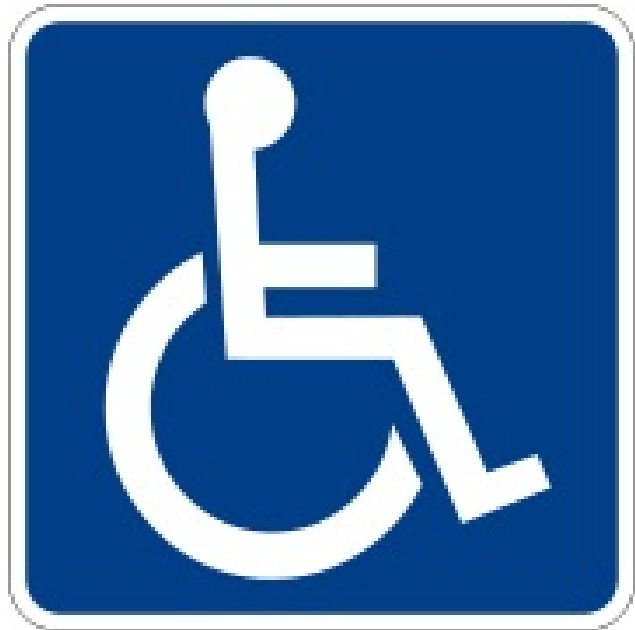
Finding: 124

The entrance is not accessible and is missing signage. An identification sign identifying that this entrance is not accessible and directional signage pointing in the direction to the accessible entrance is required.

Mount signage at inaccessible entrances directing patrons in wheelchairs to accessible entrance.

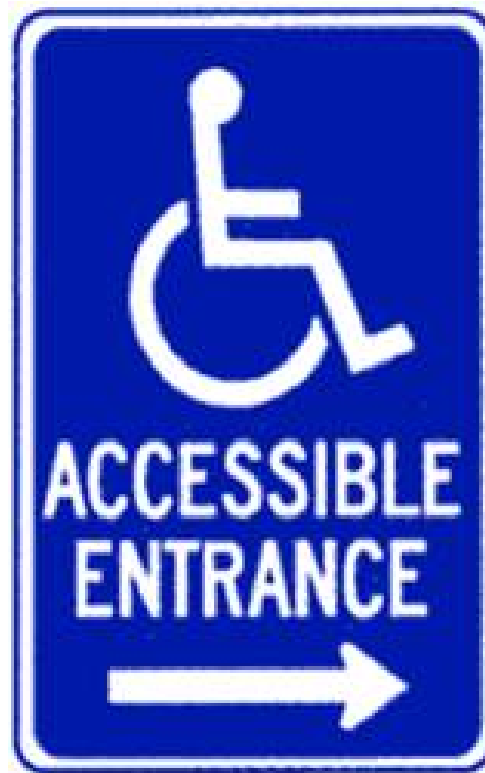
Finding: 125

The tactile sign is incorrectly located or missing

Mount signage at all permanent rooms/spaces having Braille and the international symbol of accessibility, mounted 48" to baseline of lowest character and 60" to the baseline of the highest character sign and on the latch side of the door

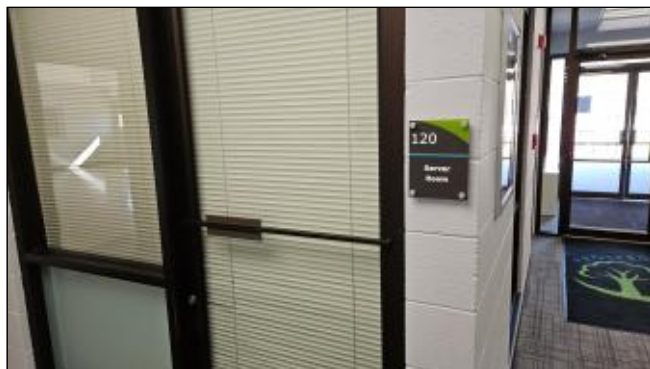
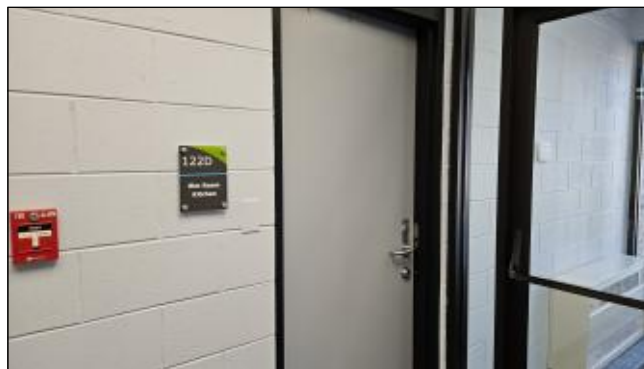
Finding: 126

The tactile restroom wall sign is missing the International Symbol of Accessibility (ISA).

Acquire and mount signage, including Braille and access symbol mounted on wall, latch side of door, 48" to baseline of lowest character and 60" to baseline of highest character.

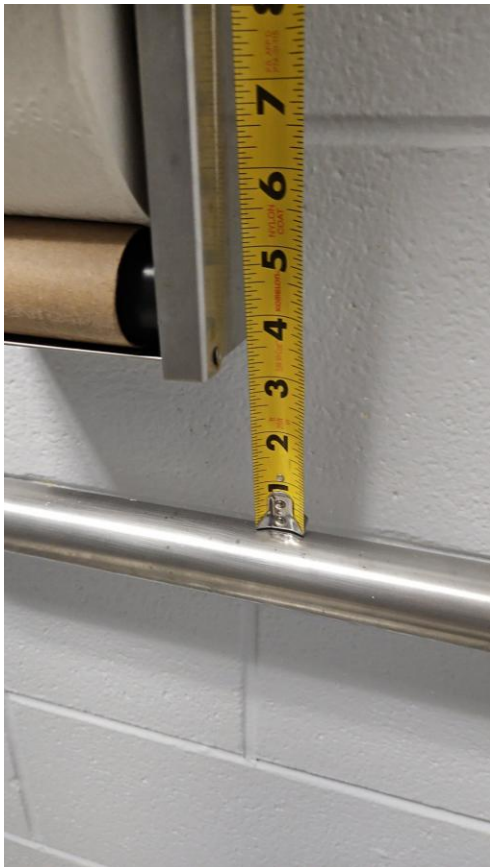
Finding #133 Additional Finding Photos

The grab bar height and/or spacing fails.

Remount toilet paper dispenser max 7" to 9" from front of toilet, 15" to 48" above the finished floor (AFF) and min 12" above or 1.5" below grab bar.

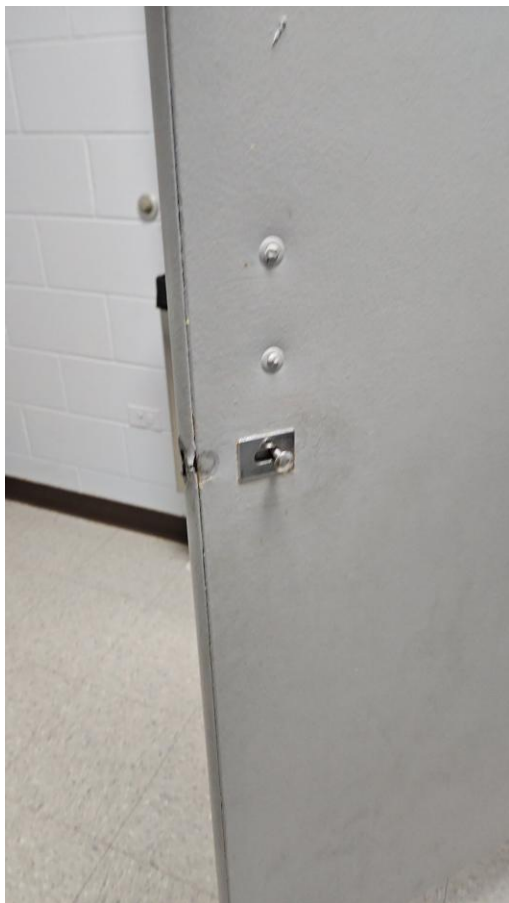
Finding: 135

The stall door fails to comply with all of the door requirements.

Replace stall hardware with hardware operable without a tight pinch or grasp on both sides of the stall door.

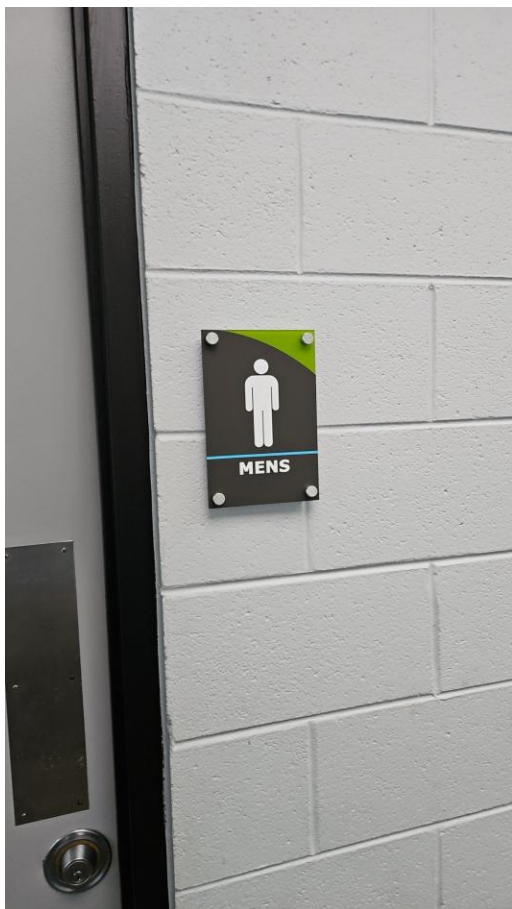
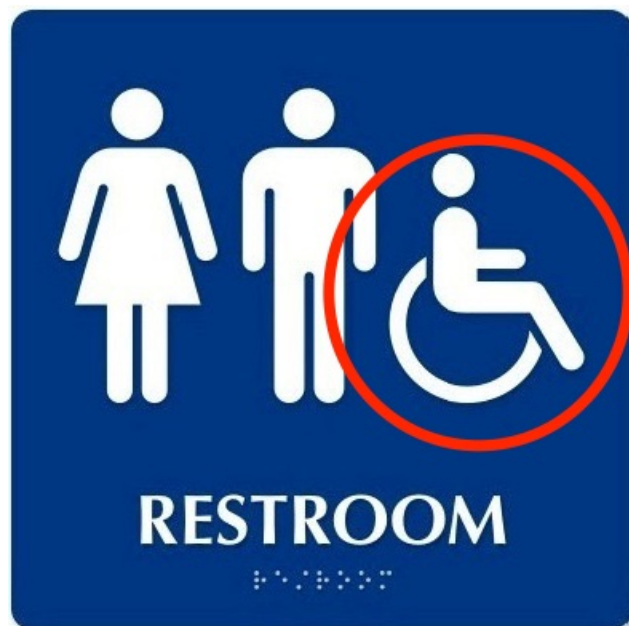
Finding: 139

The tactile restroom wall sign is missing the International Symbol of Accessibility (ISA).

Acquire and mount signage, including Braille and access symbol mounted on wall, latch side of door, 48" to baseline of lowest character and 60" to baseline of highest character.

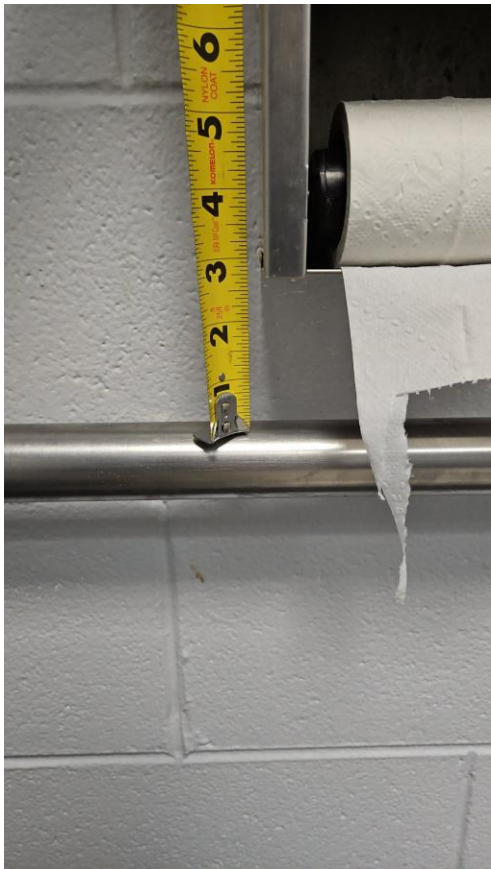
Finding #146 Additional Finding Photos

The grab bar height and/or spacing fails.

Remount toilet paper dispenser max 7" to 9" from front of toilet, 15" to 48" above the finished floor (AFF) and min 12" above or 1.5" below grab bar.

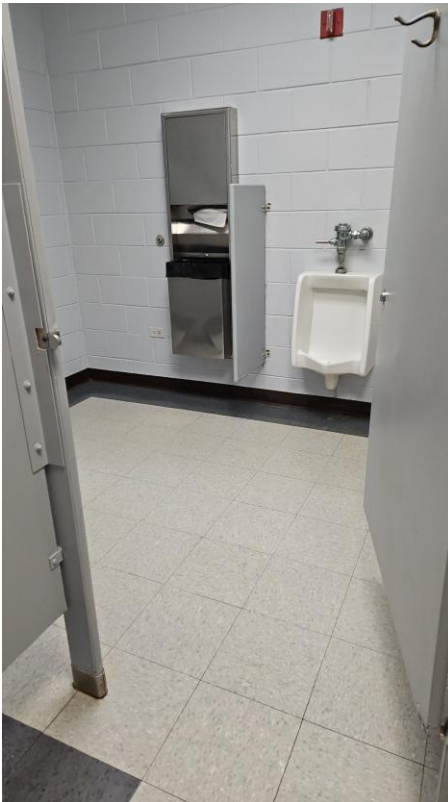
Finding #147 Additional Finding Photos

The stall door fails to comply with all of the door requirements.

Adjust stall door to be self-closing.

Replace stall hardware with hardware operable without a tight pinch or grasp on both sides of the stall door.

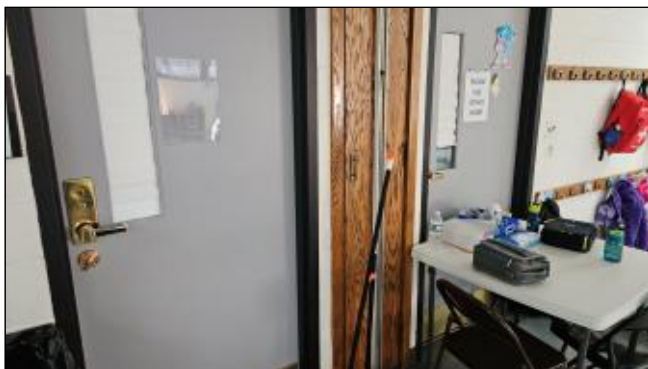
Finding: 163

Pine room - loose rug

Secure rug to prevent trip hazard.

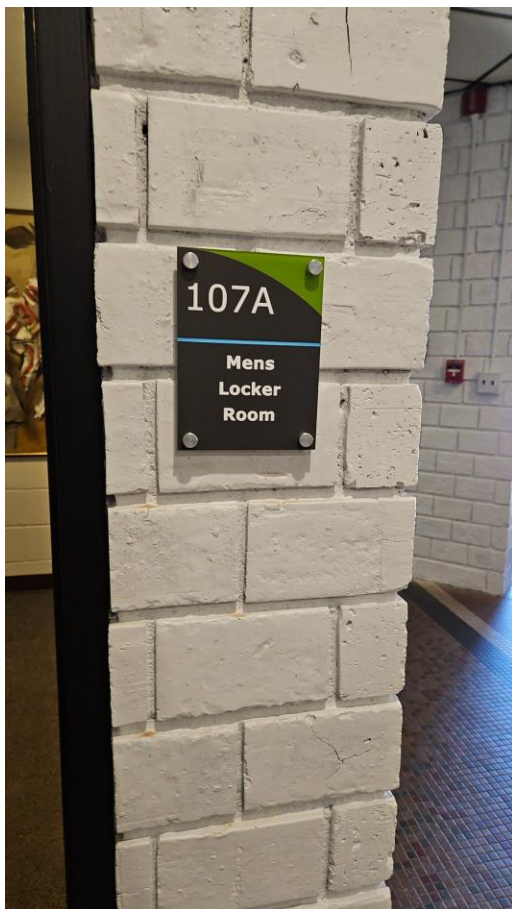
Finding #176 Continued

The tactile restroom wall sign is missing the International Symbol of Accessibility (ISA).

Acquire and mount signage, including Braille and access symbol mounted on wall, latch side of door, 48" to baseline of lowest character and 60" to baseline of highest character.

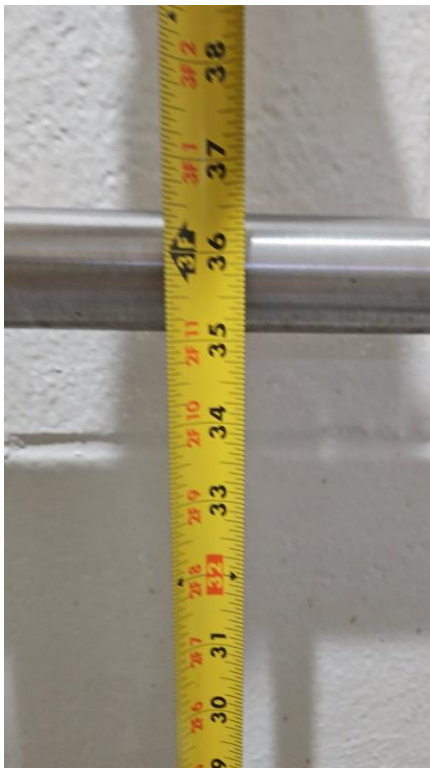
Finding #184 Additional Finding Photos

The grab bar height and/or spacing fails.

Remount grab bars in accessible stall to 33" to 36" above the finished floor (AFF).

Remount toilet paper dispenser max 7" to 9" from front of toilet, 15" to 48" above the finished floor (AFF) and min 12" above or 1.5" below grab bar.

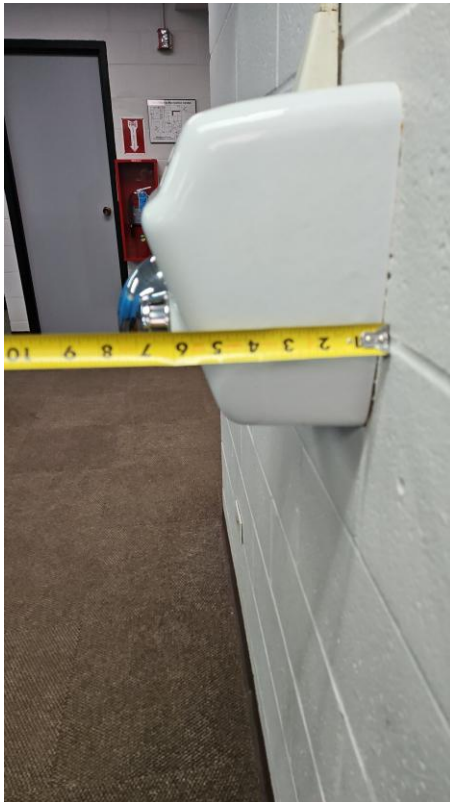
Finding #187 Additional Finding Photos

Wall-mounted objects that have leading edges between 27 inches and 80 inches from the floor must not project more than 4 inches into the circulation path. Protruding objects that extend to the floor or within 27 inches of the floor are cane detectable and are therefore not hazardous. Where it is necessary or desirable to have objects protrude from the wall, a manner of cane detection must be provided.

Relocate protruding objects or place cane detectable bollard at foot of item.
