Access Audit Final Site Report

**Gary Morava Recreation Center
110 W Camp McDonald Rd
Prospect Heights, IL 60070**

**Inspection Date: 02/29/2024
Inspectors: Shelley Zuniga**

Prepared By
WT Group

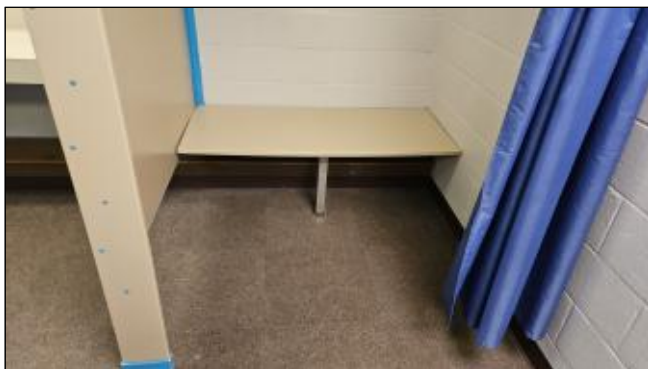
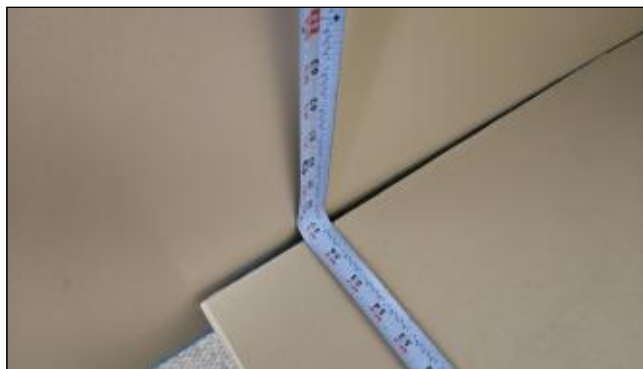
Finding: 200

The bench is not deep enough or long enough or is missing.

Replace bench in dressing stall with one having a seat depth of 20" to 24" deep, 42" long, affixed to the wall or having a back and mounted 17" to 19" AFF and provide required clear floor space on the short axis of the bench.

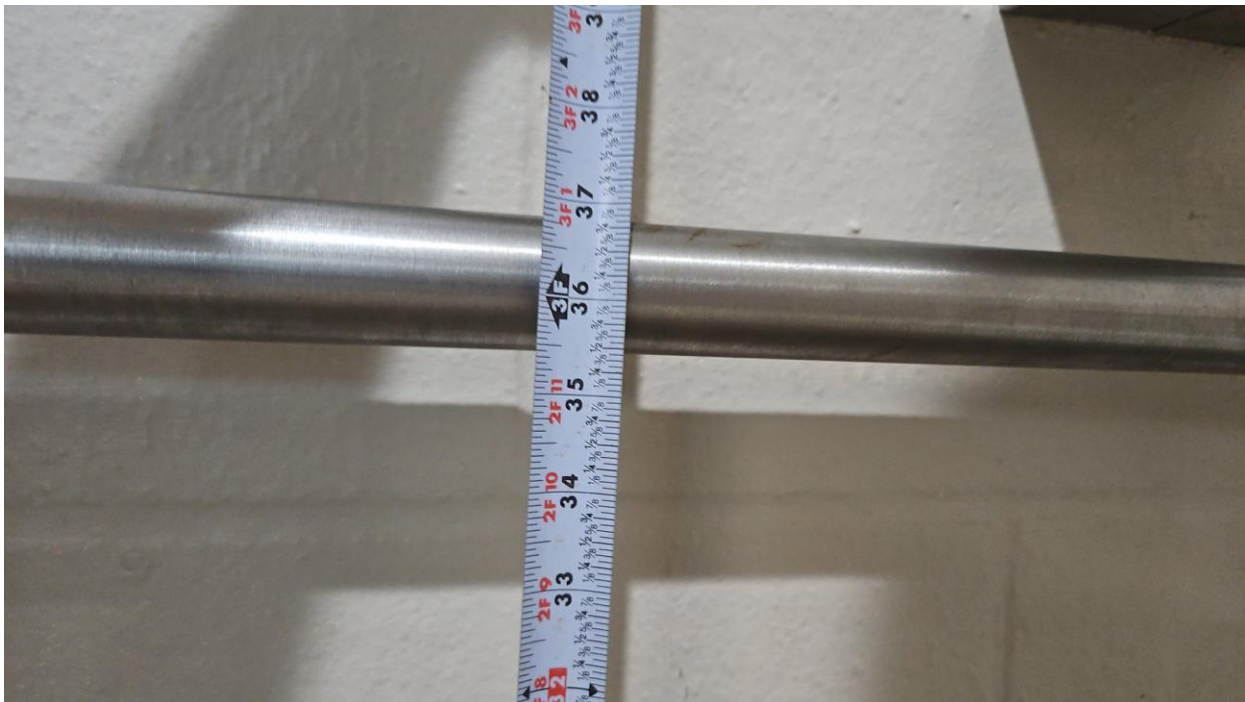
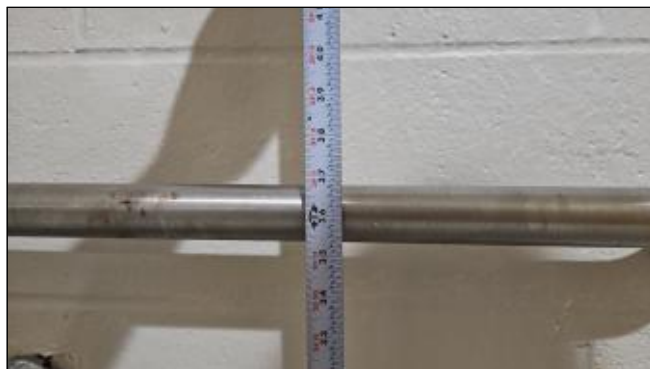
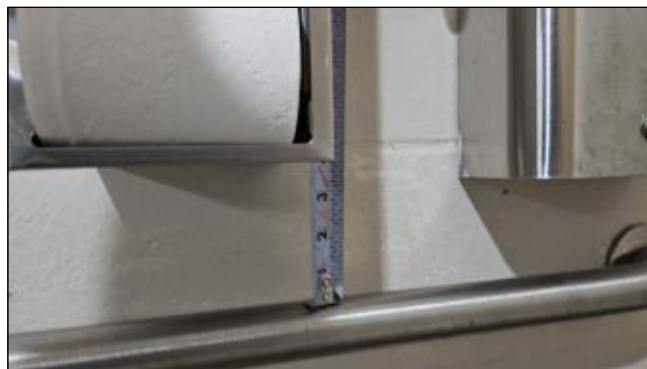
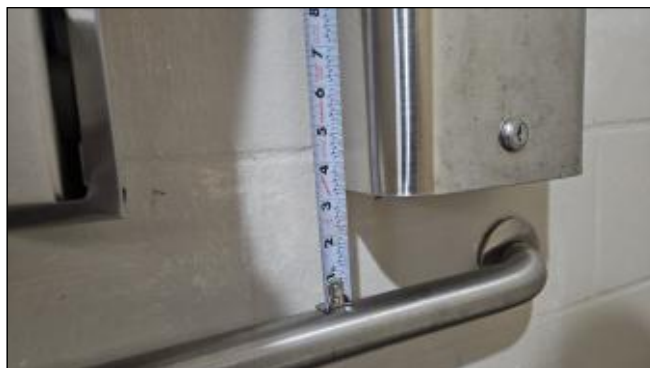
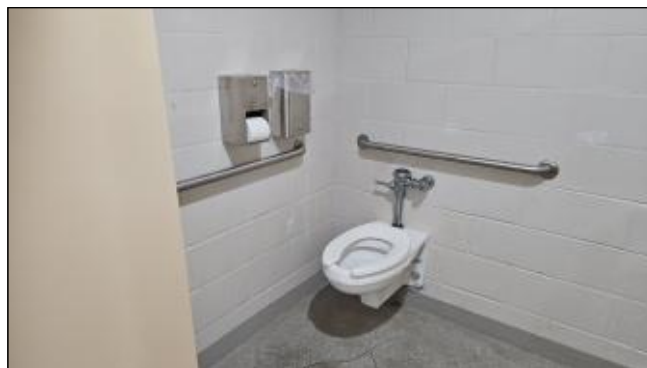
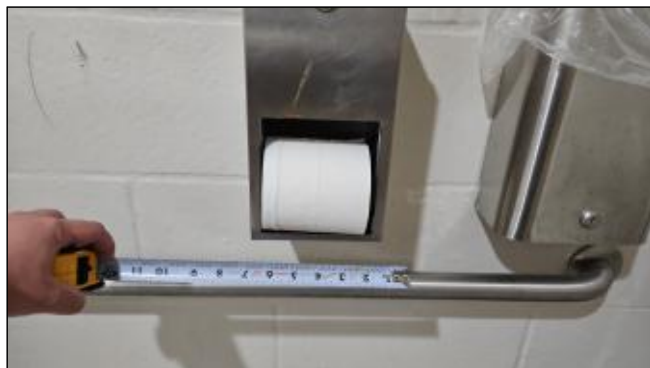
Finding: 213

The grab bar height and/or spacing fails.

Remount grab bars in accessible stall to 33" to 36" above the finished floor (AFF). Cost included in previous findings.

Remount toilet paper dispenser max 7" to 9" from front of toilet, 15" to 48" above the finished floor (AFF) and min 12" above or 1.5" below grab bar.

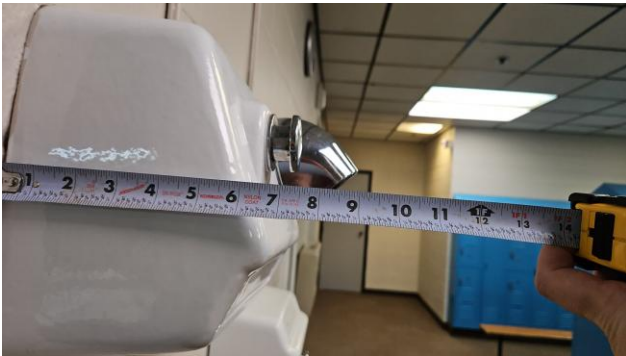
Finding: 216

Wall-mounted objects that have leading edges between 27 inches and 80 inches from the floor must not protrude more than 4 inches into the circulation path. Protruding objects that extend to the floor or within 27 inches of the floor are cane detectable and are therefore not hazardous. Where it is necessary or desirable to have objects protrude from the wall, a manner of cane detection must be provided.

Relocate protruding objects or place cane detectable bollard at foot of item.

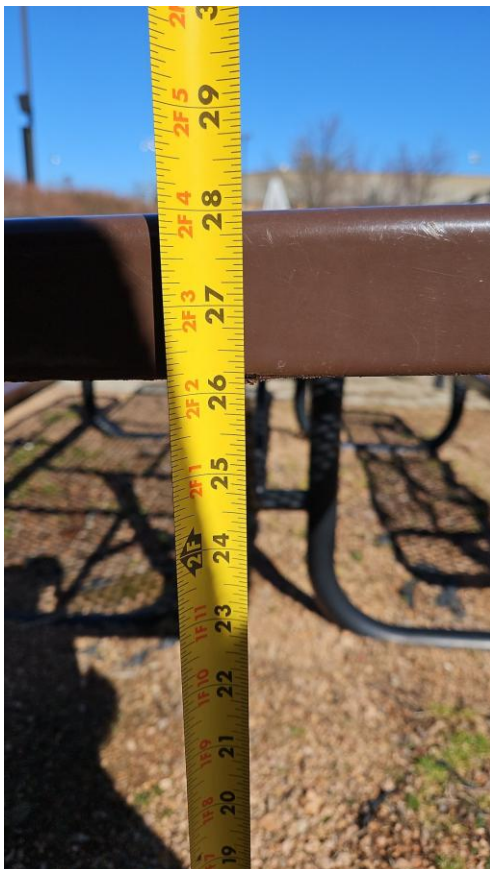
accessible table at play area has 26" high knee clearance, loose stone surface with .5" CIL from pavers

Replace picnic table with one of an accessible design. Repair pavers to eliminate CIL.
