Access Audit Final Site Report

Lions Park
110 W Camp McDonald Rd
Prospect Heights, IL 60070

Inspection Date: 02/29/2024
Inspectors: Shelley Zuniga

Prepared By
WT Group

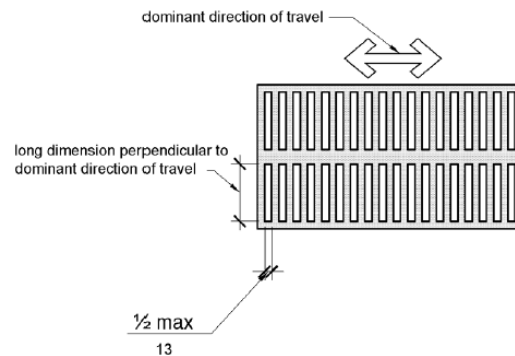
Finding #9 Additional Finding Photos

Ramp to shelter -
pavers in disrepair,
recommend full redo

See previous findings for corrections to all runs and landings of ramp.

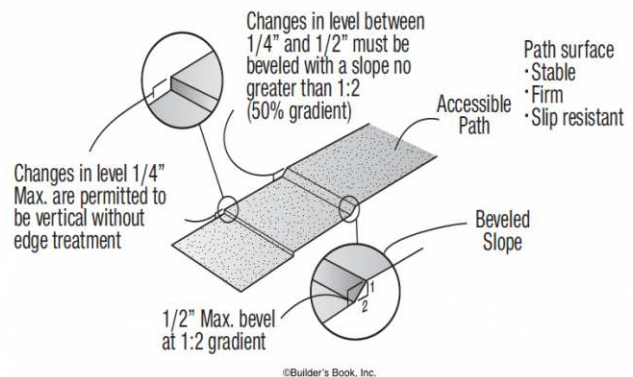
Finding #15 Additional Finding Photos

deterioration at curb
ramp from parking to
play area

Redo ramp to provide firm, stable and slip resistant surface.

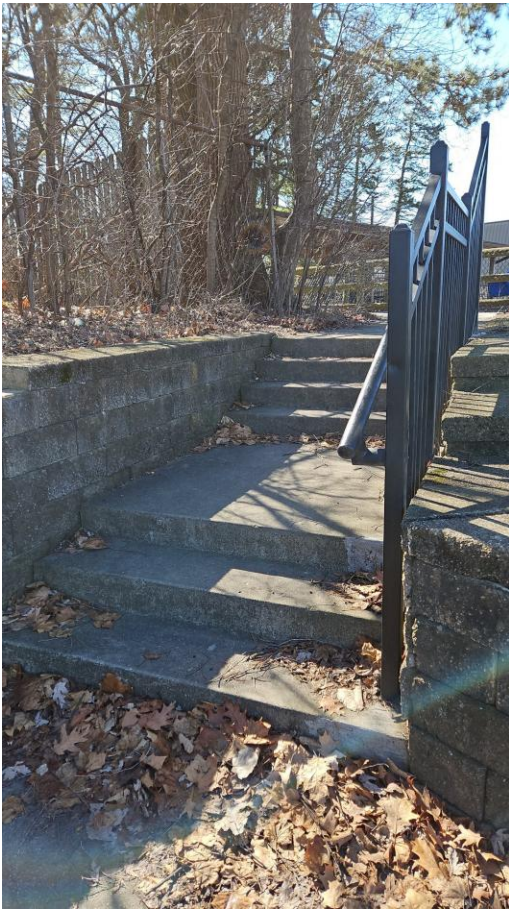
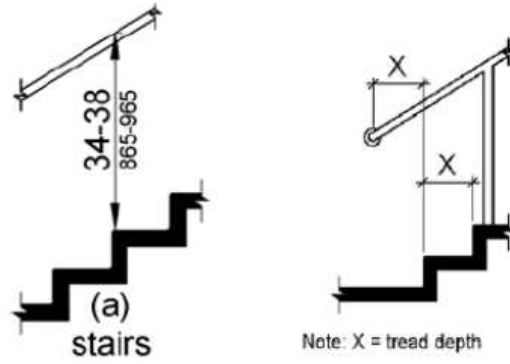
Finding #20 Continued

steps from tennis to shelter lack handrail on one side, existing handrail fails to have compliant extensions

Install handrails on both sides of stairway, mounted 34" to 38" aff with top and bottom extensions and having a 1.25" – 2" in diameter, or a non-circular grip that has a perimeter dimension of 4"- 6.25" max with a min gap of 1.5" between handrail and wall

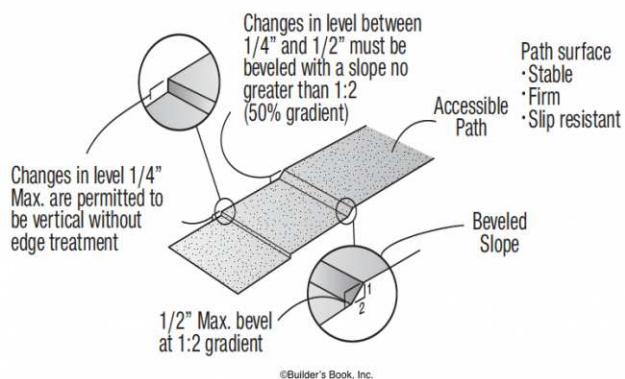
Finding #27 Additional Finding Photos

Ramp near baseball
stall - gutter
deterioration

Repair curb ramp to be firm, stable and slip resistant.

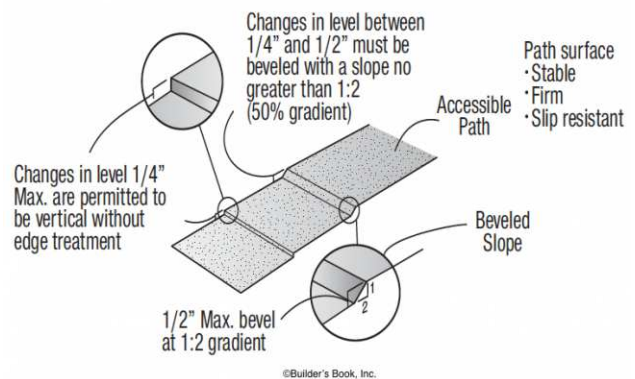
The accessible route contains loose gravel and/or surfaces that do not provide for a stable, firm slip resistant surface.

deterioration at
drainage pipe near trail

Resurface accessible route where deterioration occurs.

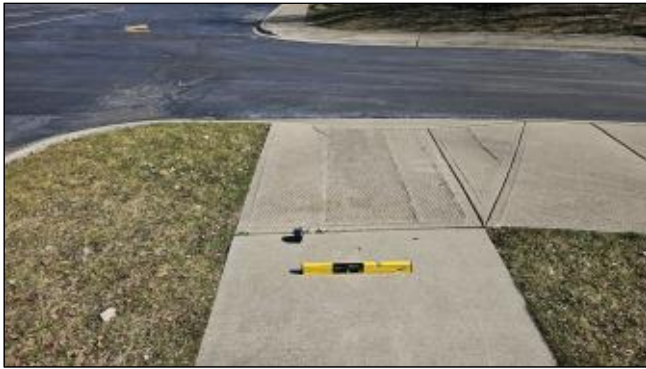
Finding #36 Additional Finding Photos

There is a gap spaced greater than a 1/2 inch.

2" gap at corner ramp
near ball field stall

Correct or fill gaps to be max .5".

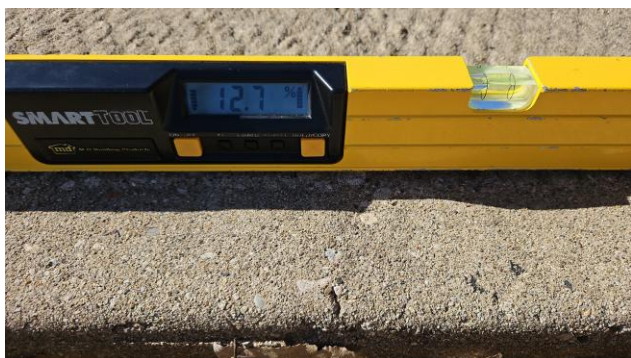
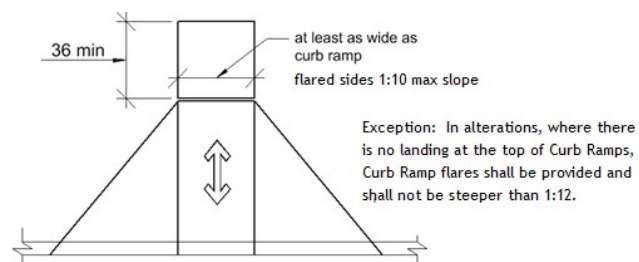
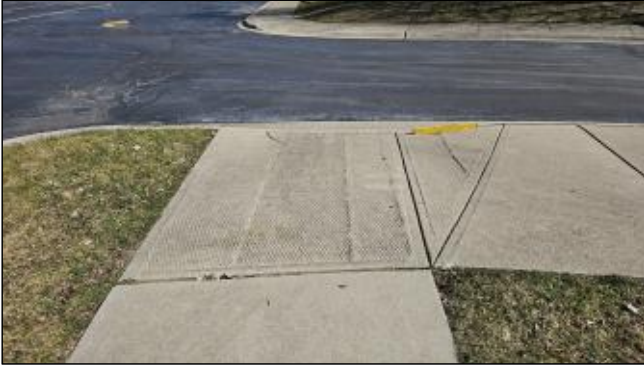
Finding #37 Additional Finding Photos

The curb ramp does not have a compliant top landing and the side flares are too steep.

Correct slope of side flares to max 8.33%

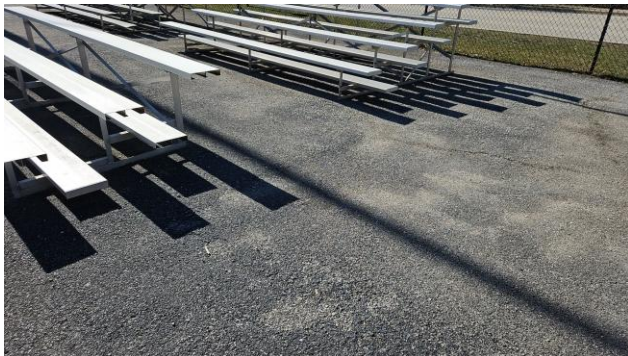
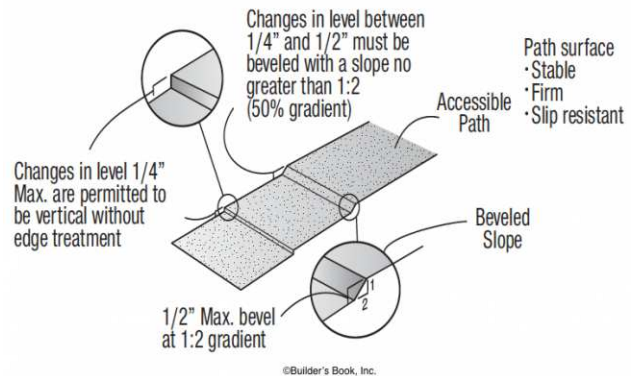
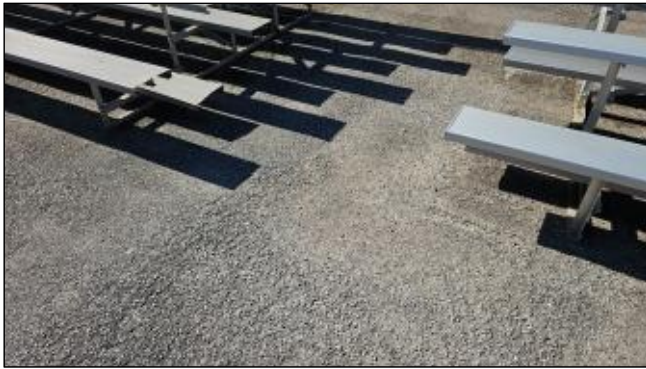
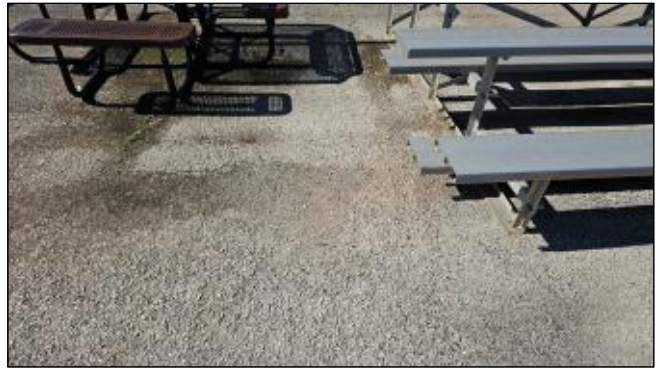
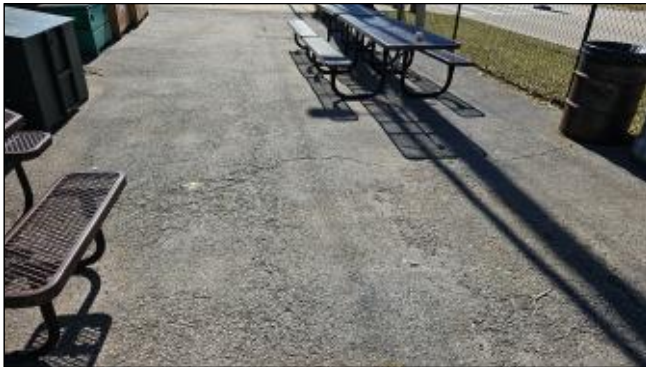
Finding #54 Additional Finding Photos

The accessible route contains loose gravel and/or surfaces that do not provide for a stable, firm slip resistant surface.

surface deteriorated at bleachers on 3rd base side, deterioration also by picnic tables

Resurface accessible route where deterioration occurs.

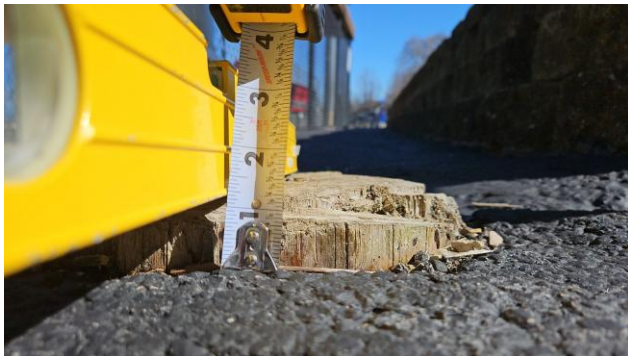
Finding: 57

The walkway contains abrupt vertical edges and/or variations over a 1/4 inch.

1.25" CIL at stump or removed post 1st base side

Repair, bevel or ramp change in level along accessible route.

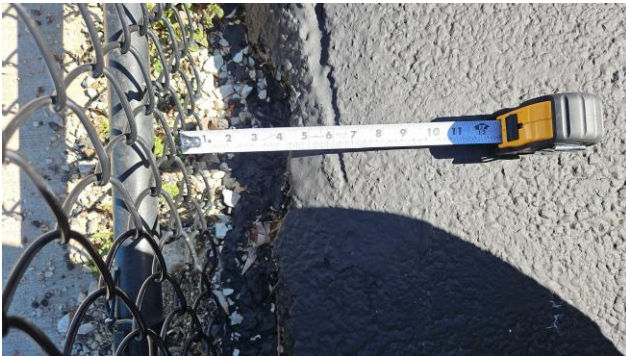
Finding: 58

There is a gap spaced greater than a 1/2 inch.

gaps up to 4" along
dugout fence first base
side

Correct or fill gaps to be max .5".

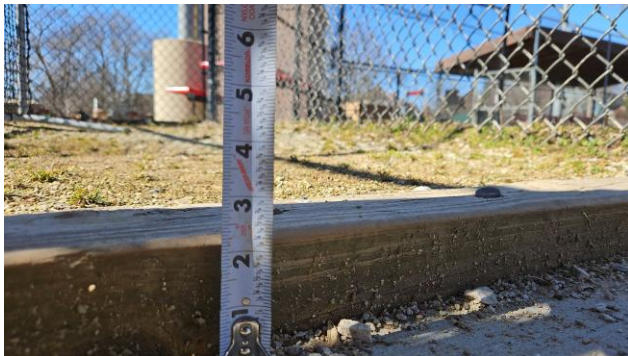
Finding: 59

The walkway contains abrupt vertical edges and/or variations over a 1/4 inch.

Repair, bevel or ramp change in level along accessible route.
