Access Audit Final Site Report

**Old Orchard Country Club
700 W Rand Rd
Mt Prospect, IL 60056**

**Inspection Date: 02/28/2024
Inspectors: Shelley Zuniga**

Prepared By
WT Group

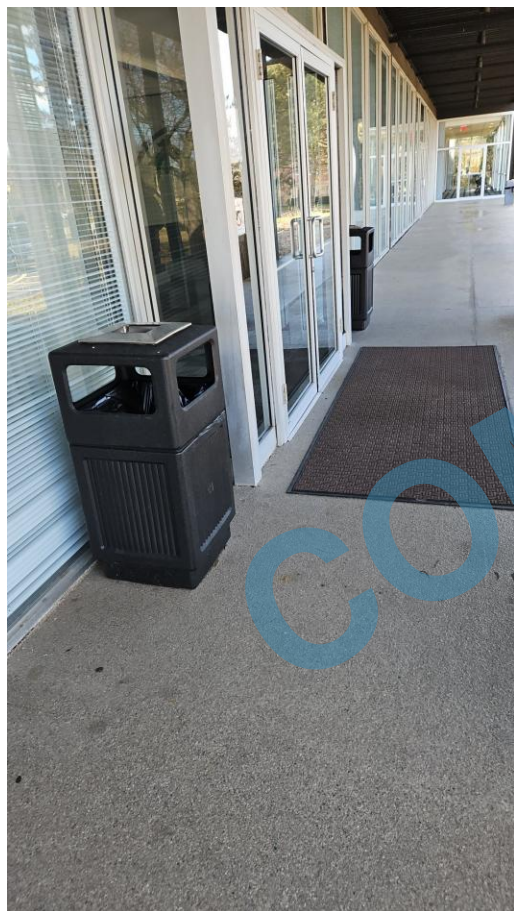
Finding: 11

Wall-mounted objects that have leading edges between 27 inches and 80 inches from the floor must not protrude more than 4 inches into the circulation path. Protruding objects that extend to the floor or within 27 inches of the floor are cane detectable and are therefore not hazardous. Where it is necessary or desirable to have objects protrude from the wall, a manner of cane detection must be provided.

Relocate protruding objects or place cane detectable bollard at foot of item.

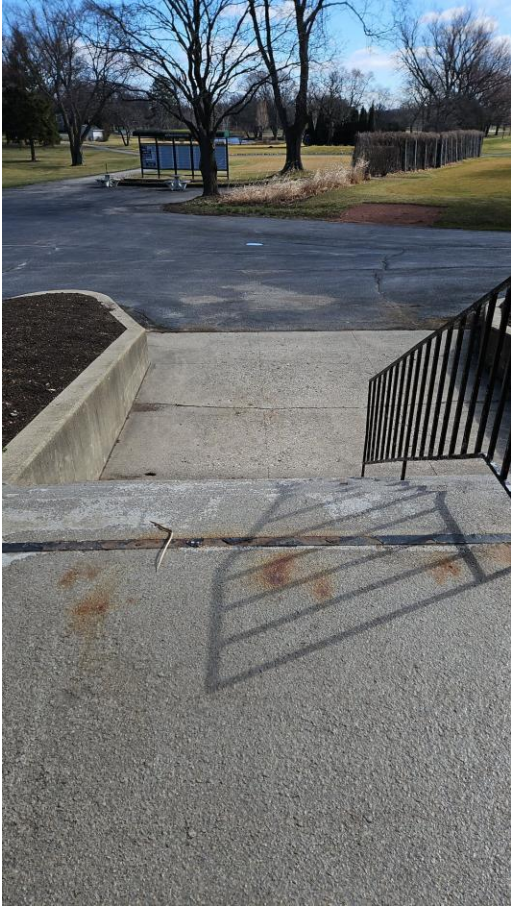
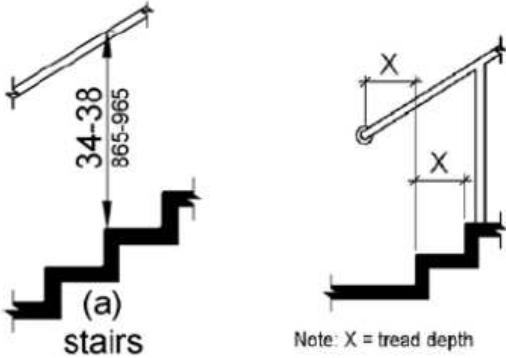
Finding: 14

route to building steep
and has surface
deterioration, leads to
stairs, no route

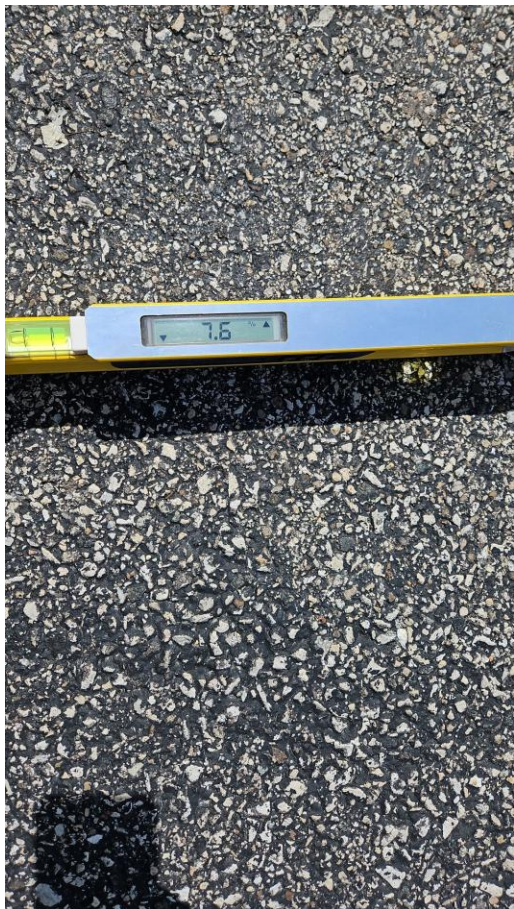
Finding #16 Additional Finding Photos

The accessible route contains loose gravel and/or surfaces that do not provide for a stable, firm slip resistant surface.

deterioration at entry
to path from drop off

Resurface accessible route where deterioration occurs.

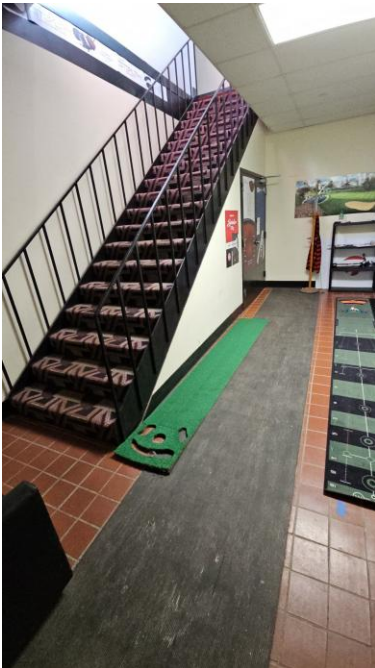
Finding: 19

Practice golf room in basement - 9 loose putting and hitting mats, 9 with pile heights of .75" to 1.75"

Replace 5% of the mats with ones having max pile or edge of 1/4".

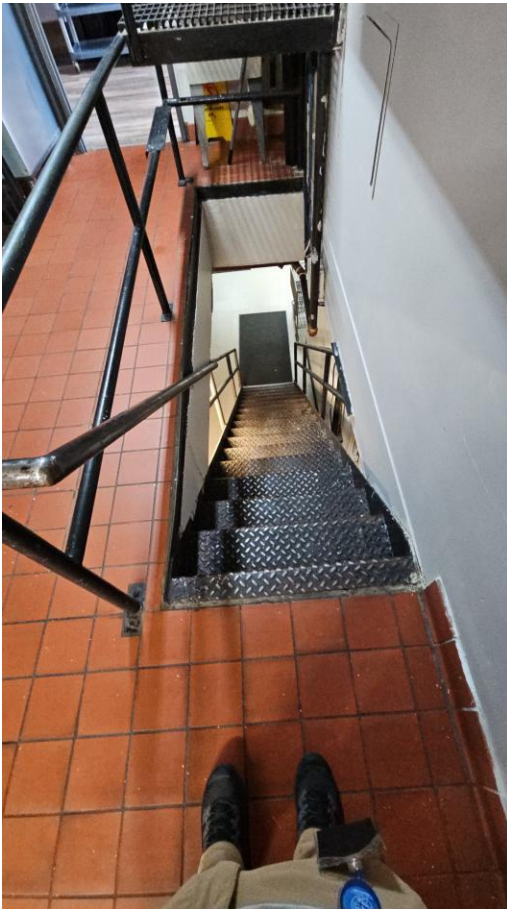
Finding: 40

Handrails fail:

Install handrails on both sides of stairway mounted 34" to 38" aff, with top and bottom extensions. Handrails must be 1.25"-2" in diameter, or a non-circular grip that has a perimeter dimension of 4"-6.25" maximum, with a minimum gap of 1.5" between handrail and wall. Handrails shall be continuous for the full flight of the stairs and continue around any switchbacks.

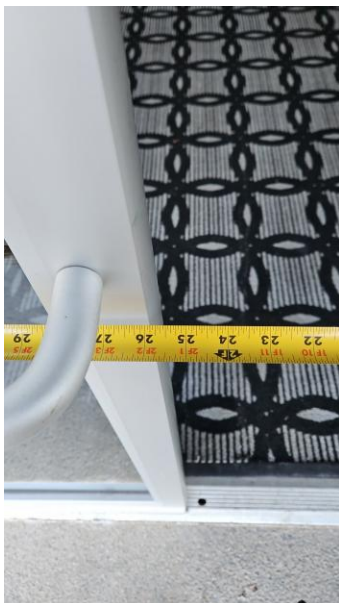
Finding: 63

Wall-mounted objects that have leading edges between 27 inches and 80 inches from the floor must not protrude more than 4 inches into the circulation path. Protruding objects that extend to the floor or within 27 inches of the floor are cane detectable and are therefore not hazardous. Where it is necessary or desirable to have objects protrude from the wall, a manner of cane detection must be provided.

Relocate protruding objects or place cane detectable bollard at foot of item.

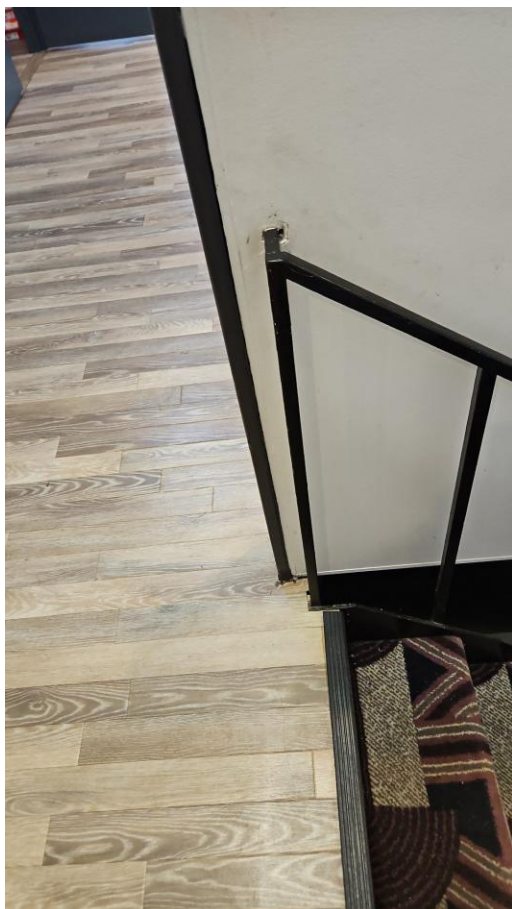
Handrails fail:

Install handrails on both sides of stairway mounted 34" to 38" aff, with top and bottom extensions. Handrails must be 1.25"-2" in diameter, or a non-circular grip that has a perimeter dimension of 4"-6.25" maximum, with a minimum gap of 1.5" between handrail and wall. Handrails shall be continuous for the full flight of the stairs and continue around any switchbacks.

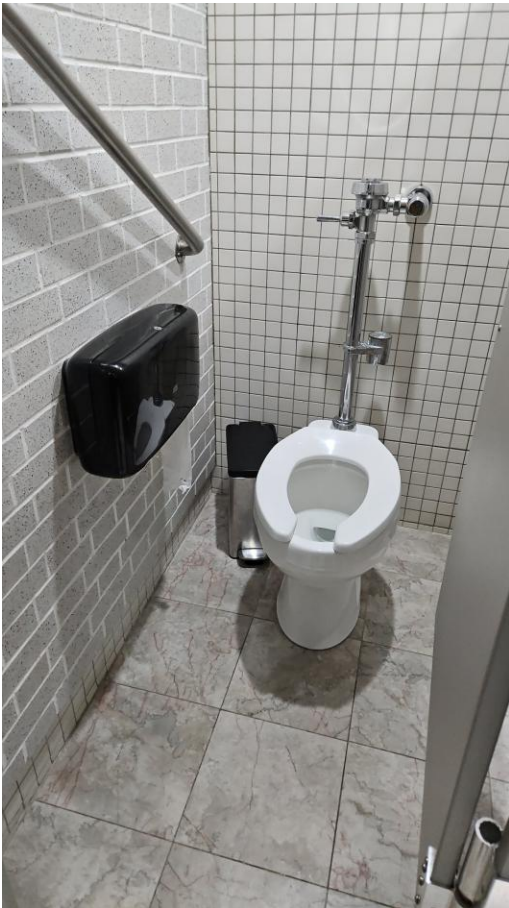
Finding: 96

Restrooms: Main Floor Women's Restroom

Correct ambulatory stall to be 35" to 37" wide and minimum 60" deep; or in the alternative, use existing ambulatory stall to create wheelchair stall if feasible.

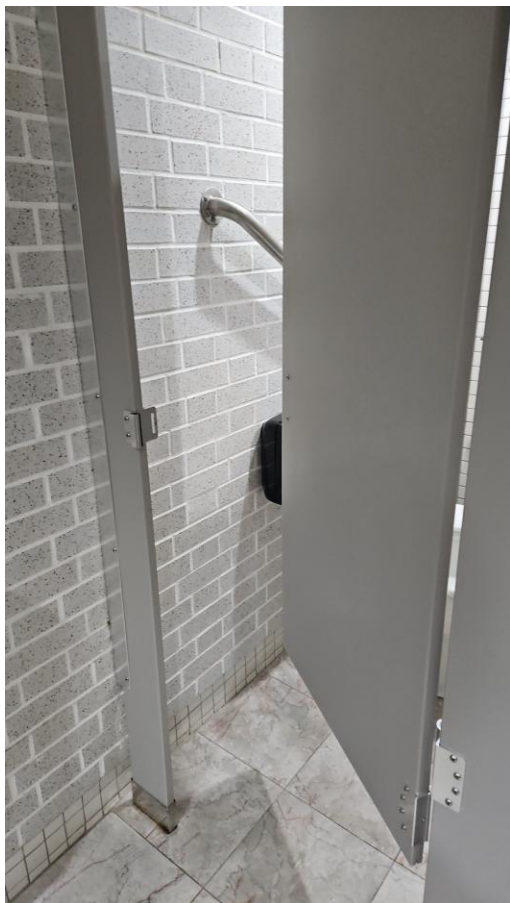
Finding: 98

Restrooms: Main Floor Women's Restroom

Add grab bars for the appropriate stall - two side bars for ambulatory, or a side and rear for the new wheelchair stall. Side bars shall be a 42" long grab bar, mounted max 12" from the rear wall at the close end and min 54" on the far end and 33" to 36" aff. Rear bar shall be 36" long and mounted 12" to the closed side and 24" to the open side of the toilet measured from the centerline.

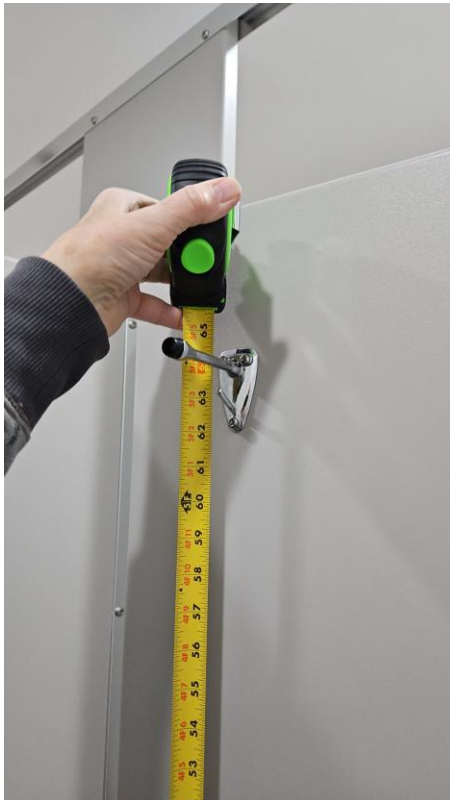
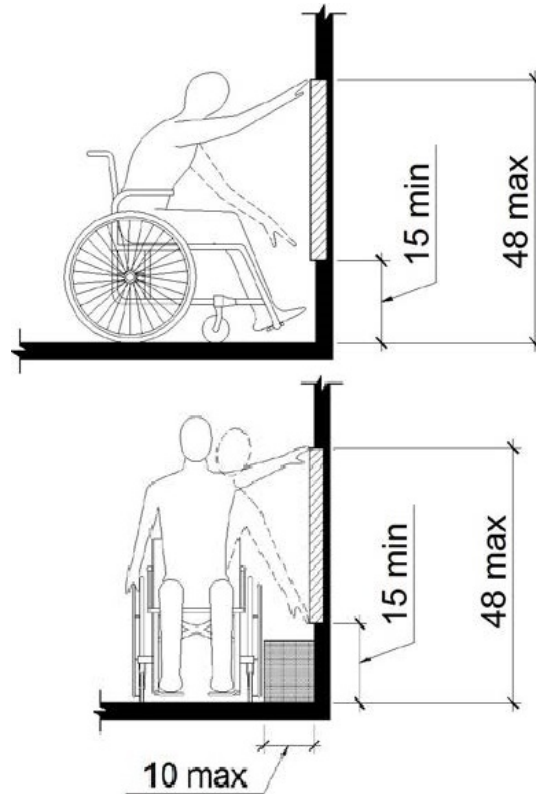
Finding: 110

Restrooms: Main Floor Men's Restroom

Create a wheelchair accessible stall with grab bars and fixtures mounted in correct locations and at correct heights.

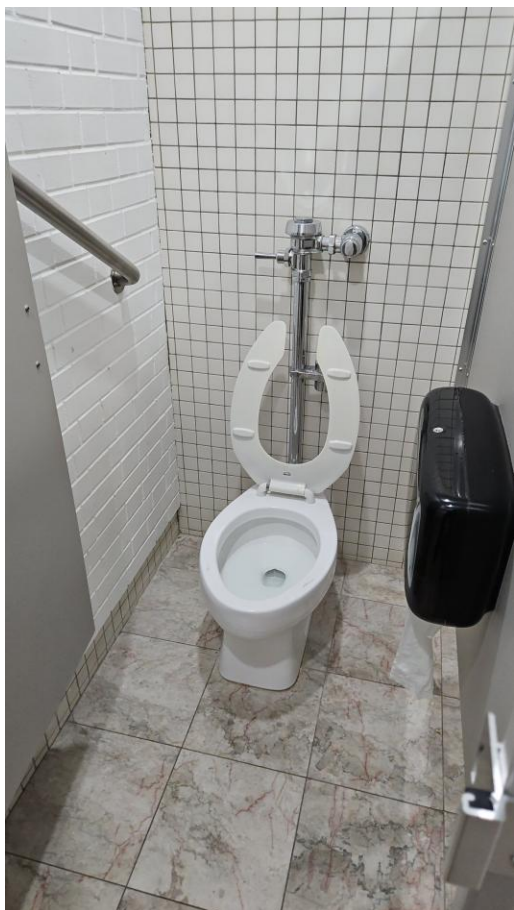
Finding: 111

Restrooms: Main Floor Men's Restroom

Correct ambulatory stall to be 35" to 37" wide and minimum 60" deep or use existing stall to create required wheelchair stall.

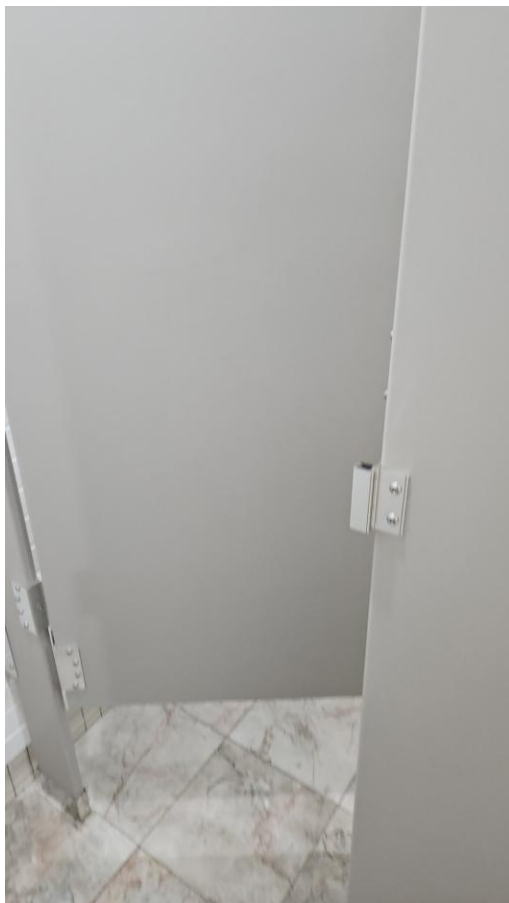
Finding: 115

Restrooms: Main Floor Men's Restroom

Add grab bars for the appropriate stall - two side bars for ambulatory, or a side and rear for the new wheelchair stall. Side bars shall be a 42" long grab bar, mounted max 12" from the rear wall at the close end and min 54" on the far end and 33" to 36" aff. Rear bar shall be 36" long and mounted 12" to the closed side and 24" to the open side of the toilet measured from the centerline.

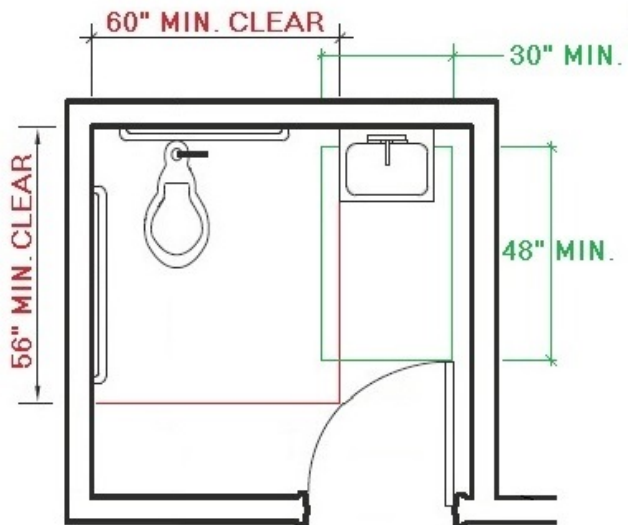
Finding: 123

Restrooms: Bridal Suite

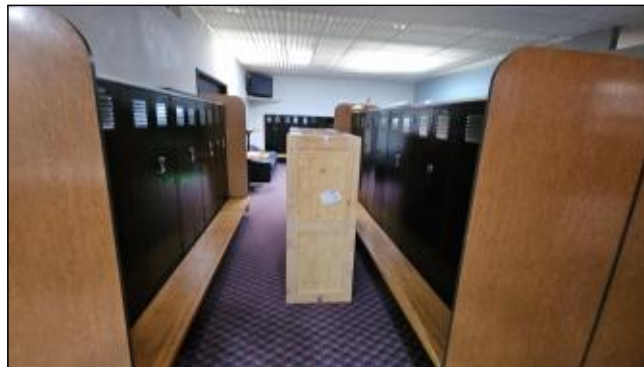
Finding: 125

Restrooms: Men's Locker Room

Provide required 30" by 48" CFS at designated accessible lockers.

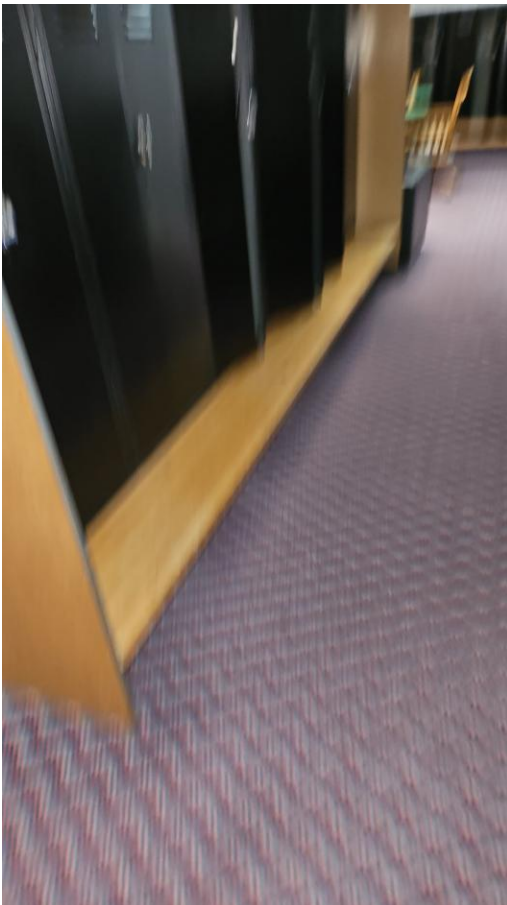
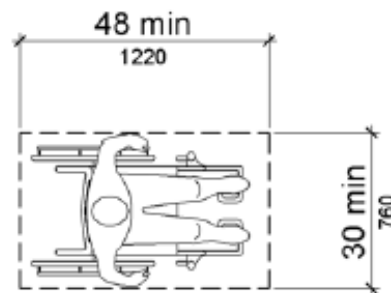
Finding: 126

Restrooms: Men's Locker Room

Replace or remount locker to max 48" to the hooks.

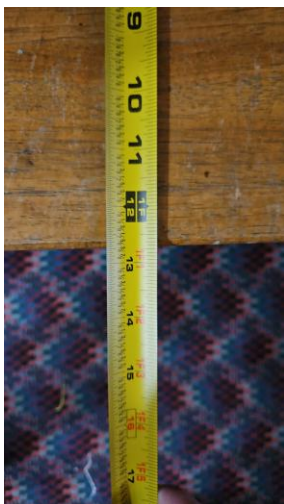
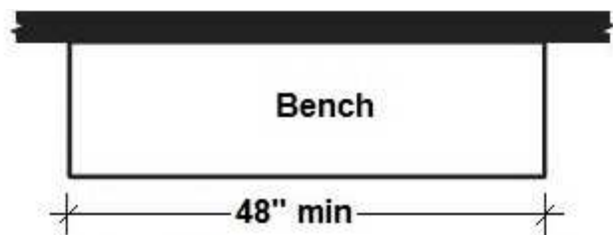
Finding #128 Additional Finding Photos

The bench is not deep enough or long enough or is missing.

Replace bench in dressing area with one having a seat depth of 20" to 24" deep, 42" long, affixed to the wall or having a back and mounted 17" to 19" AFF and provide required clear floor space on the short axis of the bench.

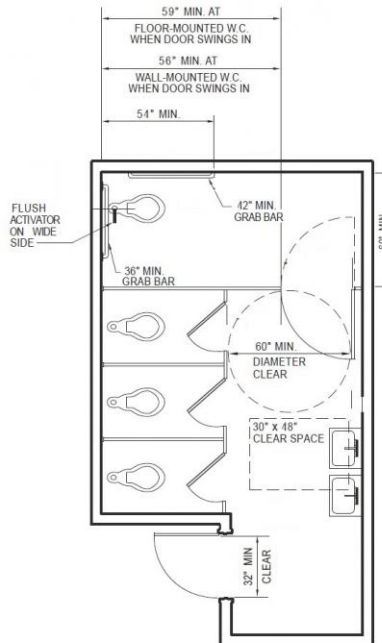
Finding: 131

Restrooms: Men's Locker Room Restroom

Acquire and mount signage, including Braille and raised lettering and mount on wall, latch side of door, 48" to baseline of lowest character and 60" to baseline of highest character.

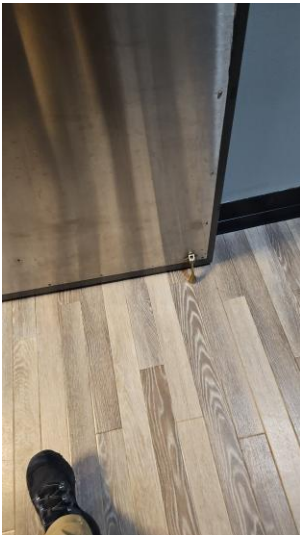
Finding: 133

Restrooms: Men's Locker Room Restroom

For all doors/gates along the public circulation route, replace with doors/gates having 80" overhead clearance and 32" clear width.

For all doors/gates along the public circulation route, repair, bevel, or ramp CILs at entries to max .25".

For all doors/gates along the public circulation route, replace hardware with lever hardware or hardware operable without a tight pinch or grasp.

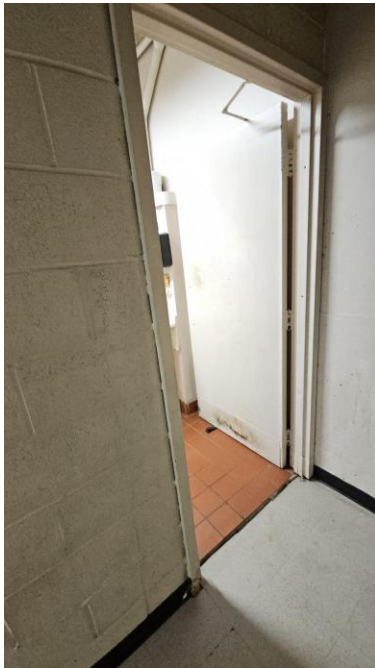
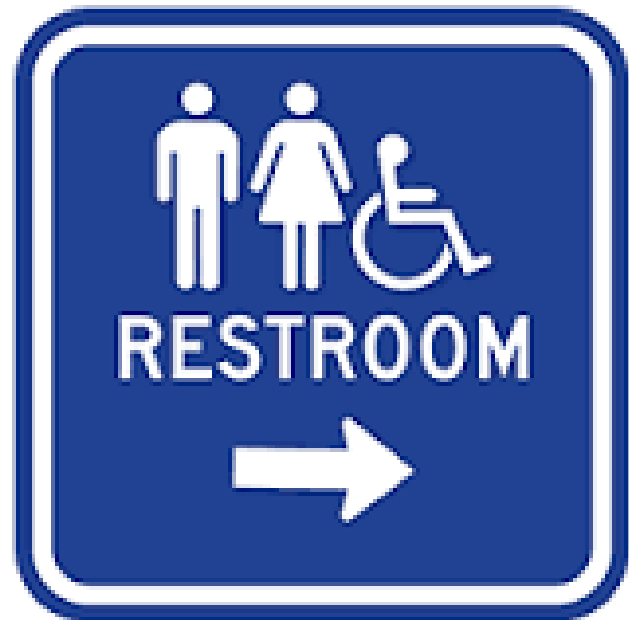
Finding: 136

Restrooms: Basement Employee Restroom

Acquire and mount signage, including Braille and raised lettering and mount on wall, latch side of door, 48" to baseline of lowest character and 60" to baseline of highest character.

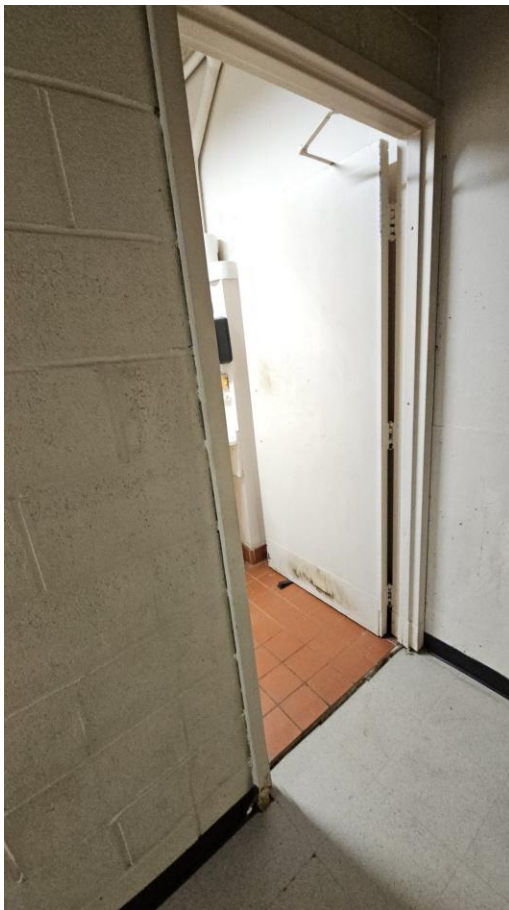
Finding: 137

Golf Course: Maintenance

Entry Door - 26# push,
fast close, knob, 1.5"
threshold , exterior
surface deteriorated,
pipe in pull side
clearance

Repair, provide beveled threshold.

Inspect, adjust, and maintain 8.5 lbf to open exterior doors.

Replace hardware with lever hardware or hardware operable without a tight pinch or grasp.

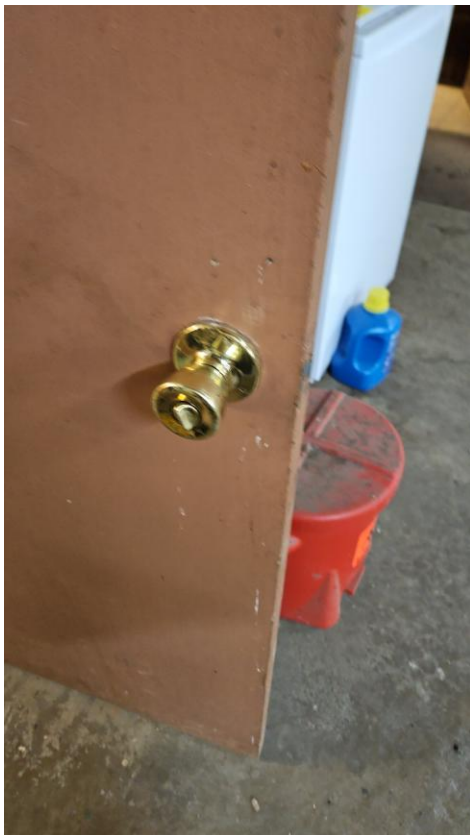
Finding #139 Additional Finding Photos

The tactile EXIT sign is missing at the door. Wall signs identifying exits shall have characters raised 1/32 inch minimum and shall be uppercase characters a minimum of 5/8 inch and a maximum of 2 inches high. Braille shall be placed directly below the tactile characters; flush left or centered. Signs shall be located a minimum of 48 inches above the floor, measured from the baseline of the lowest tactile characters and 60 inches maximum above the finish floor or ground surface, measured from the baseline of the highest tactile characters.

For all doors/gates along the public circulation route, replace with doors/gates having 80" overhead clearance and 32" clear width.

For all doors/gates along the public circulation route, replace hardware with lever hardware or hardware operable without a tight pinch or grasp.

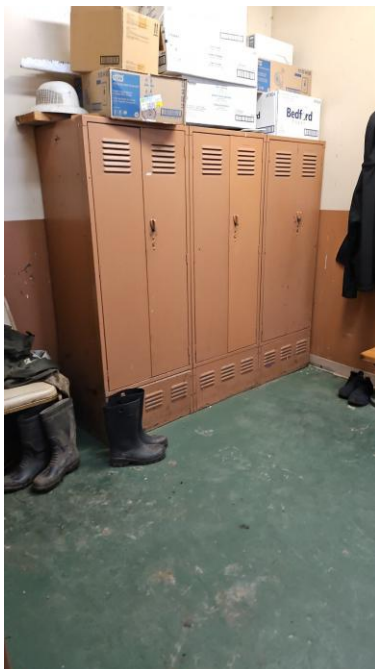
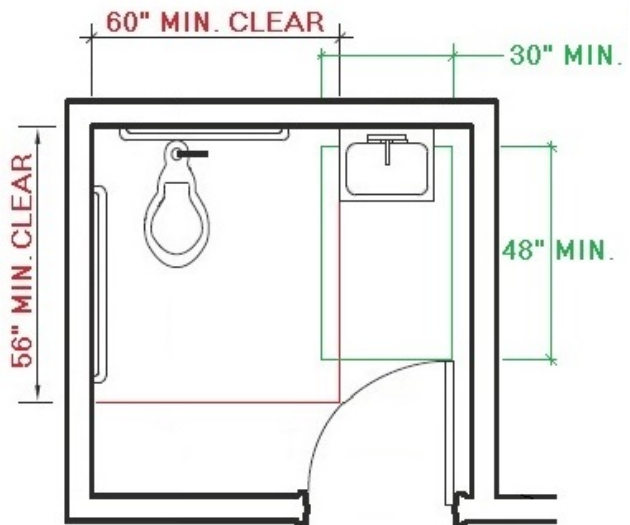
Finding #140 Additional Finding Photos

Grab bars are missing and/or incorrectly installed.

Create a compliant wheelchair accessible restroom and correct all features to be accessible if feasible. Provide at least one accessible locker.

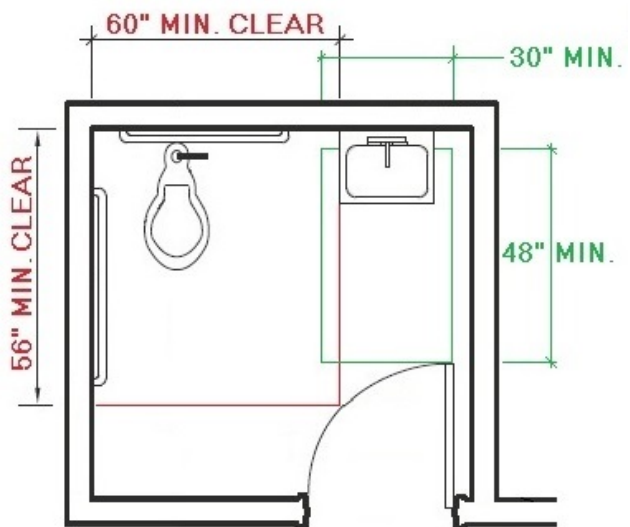
Finding: 147

Golf Course: Women's Restroom - 5th Hole

Grab bars are missing and/or incorrectly installed.

Create a compliant wheelchair accessible restroom and correct all features to be accessible if feasible. See previous finding for cost.

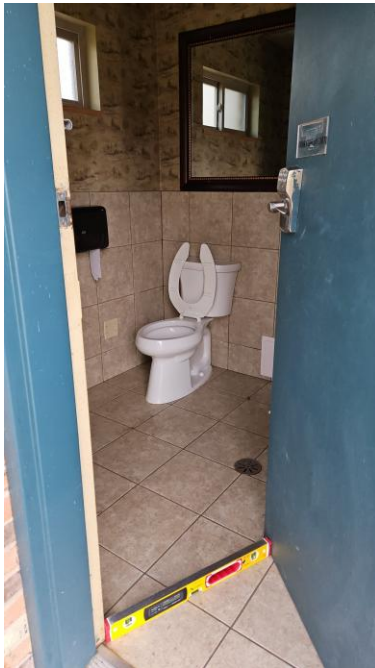
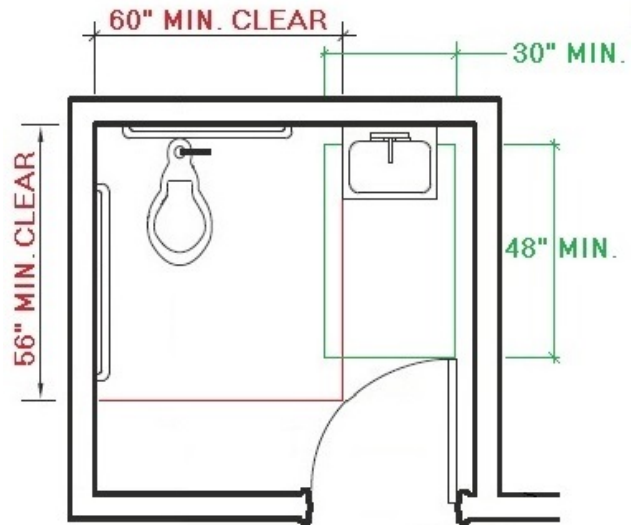
Finding: 148

Golf Course: Women's Restroom - 5th Hole

Grab bars are missing and/or incorrectly installed.

Restroom meets sizing for accessible restroom - add accessible features. Priced in previous findings.

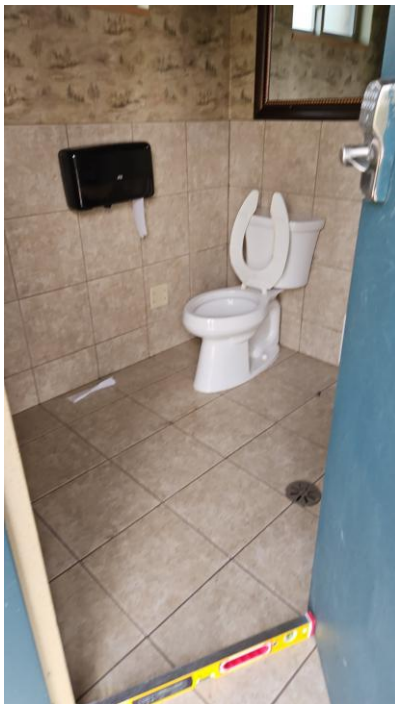
Finding: 149

Golf Course: Women's Restroom - 5th Hole

Acquire and mount signage, including Braille, raised lettering and access symbol mounted on wall, latch side of door, 48" to baseline of lowest character and 60" to baseline of highest character.

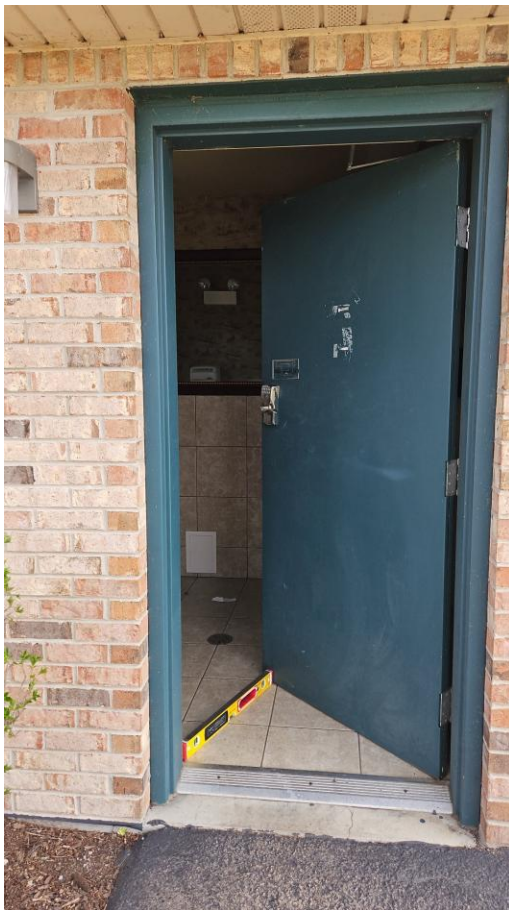
Finding: 150

Golf Course: Women's Restroom - 5th Hole

For all doors/gates along the public circulation route, remount hardware to 34" to 48" AGL.

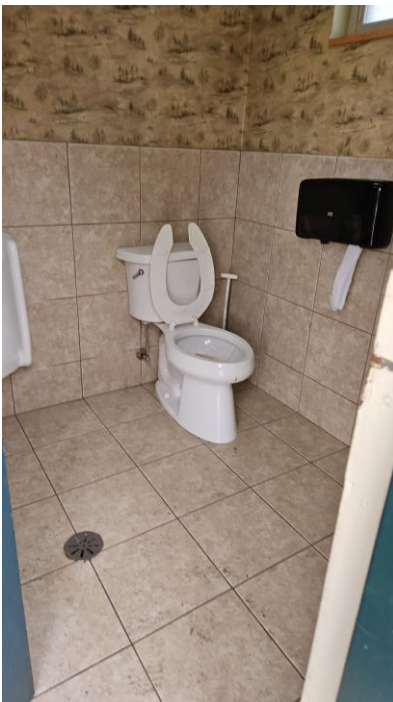
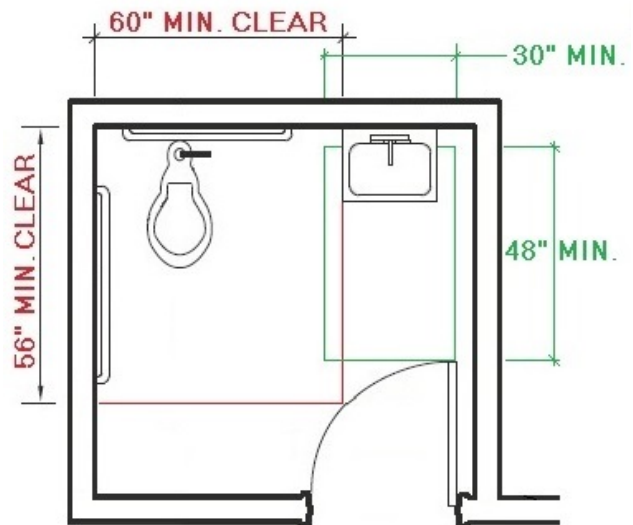
Finding: 152

Golf Course: Men's Restroom - 5th Hole

Grab bars are missing and/or incorrectly installed.

Leave as is and make other restroom accessible per previous findings.
